**CCTV REPORT FOR: 18 THE GREEN
HUDDERSFIELD
HD2 1QB**

Insured: Mr. A. & Mrs. E. Doherty
Reference: DLG-SN-22-004909 Ins Ref: 084336015

Site Visit: 20-Feb-23
Report Date: 25-Apr-23

Address: **18 THE GREEN, HUDDERSFIELD, HD2 1QB**

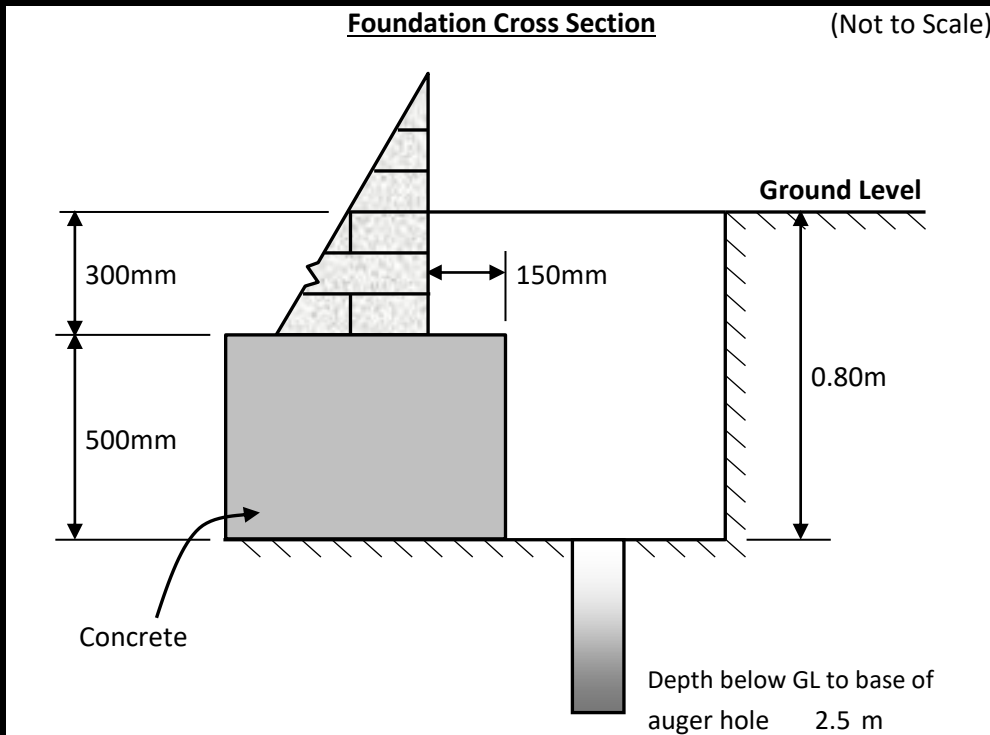
Location: **Rear of House** T/H No. **1**
 Ground Surface: **Damp** Weather: **Dry** Date: **20-Feb-23**

Roots Depth & Diameter:
 From 0.8m
 Down to 2.5m
 up to 2mm diameter

Water Depth Hit & Rise:
 None observed on site

Reason for Termination:
 Encountered obstruction
 Solid ground

General Comments :
 Ground was very dry in area of trial hole and difficult to auger.

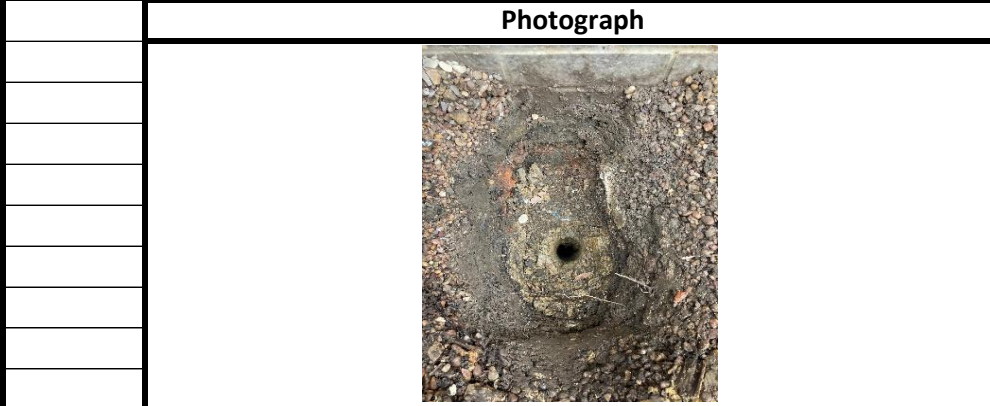
Depth (m)	Soil Descriptions <i>(NB: Field crew description only)</i>	Test Type	Depth (m)	
			From	To
G.L.				
0.80	Firm/stiff brown slightly gravelly slightly sandy CLAY	V(n) 64	0.800	
2.00	Stiff brown slightly gravelly slightly sandy CLAY	V(n) 65	1.500	
2.50	End of Borehole	V(n) 90	2.000
