Preliminary Roost Assessment and Ecological Walkover

Folly Hall, Huddersfield

Reference: 81-859

Date: May 24

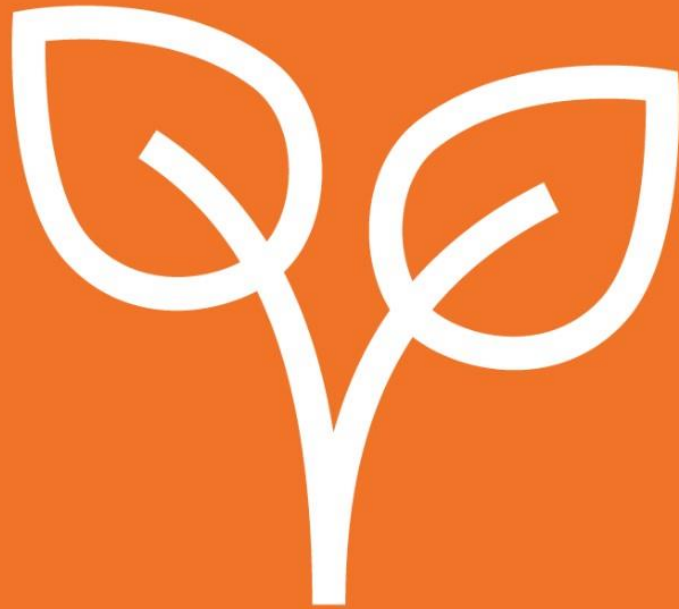
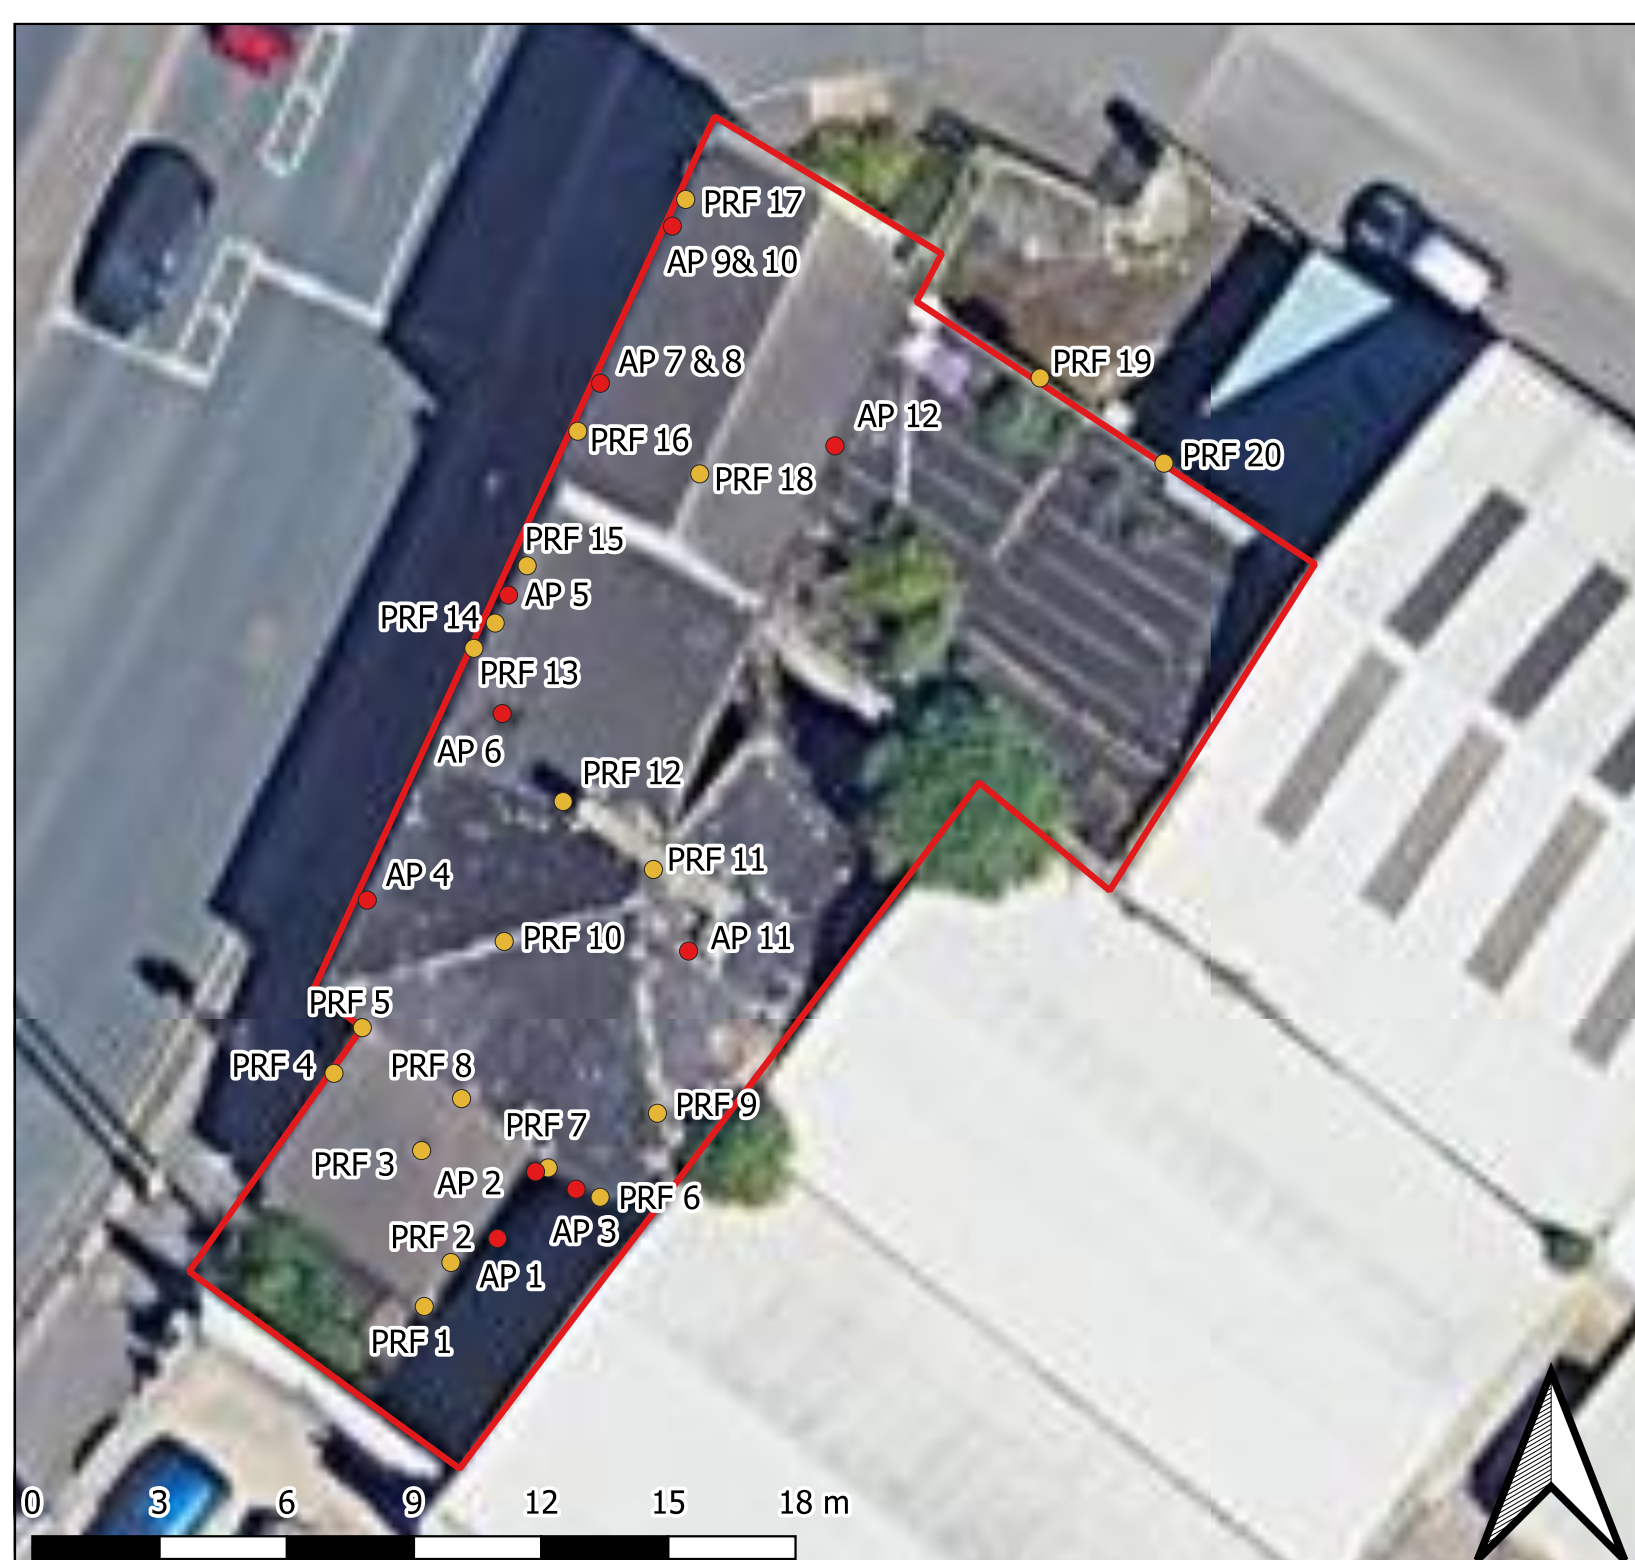
**APPENDIX I
PRELIMINARY ROOST
ASSESSMENT PLAN**

An access point (AP) into the small extension was identified along the east of the extension. This was within a doorway under where a small section of roof had fallen (AP1). This access point provided access into the small extension; however, an internal survey could not be undertaken as the building was deemed unsafe. Because of this, the presence of potential roost features that could support a small number of bats on a regular basis cannot be discounted.

Damaged and lifted roof tiles were present along both ridges of the hipped roof (PRF 9 and PRF 10). Due to the size of the ridges, they are likely to support a small number of opportunistic crevice-dwelling bats on an occasional basis. These features have the potential to provide access into the loft void, as an internal survey could not be undertaken. Because of this, the presence of potential roost features that could support a small number of bats on a regular basis cannot be discounted. The loft void is unlikely to support maternity or hibernation roosts as it is exposed to the weather through the large gaps in the roof where the roof collapsed because of the damage caused by the fire. This damage is likely to cause fluctuating temperatures within the loft.

A stone brick structure was identified along the top of the hipped roof (PRF 11). Multiple brickwork crevices were noted within the feature. These crevices are likely to support opportunistic crevice-dwelling bats on an occasional basis.

Conclusions and Recommendations	<p>The building was assessed as having moderate bat roosting potential. As such, Two Nocturnal Bat Surveys are required on the building between May and September (inclusive), with at least one survey being completed between May and August (inclusive). The surveys will be spaced three weeks apart. If bats are identified roosting within the building, a total of three surveys spaced three weeks apart would be required to characterise the roost and a European Protected Species Licence (EPSL) would be required with up-to-date surveys from the survey season prior to the application submission. An EPSL can only be applied for when planning permission has been obtained and all wildlife conditions discharged.</p> <p>The building was assessed as having nesting bird value. The works should be conducted outside of the nesting bird season (March to September inclusive). If this is not possible, a nesting bird check will be undertaken by a suitably qualified ecologist up to 24 hours before works commence. Should any nests, or nests in construction be located, a suitable stand-off distance should be maintained until the young have fledged. The ecologist will advise on suitable stand-off and provide a toolbox talk to all site contractors regarding their working limits and legal implications. It is recommended that bat and bird boxes are incorporated into the development.</p>
