410004-FCA-00-00-SU-A-0750-S2-P01 - Highways Dilapidation Survey

Taken 17/07/2024

For Planning application 2023/92712 and land adjacent, 36 Oxford Road, Dewsbury, WF13 4LL

To be read in conjunction with drawing 410004-FCA-00-00-DR-A-0750-S2-P01

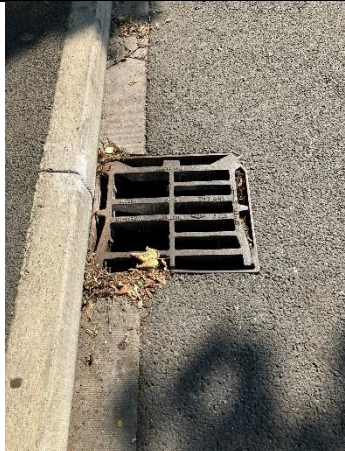
<p>View 01 - Gully 01</p> <p>Condition – Poor.</p> <p><i>Damaged metal grate with missing bars.</i></p> <p><i>The gully and drainage system is backed up with silt and debris (litter), see below.</i></p>

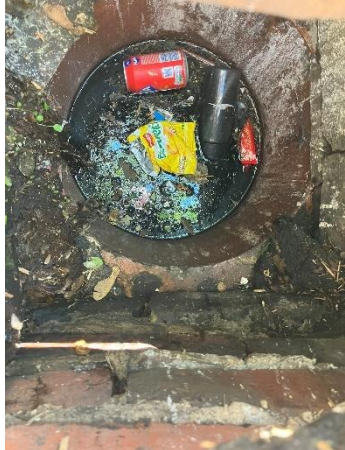
<p>View 02 - Gully 01</p> <p>This is a typical example of the gullies along Oxford Road. These are generally backed up (although not fully) with silt and debris.</p>

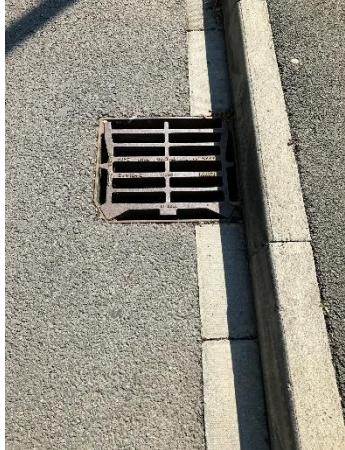
<p>View 03 - Gully 02</p> <p>Condition – Reasonable.</p> <p><i>The grate is complete, in tacked and shows no signs of damage. It is set hard against the Kerb and level with the surface.</i></p>

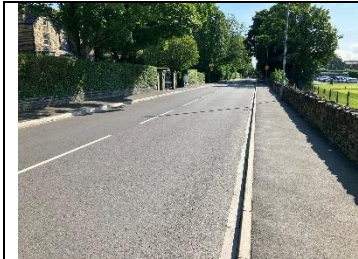
<p>View 04 - Oxford Road 00</p> <p>Location – Adjacent Corner of proposed Site</p> <p>Condition – Reasonable</p>

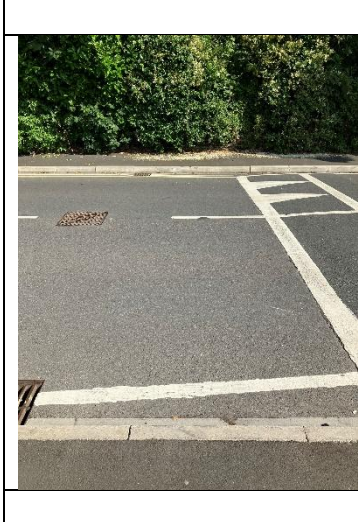
<p>View 11 - Oxford Road</p> <p>Location – Between Speed Hump and Gullies/MH02 (See plan)</p> <p>Condition – Reasonable.</p>

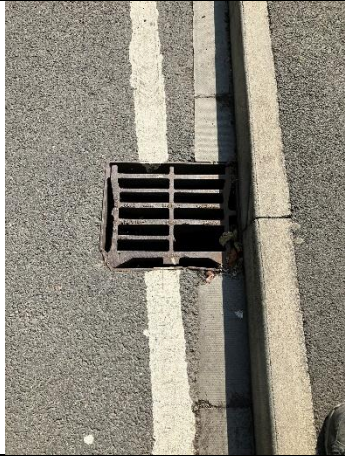
View 12 - Gully 04

Condition – *Poor.*

Damaged metal grate with missing bars.

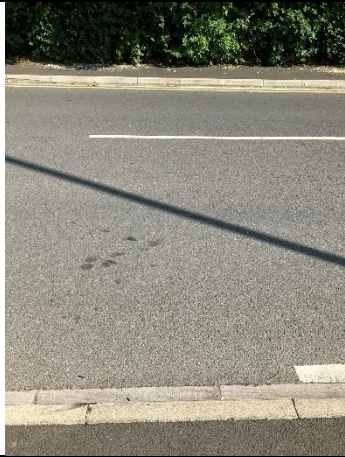
View 13 - Oxford Road

Condition – *Reasonable.*

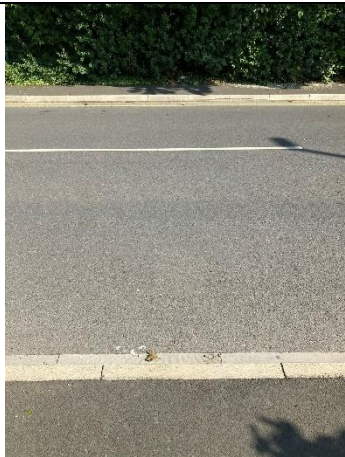
View 14 - Oxford Road

Condition – *Reasonable.*

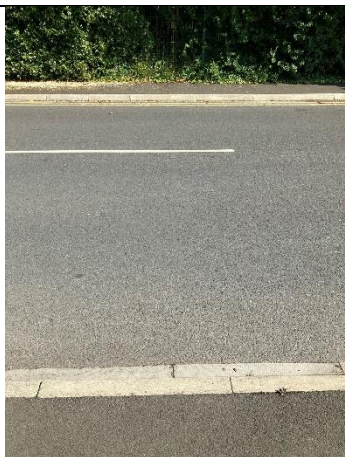
View 15 - Oxford Road

Condition – *Reasonable.*

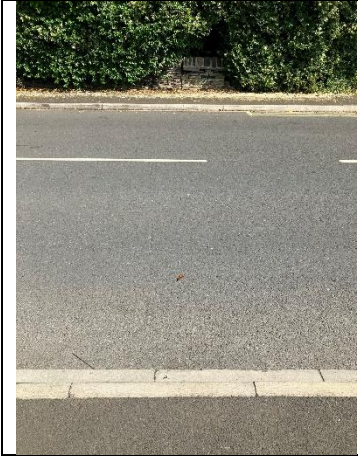
<p>View 16 - Oxford Road</p> <p>Location – See Plan</p> <p>Condition – Reasonable.</p>

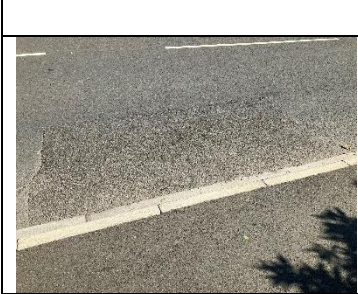
<p>View 18 - Oxford Road</p> <p>Location – See Plan</p> <p>Condition – Repaired.</p>

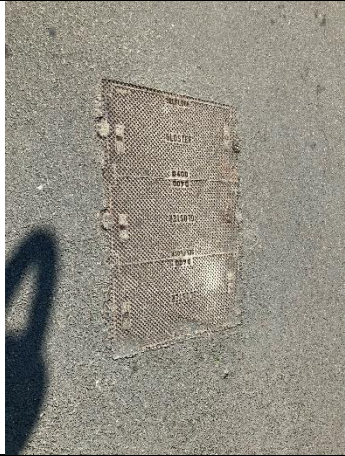
View 28 – Inspection Chamber 01

Condition – Reasonable.

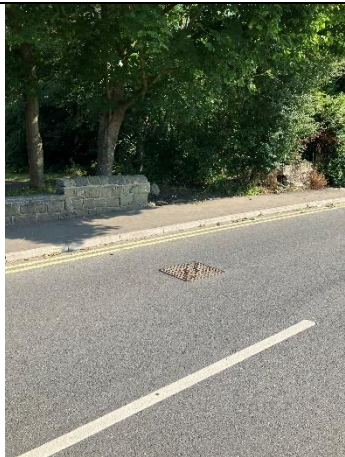
View 29 – Oxford Road

Condition – Reasonable.

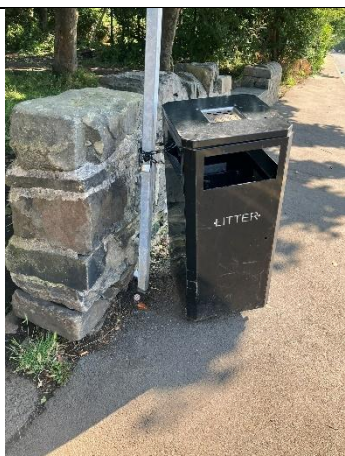
View 31 – Oxford Road

Condition – Poor.

Litter bin is not secured to the ground, but is chained to an adjacent sign.

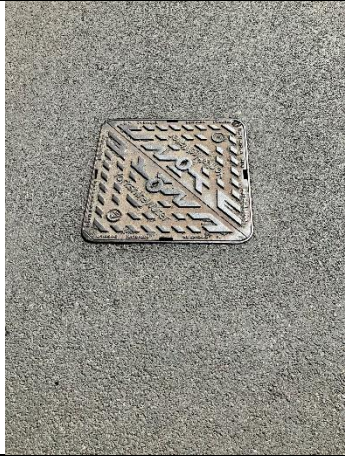
View 32 – Man Hole 04

Condition – *Reasonable.*

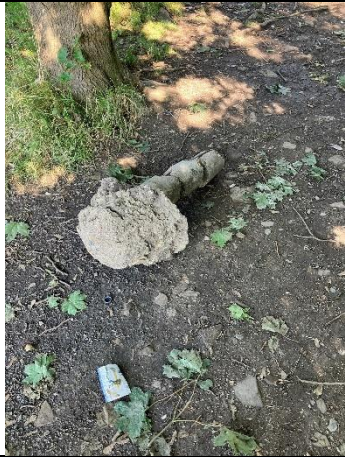
View 33 – Broken Bollard

Condition – *Damaged.*

Concrete bollard is damaged and has been uprooted.

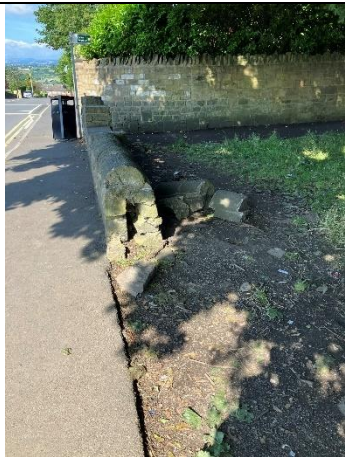
View 34 – Broken Wall

Condition – *Damaged.*

Stone wall is damaged and incomplete.

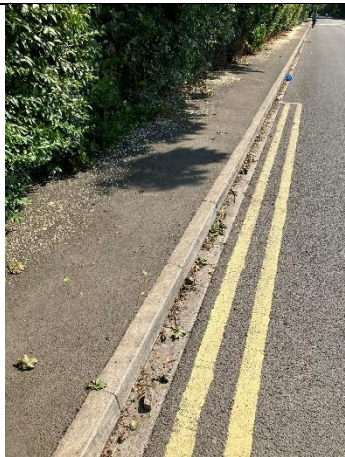
View 35 – Oxford Road

Condition – *Reasonable.*

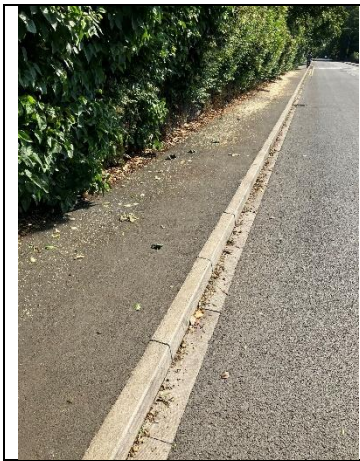
<p>View 36 – Oxford Road</p> <p>Location – See Plan.</p> <p>Condition – Reasonable.</p>

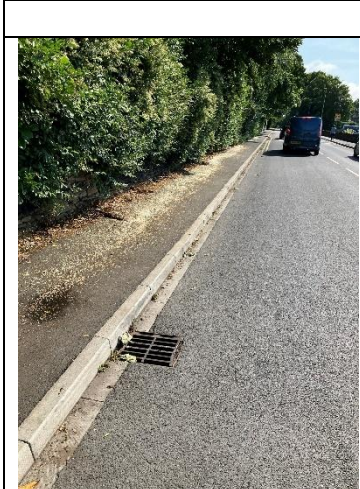
<p>View 37 – Oxford Road</p> <p>Location – See Plan.</p> <p>Condition – Reasonable.</p>

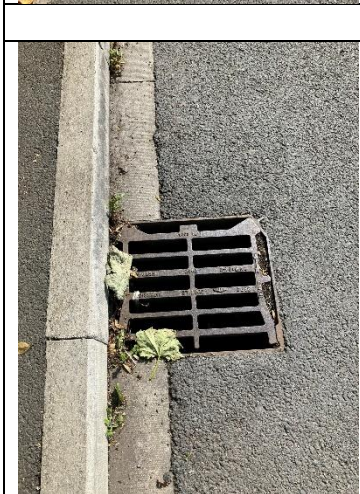
<p>View 38 – Gully 05</p> <p>Location – See Plan.</p> <p>Condition – Reasonable.</p> <p><i>The grate is complete, in tacked and shows no signs of damage. It is set hard against the Kerb and level with the surface.</i></p>

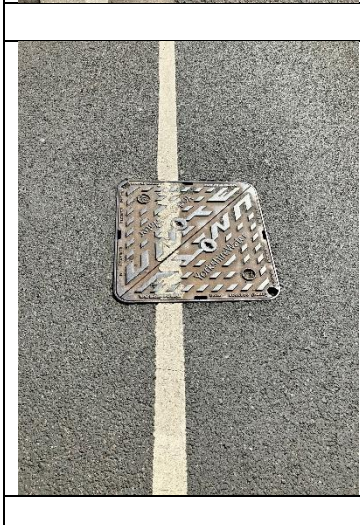
<p>View 39 – Man Hole 03</p> <p>Location – See Plan.</p> <p>Condition – Reasonable.</p>

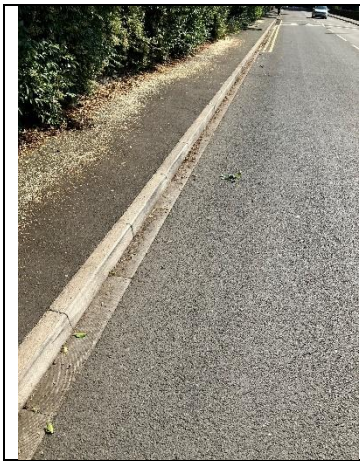
<p>View 40 – Oxford Road</p> <p>Location – See Plan.</p> <p>Condition – Reasonable.</p>

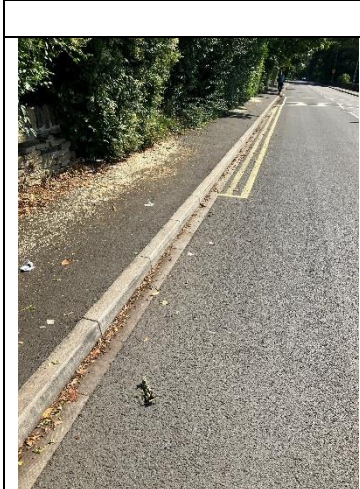
<p>View 41 – Oxford Road</p> <p>Location – See Plan.</p> <p>Condition – Reasonable.</p>

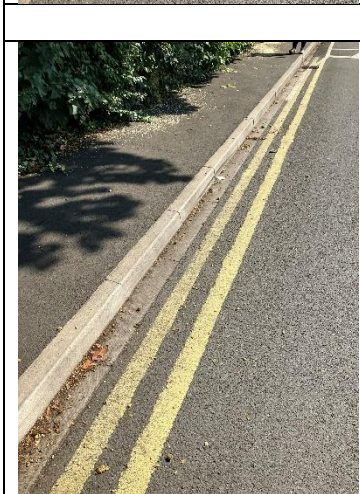
<p>View 42 – Oxford Road</p> <p>Location – See Plan.</p> <p>Condition – Reasonable.</p>

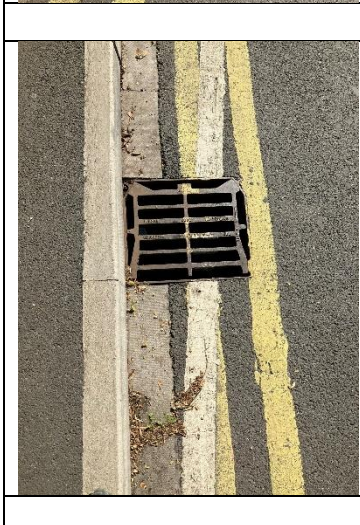
<p>View 43 – Gully 03</p> <p>Location – See Plan.</p> <p>Condition – Reasonable.</p>

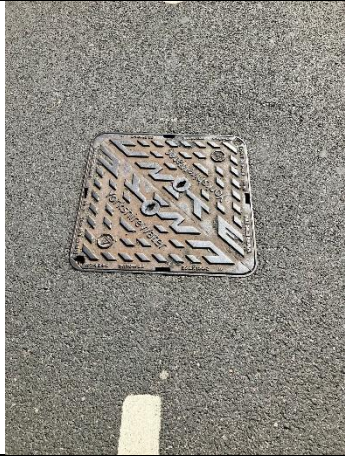
View 44 – Man Hole 03

Condition – Reasonable.

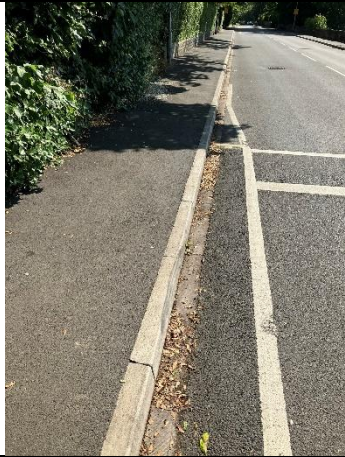
View 45 – Oxford Road

Condition – Reasonable.

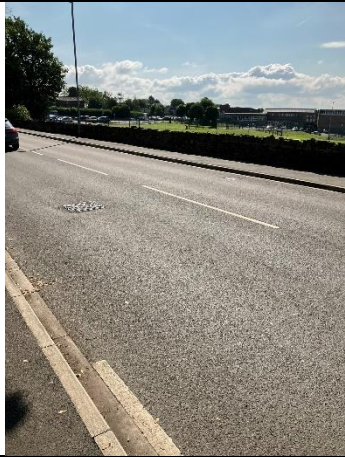
View 46 – Oxford Road

Condition – Reasonable.

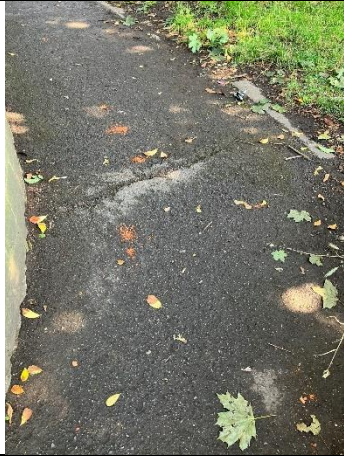
View 47 – Brunswick Street (Pedestrian), Oxford Road End

Condition – *Poor.*

Tarmac path has been bowed and cracked by tree roots.

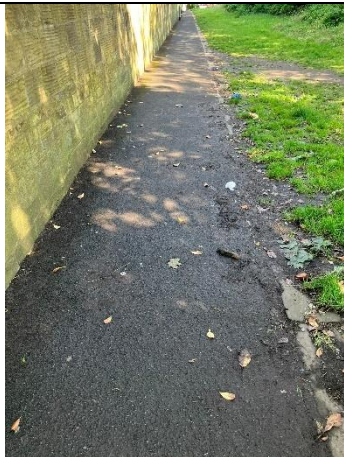
View 48 – Brunswick Street (Pedestrian)

Condition – *Reasonable.*

Slight damages at edges and stone kerb covered and overgrown.

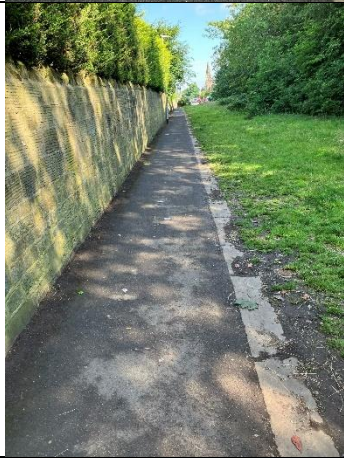
View 49 – Brunswick Street (Pedestrian)

Condition – *Reasonable.*

Slight damages at edges and stone kerb covered and overgrown.

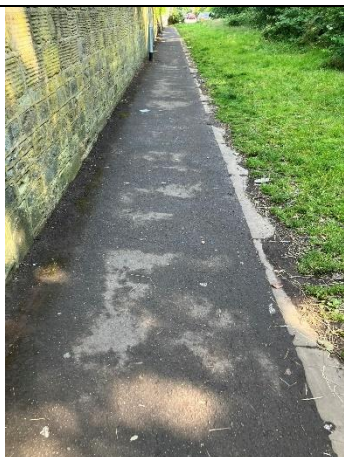
View 50 – Brunswick Street (Pedestrian)

Condition – *Reasonable.*

Slight damages at edges and stone kerb covered and overgrown.

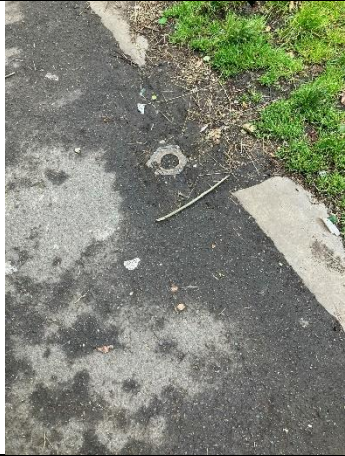
View 51 – Brunswick Street (Pedestrian)

Condition – Reasonable.

Slight damages at edges and stone kerb covered and overgrown.

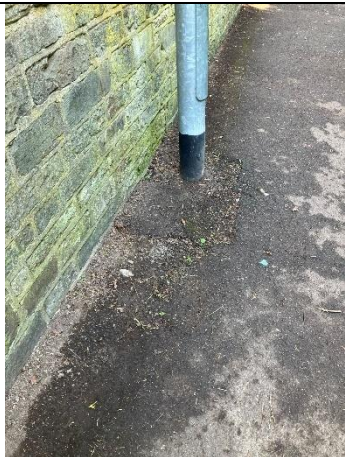
View 52 – Lamppost

Condition – Reasonable.

Slight damages at edge. Tarmac patched around lamppost.

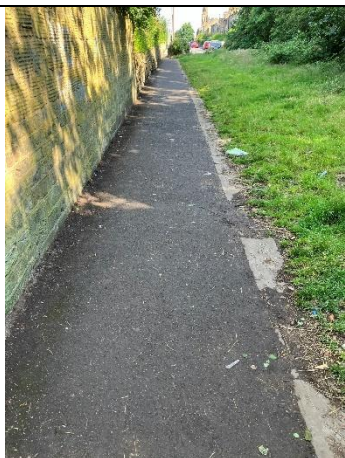
View 53 – Brunswick Street (Pedestrian)

Condition – Reasonable.

Slight damages at edges and stone kerb covered and overgrown.

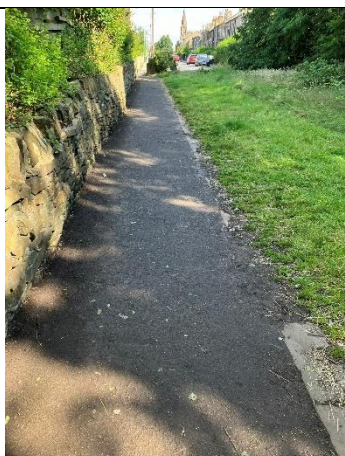
View 54 – Brunswick Street (Pedestrian)

Condition – Reasonable.

Slight damages at edges and stone kerb covered and overgrown.

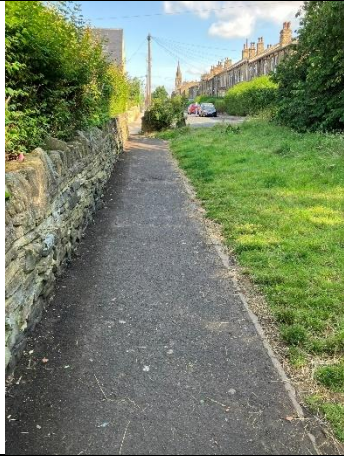
View 55 – Brunswick Street (Pedestrian)

Condition – Reasonable.

Slight damages at edges and stone kerb covered and overgrown.

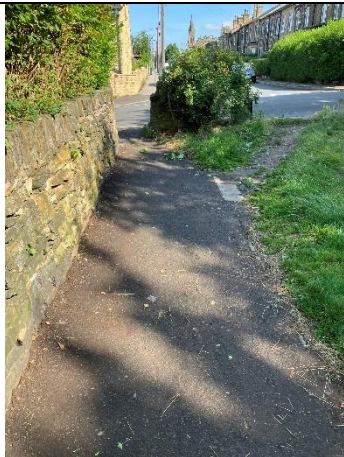
View 56 – Brunswick Street (Pedestrian)

Condition – Reasonable.

Slight damages at edges and stone kerb covered and overgrown.

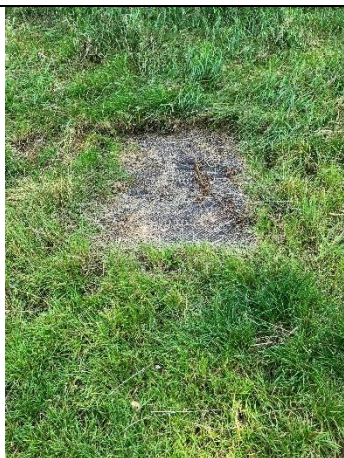
View 57 – Inspection Chamber 02

Condition – Reasonable.

Appears in reasonable condition, covered and overgrown at the edges.

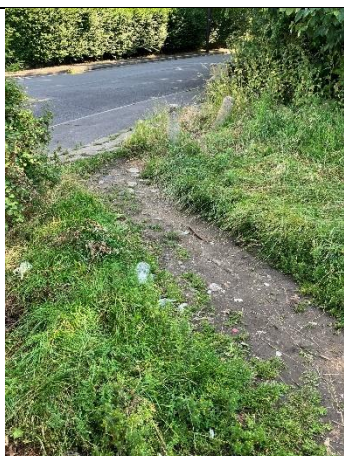
View 58 – Brunswick Street (Pedestrian), Reservoir Street end.

Condition – Poor.

Stone wall missing and grass missing through desire lines.

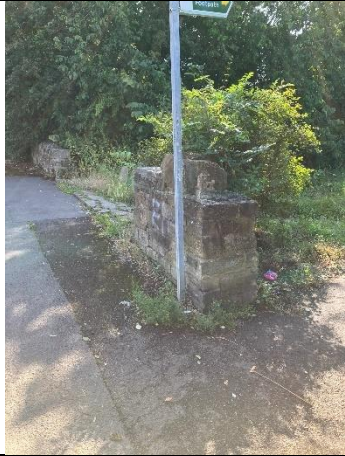
View 59 – Brunswick Street (Pedestrian), Reservoir Street end.

Condition – Reasonable.

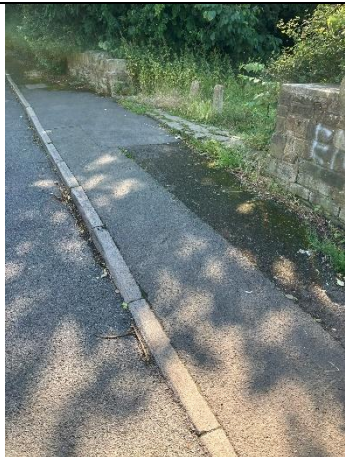
View 60 – Brunswick Street (Pedestrian), Reservoir Street end.

Condition – Reasonable.

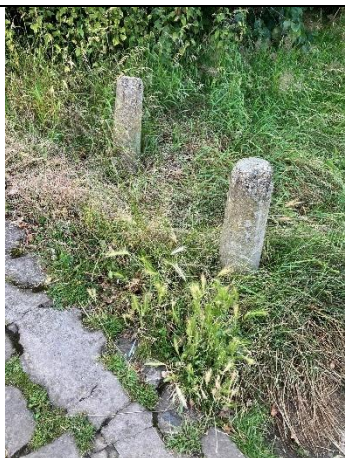
View 61 – Brunswick Street (Pedestrian), Reservoir Street end.

Condition – Reasonable.

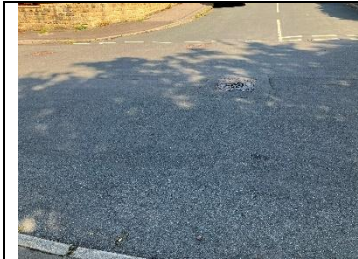
<p>View 62 –Reservoir Street.</p> <p>Location – See Plan.</p> <p>Condition – <i>Poor.</i></p>

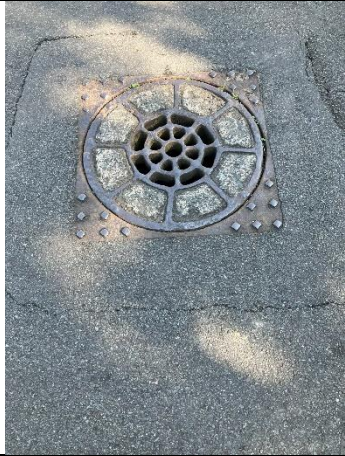
View 66 – Man Hole 07

Condition – Poor.

Road surface cracked and damaged particularly around the man holes.

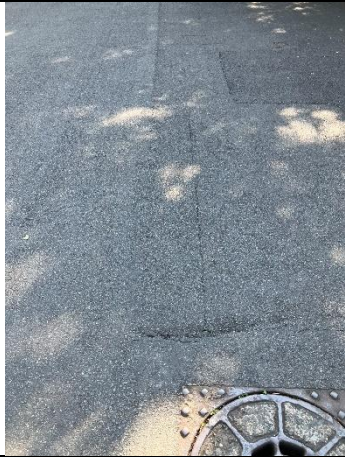
View 67 – Reservoir Street

Condition – Poor.

Road surface cracked and damaged.

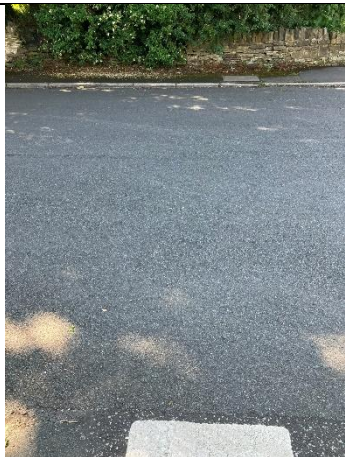
View 69 – Reservoir Street

Condition – Poor.

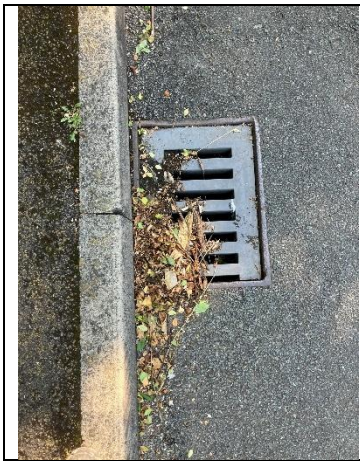
<p>View 70 – Gully 07</p> <p>Location – See Plan.</p> <p>Condition – Reasonable.</p> <p><i>Metal grate has been replaced with composite plastic cover. Appears in reasonable condition, although covered with and containing of debris.</i></p>

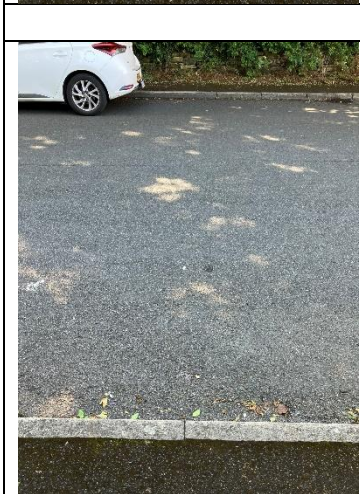
<p>View 72 – Reservoir Street</p> <p>Location – See Plan.</p> <p>Condition – Poor.</p>

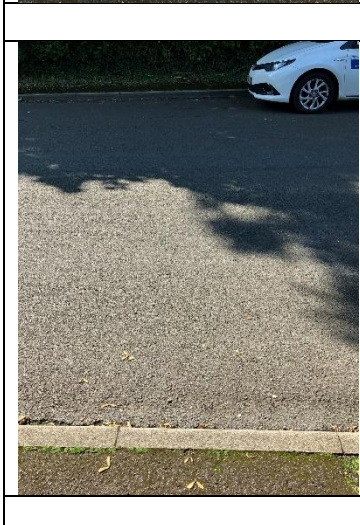
<p>View 73 – Reservoir Street</p> <p>Location – See Plan.</p> <p>Condition – Poor.</p>

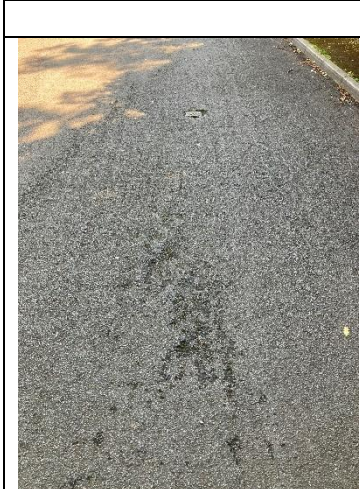
<p>View 75 – Reservoir Street</p> <p>Location – See Plan.</p> <p>Condition – Poor.</p> <p><i>Road surface cracked and damaged.</i></p>

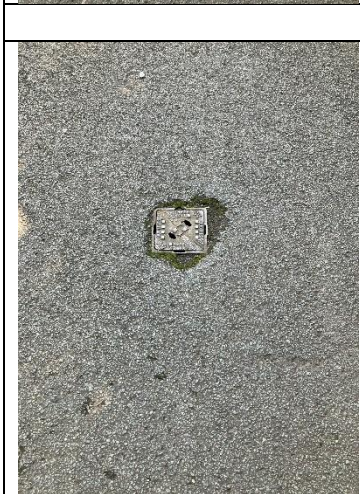
<p>View 76 – Stop Valve</p> <p>Location – See Plan.</p> <p>Condition – Poor.</p> <p><i>Road surface cracked and damaged, particularly around Stop Valve.</i></p>

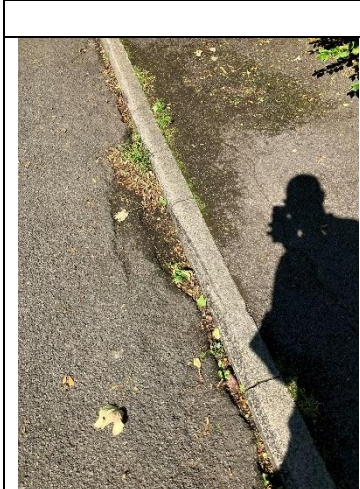
<p>View 79 – Reservoir Street</p> <p>Location – See Plan.</p> <p>Condition – <i>Poor.</i></p> <p><i>Road surface cracked and damaged, particularly at edges.</i></p>

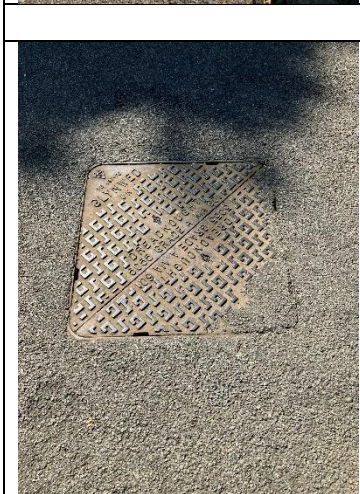
<p>View 80 – Man Hole 07</p> <p>Location – See Plan.</p> <p>Condition – <i>Poor.</i></p> <p><i>Road surface cracked and damaged, particularly around Man Holes. Surface treatment appears to cover some of the Man Hole cover, suggesting it is lower.</i></p>

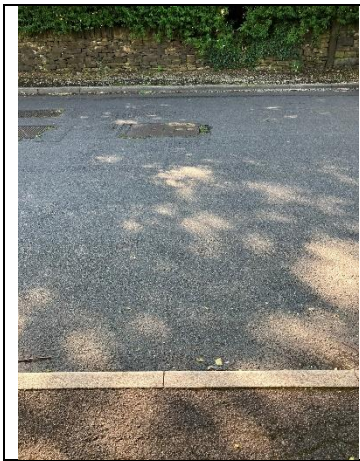
<p>View 82 – Reservoir Street</p> <p>Location – See Plan.</p> <p>Condition – <i>Poor.</i></p> <p><i>Road surface cracked and damaged, particularly at edges and around Man Holes.</i></p>

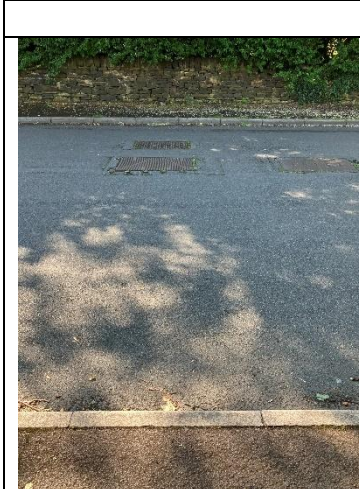
<p>View 83 – Reservoir Street</p> <p>Location – See Plan.</p> <p>Condition – <i>Poor.</i></p> <p><i>Road surface cracked and damaged, particularly at edges and around Man Holes.</i></p>

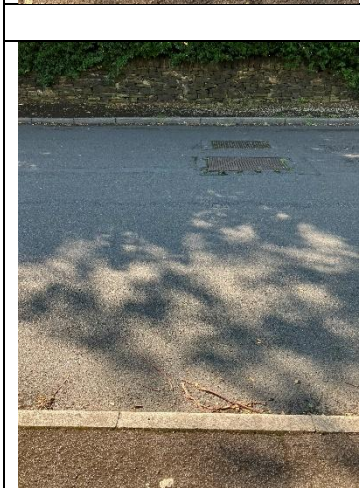
<p>View 84 – Reservoir Street</p> <p>Location – See Plan.</p> <p>Condition – <i>Poor.</i></p> <p><i>Road surface cracked and damaged, particularly at edges and around Man Holes.</i></p>

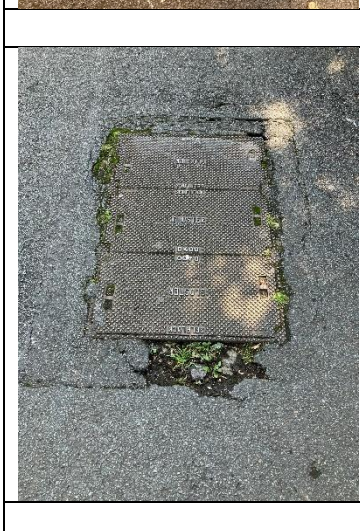
<p>View 85 – Reservoir Street</p> <p>Location – See Plan.</p> <p>Condition – <i>Very Poor.</i></p> <p><i>Road surface cracked and damaged, particularly at edges and around Man Holes. Cover appears lower than surrounding surface, which has also broken up at the edges.</i></p>

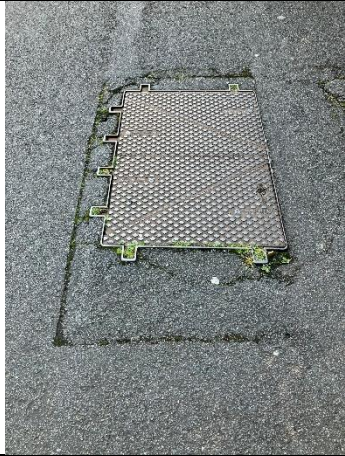
View 86 – Reservoir Street

Condition – Poor.

Road surface cracked and damaged, particularly around Man Holes. Cover appears lower than surrounding surface, which has also broken up at the edges.

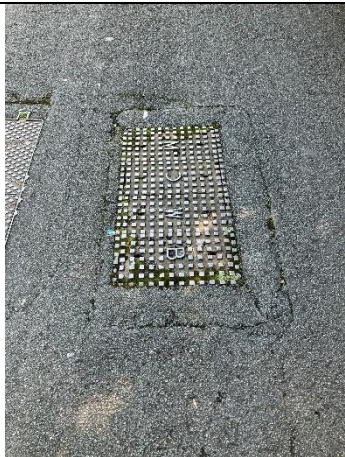
View 87 – Reservoir Street

Condition – Poor.

Road surface cracked and damaged, particularly around Man Holes. Cover appears lower than surrounding surface.

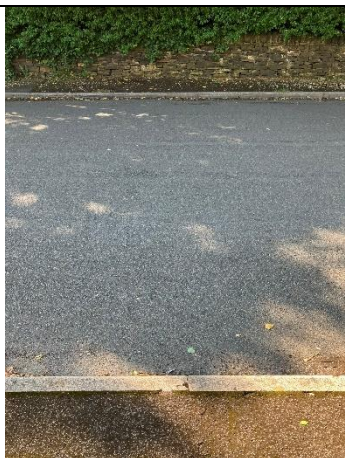
View 88 – Reservoir Street

Condition – Poor.

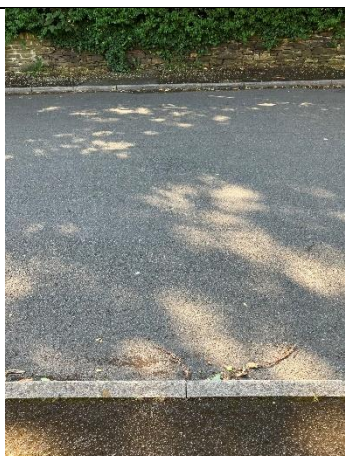
View 89 – Reservoir Street

Condition – Poor.

Road surface cracked and damaged, particularly at edges.

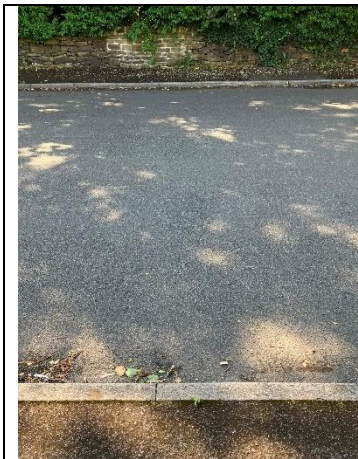
<p>View 90 – Reservoir Street</p> <p>Location – See Plan.</p> <p>Condition – <i>Poor.</i></p> <p><i>Road surface cracked and damaged, particularly at edges.</i></p>

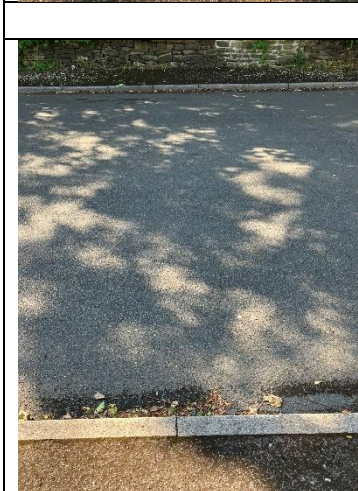
<p>View 91 – Reservoir Street</p> <p>Location – See Plan.</p> <p>Condition – <i>Poor.</i></p> <p><i>Road surface cracked and damaged, particularly at edges.</i></p>

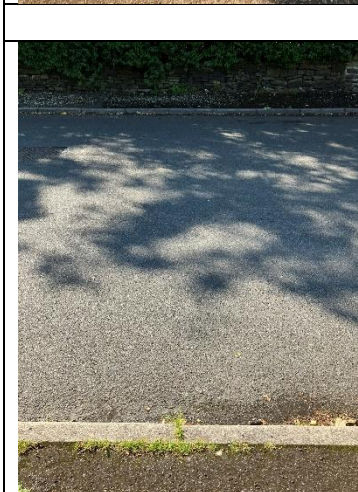
<p>View 92 – Reservoir Street</p> <p>Location – See Plan.</p> <p>Condition – <i>Poor.</i></p> <p><i>Road surface cracked and damaged, particularly at edges.</i></p>

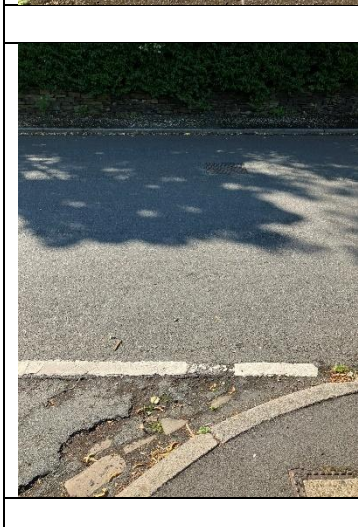
<p>View 93 – Junction of Reservoir Street and Clarke Street</p> <p>Location – See Plan.</p> <p>Condition – <i>Very Poor.</i></p> <p><i>Road surface cracked and damaged, particularly at edges. Original stone cobbles showing though.</i></p>

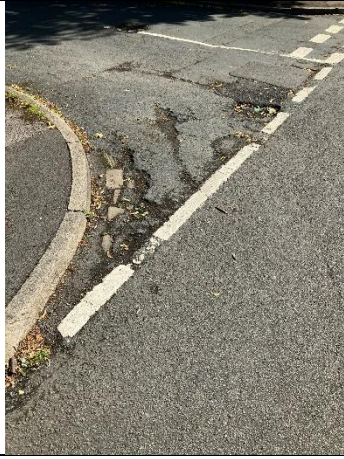
View 94 – Junction of Reservoir Street and Clarke Street

Condition – *Very Poor.*

Road surface cracked and damaged, particularly at edges. Original stone cobbles showing through.

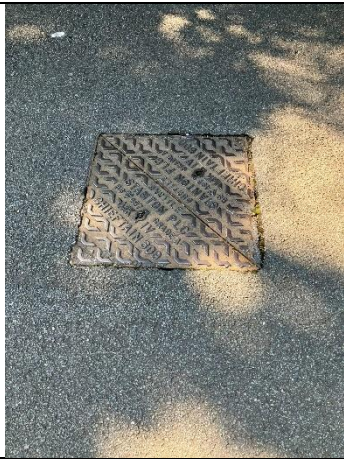
View 95 – Man Hole 08

Condition – *Poor.*

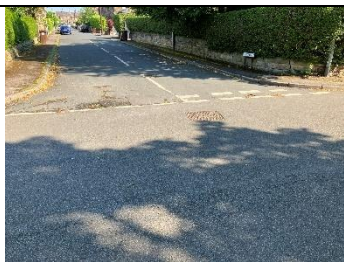
View 96 – Junction of Reservoir Street and Clarke Street

Condition – *Very Poor.*

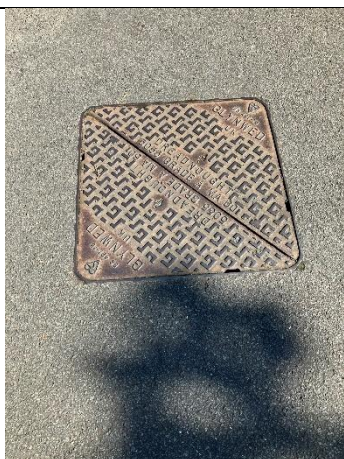
View 97 – Man Hole 09

Condition – *Reasonable.*

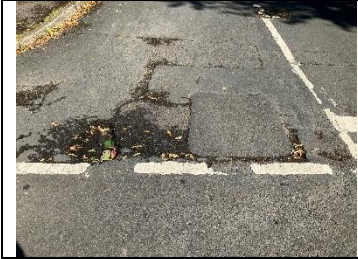
<p>View 98 – Junction of Reservoir Street and Clarke Street</p> <p>Location – See Plan.</p> <p>Condition – <i>Very Poor.</i></p>

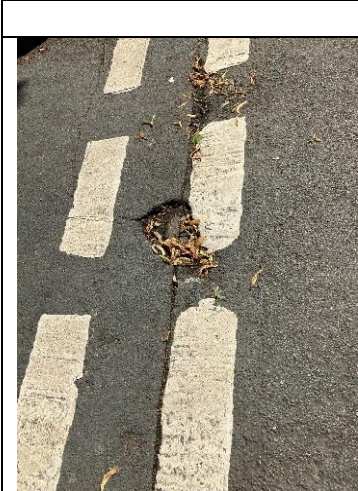
<p>View 99 – Junction of Reservoir Street and Clarke Street</p> <p>Location – See Plan.</p> <p>Condition – <i>Very Poor.</i></p> <p><i>Road surface cracked and damaged, particularly at edges. Original stone cobbles showing though. Visible pot holes.</i></p>

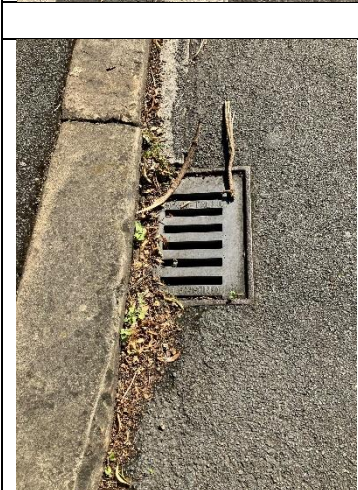
<p>View 100 – Gully 09</p> <p>Location – See Plan.</p> <p>Condition – <i>Poor.</i></p> <p><i>Road surface cracked and damaged, particularly at edges and around gully. Metal grate has been replaced with a composite plastic one.</i></p>

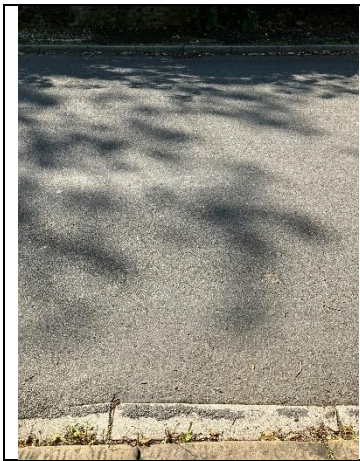
<p>View 102 – Reservoir Street</p> <p>Location – See Plan.</p> <p>Condition – <i>Poor.</i></p> <p><i>Road surface cracked and damaged, particularly at edges.</i></p>

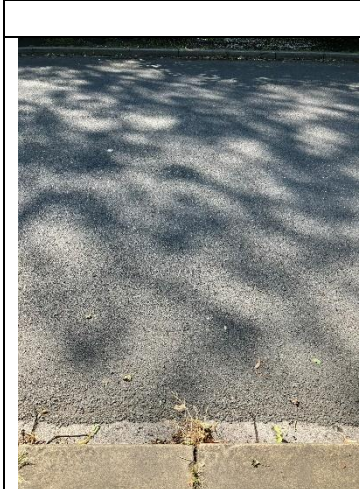
<p>View 103 – Reservoir Street</p> <p>Location – See Plan.</p> <p>Condition – <i>Poor.</i></p> <p><i>Road surface cracked and damaged, particularly at edges.</i></p>

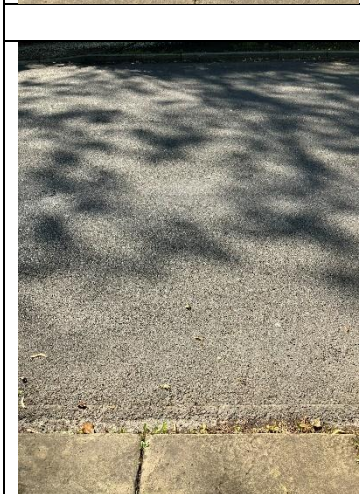
<p>View 104 – Reservoir Street</p> <p>Location – See Plan.</p> <p>Condition – <i>Poor.</i></p> <p><i>Road surface cracked and damaged, particularly at edges.</i></p>

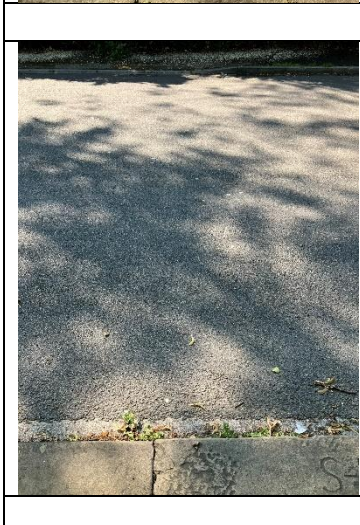
<p>View 105 – Reservoir Street</p> <p>Location – See Plan.</p> <p>Condition – <i>Poor.</i></p> <p><i>Road surface cracked and damaged, particularly at edges.</i></p>

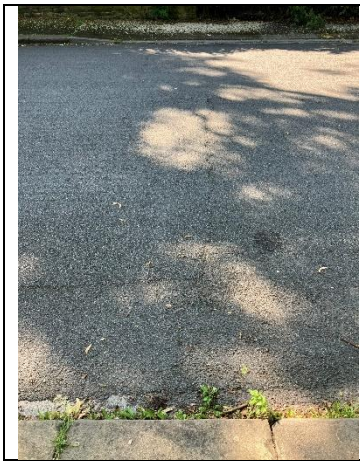
<p>View 106 – Reservoir Street</p> <p>Location – See Plan.</p> <p>Condition – <i>Poor.</i></p> <p><i>Road surface cracked and damaged, particularly at edges.</i></p>

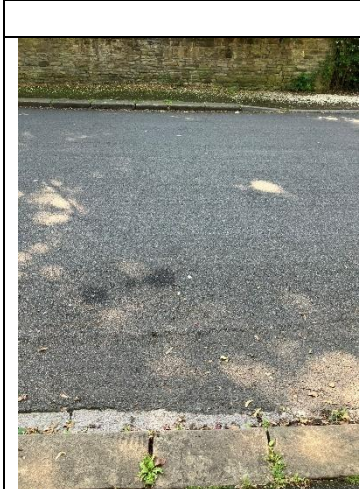
<p>View 107 – Reservoir Street</p> <p>Location – See Plan.</p> <p>Condition – <i>Poor.</i></p> <p><i>Road surface cracked and damaged, particularly at edges.</i></p>

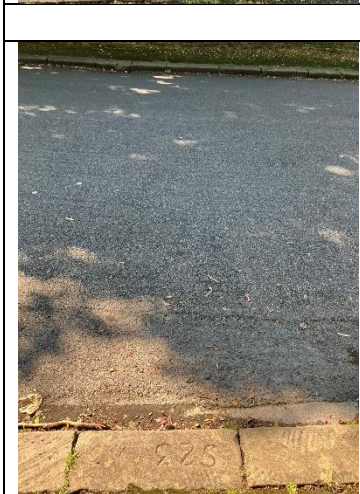
<p>View 108 – Reservoir Street</p> <p>Location – See Plan.</p> <p>Condition – <i>Poor.</i></p> <p><i>Road surface cracked and damaged, particularly at edges.</i></p>

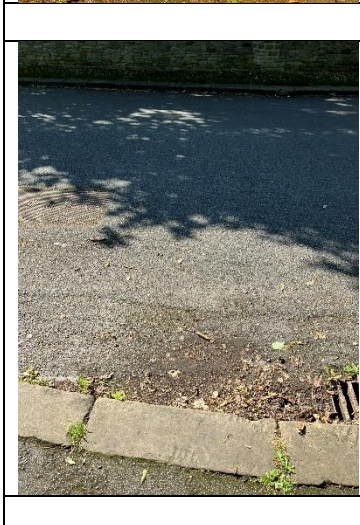
<p>View 109 – Reservoir Street</p> <p>Location – See Plan.</p> <p>Condition – <i>Poor.</i></p> <p><i>Road surface cracked and damaged, particularly at edges.</i></p>

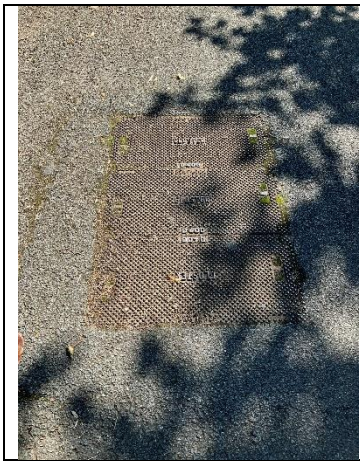
<p>View 110 – Inspection Chamber 07</p> <p>Location – See Plan.</p> <p>Condition – Poor.</p> <p><i>Road surface cracked and damaged, particularly around Inspection Chamber.</i></p>

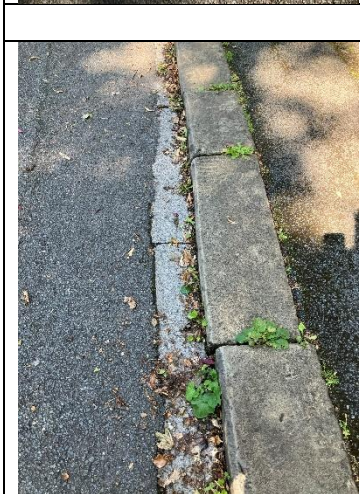
<p>View 112 – Reservoir Street</p> <p>Location – See Plan.</p> <p>Condition – Poor.</p> <p><i>Existing stone kerbs have dropped and are uneven.</i></p>

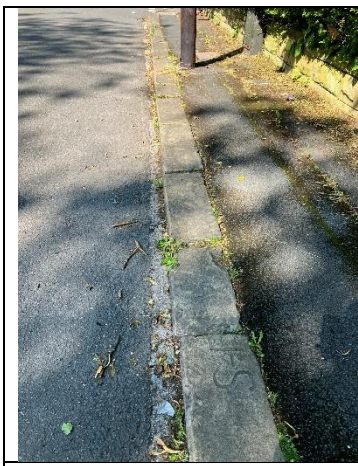
<p>View 114 – Reservoir Street</p> <p>Location – See Plan.</p> <p>Condition – <i>Poor.</i></p> <p><i>Existing stone kerbs have dropped and are uneven.</i></p>
 	<p>View 115 – Reservoir Street</p> <p>Location – See Plan.</p> <p>Condition – <i>Poor.</i></p> <p><i>Existing stone kerbs have dropped and are uneven.</i></p>

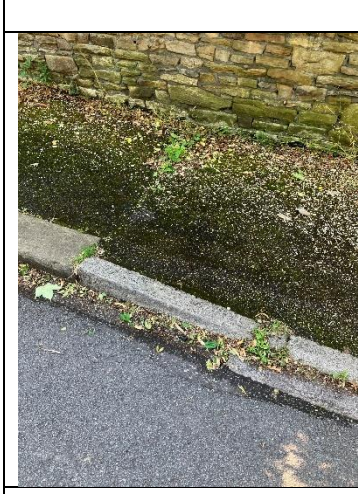
<p>View 116 – Reservoir Street</p> <p>Location – See Plan.</p> <p>Condition – <i>Very Poor.</i></p> <p><i>Road surface cracked and damaged, particularly at edges. Pavement surface extremely poor.</i></p>

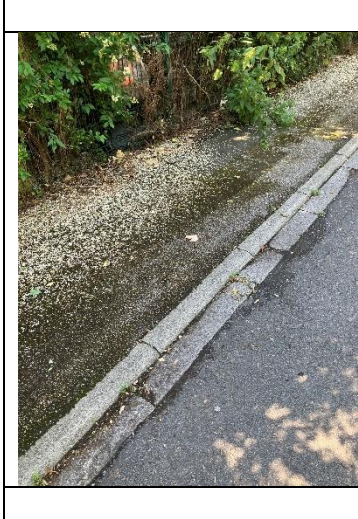
<p>View 117 – Reservoir Street</p> <p>Location – See Plan.</p> <p>Condition – <i>Very Poor.</i></p> <p><i>Road surface cracked and damaged, particularly at edges. Pavement surface extremely poor: patched, broken, damaged, missing.</i></p>

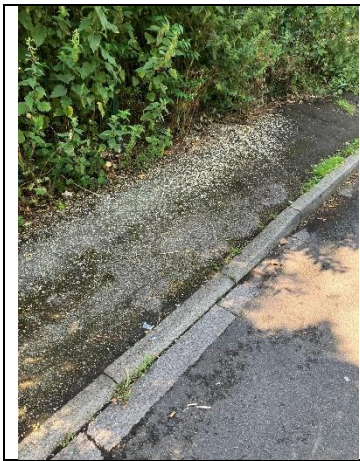
<p>View 118 – Reservoir Street</p> <p>Location – See Plan.</p> <p>Condition – <i>Very Poor.</i></p> <p><i>Road surface cracked and damaged, particularly at edges. Pavement surface extremely poor: patched, broken, damaged, missing.</i></p>

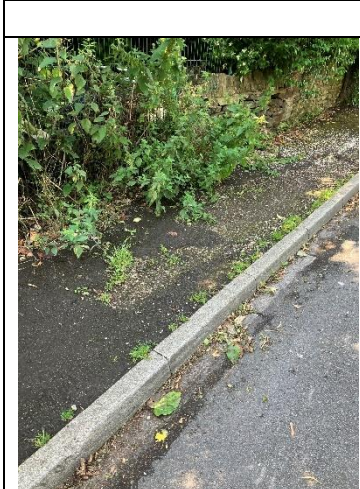
<p>View 119 – Reservoir Street</p> <p>Location – See Plan.</p> <p>Condition – <i>Very Poor.</i></p> <p><i>Road surface cracked and damaged, particularly at edges. Pavement surface extremely poor: patched, broken, damaged, missing. Vegetation overgrowing.</i></p>

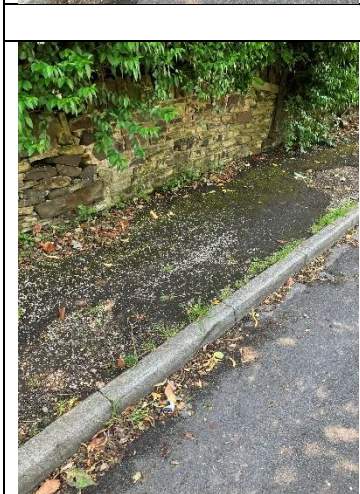
<p>View 120 – Reservoir Street</p> <p>Location – See Plan.</p> <p>Condition – <i>Very Poor.</i></p> <p><i>Road surface cracked and damaged, particularly at edges. Pavement surface extremely poor: patched, broken, damaged, missing. Vegetation overgrowing.</i></p>

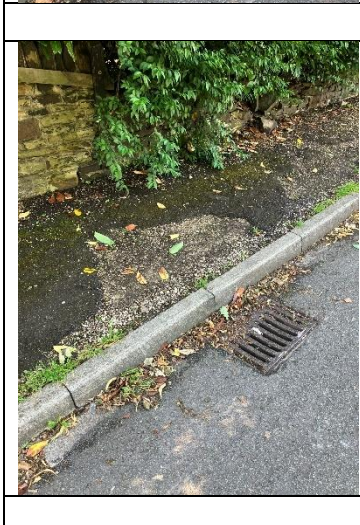
<p>View 121 – Reservoir Street</p> <p>Location – See Plan.</p> <p>Condition – <i>Very Poor.</i></p> <p><i>Road surface cracked and damaged, particularly at edges. Pavement surface extremely poor: patched, broken, damaged, missing. Vegetation overgrowing.</i></p>

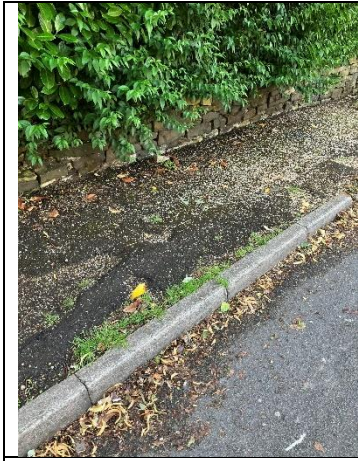
<p>View 122 – Reservoir Street</p> <p>Location – See Plan.</p> <p>Condition – <i>Very Poor.</i></p> <p><i>Road surface cracked and damaged, particularly at edges. Pavement surface extremely poor: patched, broken, damaged, missing. Vegetation overgrowing.</i></p>

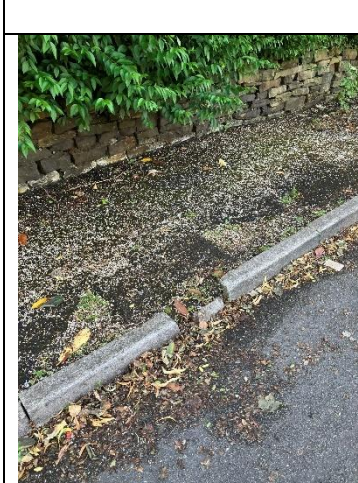
<p>View 123 – Reservoir Street</p> <p>Location – See Plan.</p> <p>Condition – <i>Very Poor.</i></p> <p><i>Road surface cracked and damaged, particularly at edges. Pavement surface extremely poor: patched, broken, damaged, missing. Vegetation overgrowing.</i></p>

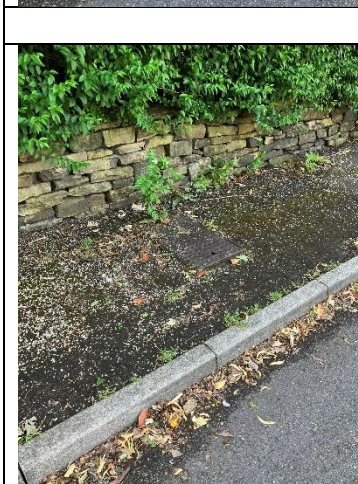
<p>View 124 – Reservoir Street</p> <p>Location – See Plan.</p> <p>Condition – <i>Very Poor.</i></p> <p><i>Road surface cracked and damaged, particularly at edges. Pavement surface extremely poor: patched, broken, damaged, missing. Vegetation overgrowing.</i></p>

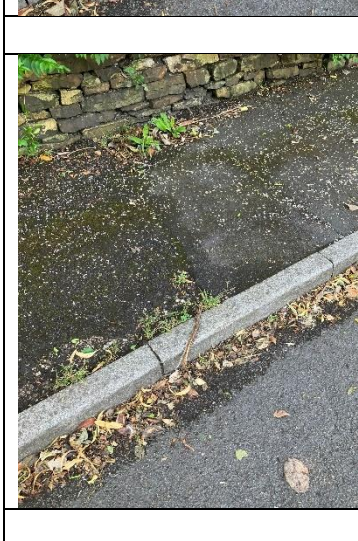
<p>View 125 – Reservoir Street</p> <p>Location – See Plan.</p> <p>Condition – <i>Very Poor.</i></p> <p><i>Road surface cracked and damaged, particularly at edges. Pavement surface extremely poor: patched, broken, damaged, missing. Vegetation overgrowing.</i></p>

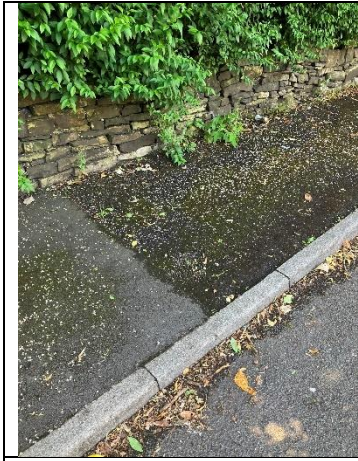
<p>View 126 – Reservoir Street</p> <p>Location – See Plan.</p> <p>Condition – <i>Very Poor.</i></p> <p><i>Road surface cracked and damaged, particularly at edges. Pavement surface extremely poor: patched, broken, damaged, missing. Vegetation overgrowing.</i></p>

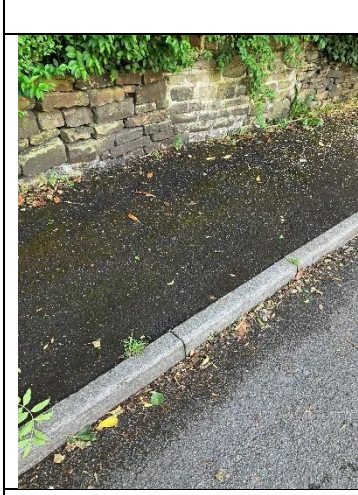
<p>View 127 – Reservoir Street</p> <p>Location – See Plan.</p> <p>Condition – <i>Very Poor.</i></p> <p><i>Road surface cracked and damaged, particularly at edges. Pavement surface extremely poor: patched, broken, damaged, missing. Vegetation overgrowing.</i></p>

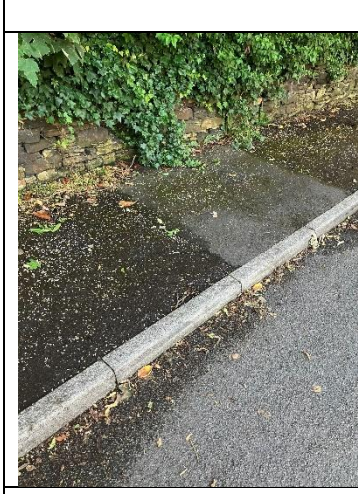
<p>View 128 – Reservoir Street</p> <p>Location – See Plan.</p> <p>Condition – <i>Very Poor.</i></p> <p><i>Road surface cracked and damaged, particularly at edges. Pavement surface extremely poor: patched, broken, damaged, missing. Vegetation overgrowing.</i></p>

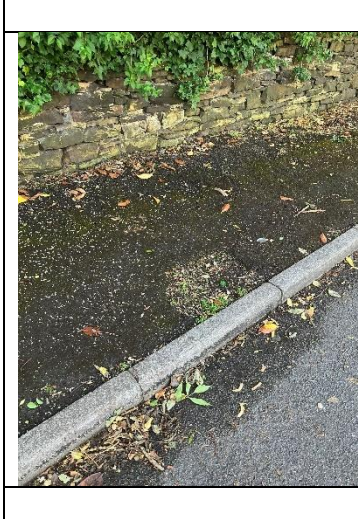
<p>View 129 – Reservoir Street</p> <p>Location – See Plan.</p> <p>Condition – <i>Very Poor.</i></p> <p><i>Road surface cracked and damaged, particularly at edges. Pavement surface extremely poor: patched, broken, damaged, missing. Vegetation overgrowing.</i></p>

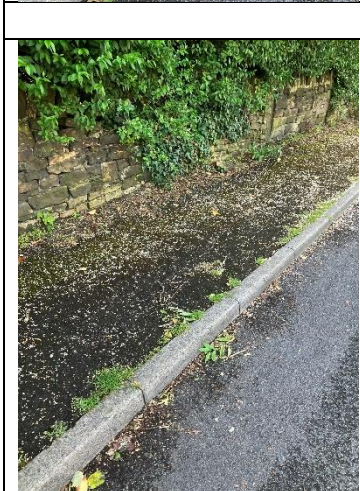
<p>View 131 – Reservoir Street</p> <p>Location – See Plan.</p> <p>Condition – <i>Very Poor.</i></p> <p><i>Road surface cracked and damaged, particularly at edges. Pavement surface extremely poor: patched, broken, damaged, missing. Vegetation overgrowing.</i></p>
 	<p>View 132 – Reservoir Street</p> <p>Location – See Plan.</p> <p>Condition – <i>Very Poor.</i></p> <p><i>Road surface cracked and damaged, particularly at edges. Pavement surface extremely poor: patched, broken, damaged, missing. Vegetation overgrowing.</i></p>
 	<p>View 133 – Reservoir Street</p> <p>Location – See Plan.</p> <p>Condition – <i>Very Poor.</i></p> <p><i>Road surface cracked and damaged, particularly at edges. Pavement surface extremely poor: patched, broken, damaged, missing. Vegetation overgrowing.</i></p>

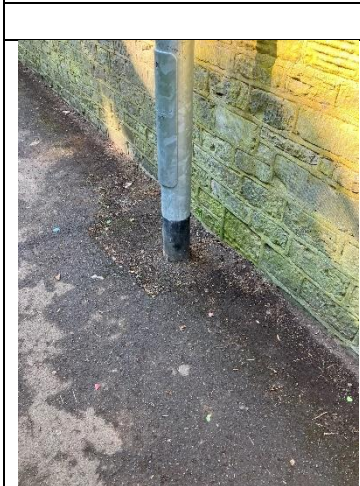
<p>View 145 – Reservoir Street</p> <p>Location – See Plan.</p> <p>Condition – <i>Reasonable.</i></p> <p><i>Slight damages at edge. Tarmac patched around lamppost.</i></p>
