**APPLICATION FOR TREE WORK**

<b>Tree Preservation Order Ref:</b>	<b>35/91/a1</b>
<b>Location:</b>	<b>Teasel Close, Hightown, Liversedge, WF15 8BJ</b>
<b>Applicant:</b>	<b>Phil Amess Tree &amp; Woodlands Inspector PLACE Kirklees Council</b>
<b>Date:</b>	<b>28<sup>th</sup> August 2024</b>

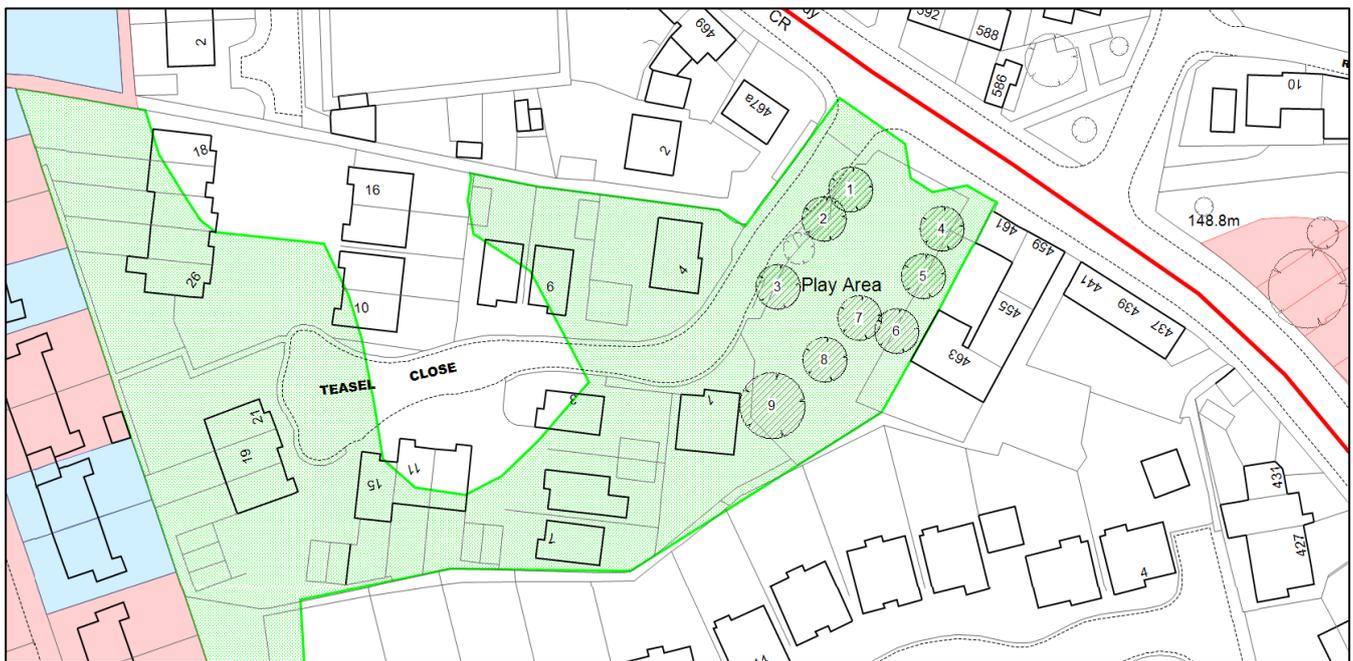
**T1-T8**

**Species** – Mixed broadleaf consisting of Lime (*Tilia x europaea*), Horse Chestnut (*Aesculus hippocastanum*) and Sycamore (*Acer pseudoplatanus*).

**Condition** – All trees in this group are semi-mature & stand at a similar height of approximately 14-17m with similarly sized crown spreads of approximately 5-7m. There appears to have been little to no maintenance on these trees for a number of years and they are all laden with thick ivy & epicormic growth which makes it difficult to fully assess their condition during a VTA. Generally, vigour was good across the group with the exception of 1 x Horse Chestnut (T2) which had a largely sparse crown. Both Horse Chestnuts (T1, T2) were blighted with Horse Chestnut Leaf Miner damage as is typical of this species.

**Works Proposed** – I propose to sever the ivy at base & strip to 1m of all trees in group. I also propose to carry out a crown clean of all trees to include the removal of dead/defective branches & to carry out a crown lift to approximately 4-5m to include the removal of epicormic & non-scaffold limbs. This work should enable better monitoring of the condition of the trees going forwards & should also remove growth which is impeding the footways & play area below. The work proposed should not detract from the amenity value of the trees as individuals or as part of the overall group.
