83 Meltham Road, Huddersfield

Bat and Bird Survey Report

14th January 2025

Document ref: MBE/BAT/2024/134/01				
Purpose and Description	Originated	Checked	Reviewed	Date
For Planning	R Bell MCIEEM	P Middleton MCIEEM	R Bell MCIEEM	14/01/2025

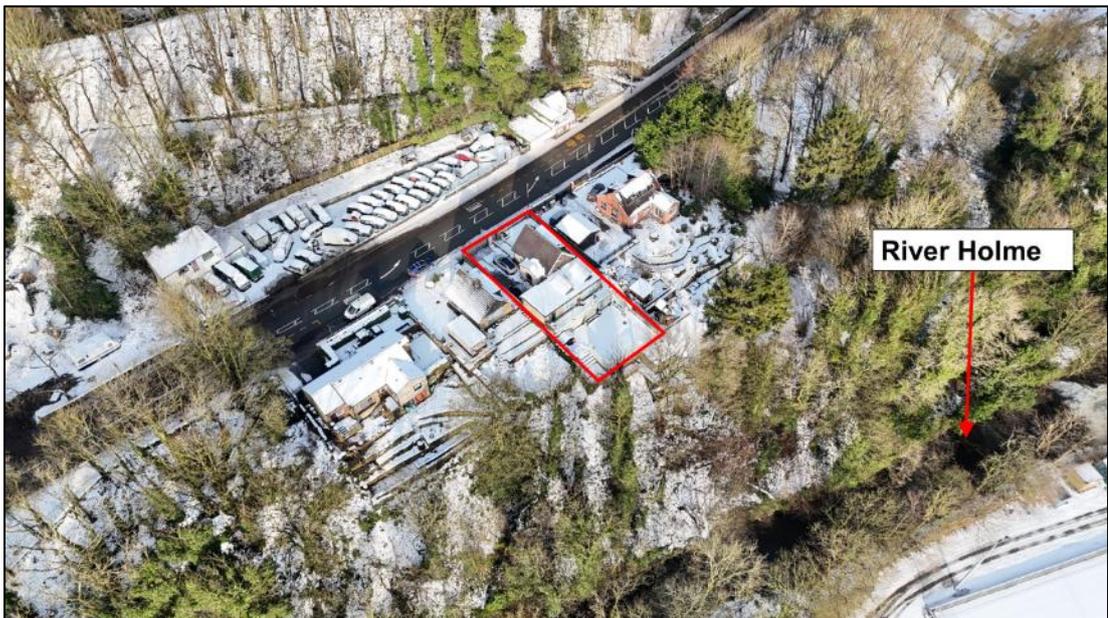
- 3.1.1 The surveyed building was located adjacent to a belt of woodland which extended along the valley of the River Holme. Further woodland was also present on the opposite side of Meltham Road (Figure 1, Plate 1). Consequently, it was considered that extensive and well connected high-quality bat foraging habitat was located adjacent to the site.
- 3.1.2 An above average abundance of bats of a varied range of species was expected to use the local area.

Plate 1. Setting of surveyed dwelling (see red outline) relative to woodland and River Holme

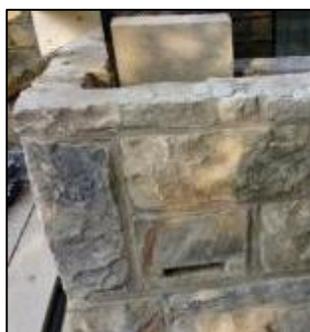
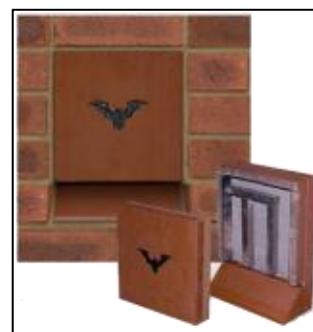
Plates 9-10. Build-in bat roost products

6.3.2 Regardless of bat roost presence/absence, in accordance with the aims of the National Planning Policy Framework (2024), it is recommended that at least one new bat roosting feature be incorporated within the new dwelling. It is advised that an enclosed and integrated bat box, of a design such as either the PRO UK Build-in WoodStone Bat Box or Ibstock Enclosed Bat Box C (Plates 9-10) be installed, at wall top height on the south or west elevation. The box should be sited away from areas of light spill. For further information on appropriate bat roosting features please contact Middleton Bell Ecology.

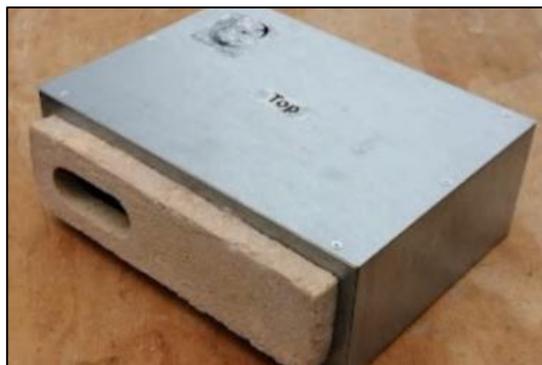
Plate 11. S Brick

- 6.3.3 If demolition works are to commence during the main bird nesting period (March to August inclusive), then they should be preceded by a nesting bird check, to be undertaken by an ecologist.
- 6.3.4 In accordance with the aims of the National Planning Policy Framework, and to provide an enhancement for nesting birds, it is recommended that one integrated swift *Apus apus* box (i.e. S Brick (Plate 11) be installed within the new dwelling. This box should be fitted at wall top height and may be installed across any elevation. Studies have shown that swift boxes are used by other bird species that utilise buildings and consequently this measure will provide potential nesting space for house sparrows *Passer domesticus* and starlings *Sturnus vulgaris*, in addition to potentially providing future nest space for swift.
