Healey Lane, Batley

Stage 1 Road Safety Audit

STAGE 1 ROAD SAFETY AUDIT

Ref: 25-117-001.02

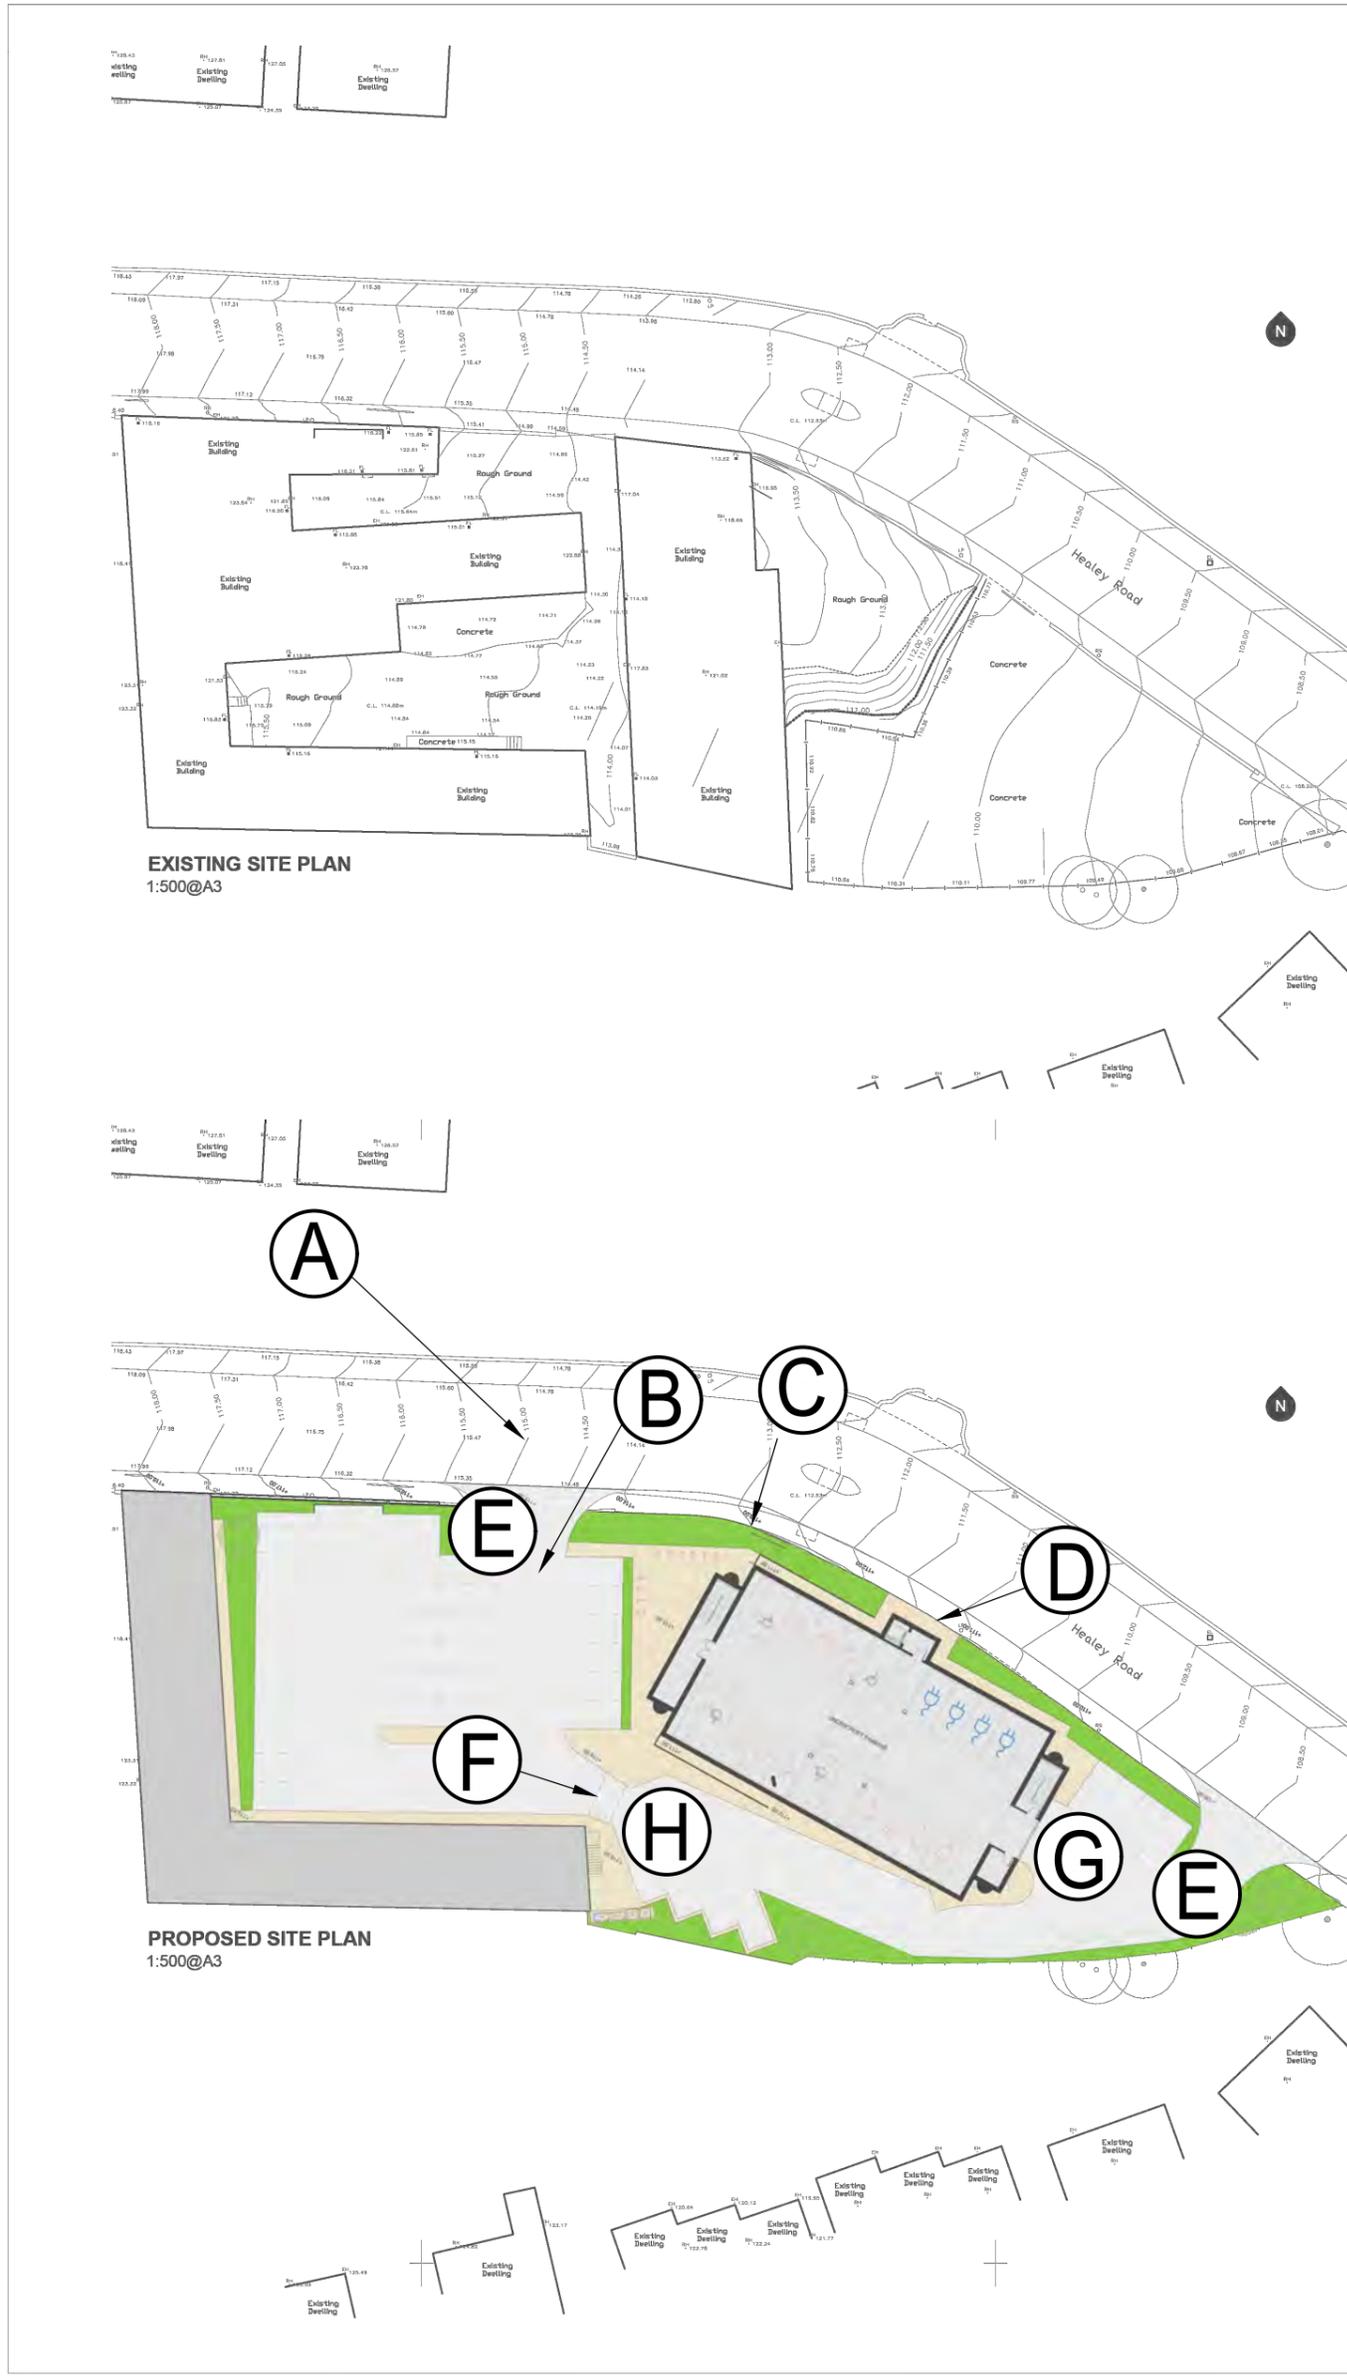
Appendix BGH1

Risk of collisions between vehicles waiting to turn right into the access from Healey Lane and vehicles travelling westbound.

The level difference between the back of footway and the hardstanding around the building presents a trip/fall hazard for pedestrians using Healey Lane.

Drivers failing to observe the one way system and attempting to leave or enter the wrong accesses.

The access to the under croft car park only allows single passing of vehicles. Drivers entering and leaving at the same time will fail to see each other leading to an increased risk of vehicle to vehicle collisions.
