# 35 St Johns Road Birkby

## Bat Survey Report

3<sup>rd</sup> March 2025

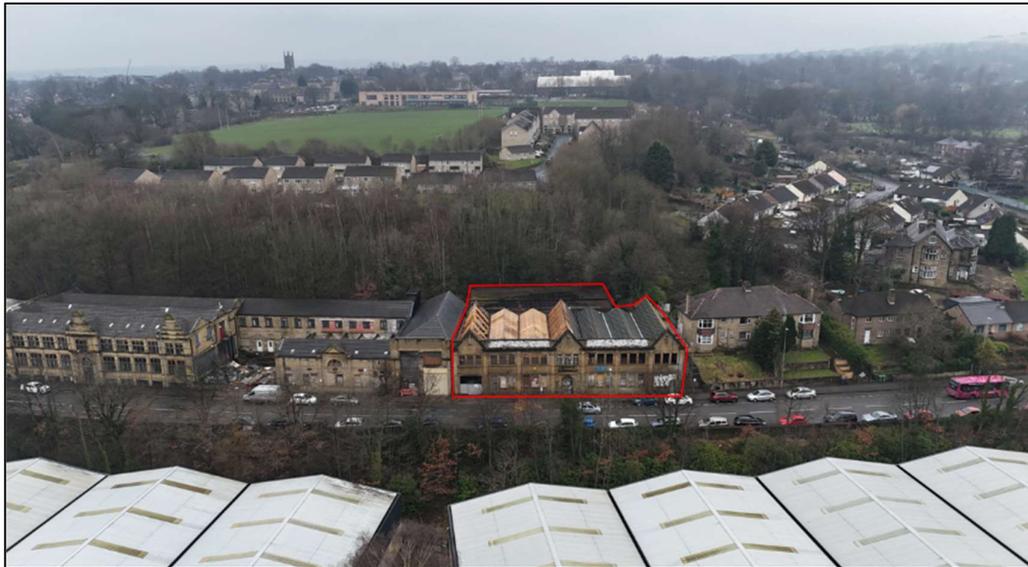
**Plate 1. The building outlined in red (viewed from the east)**

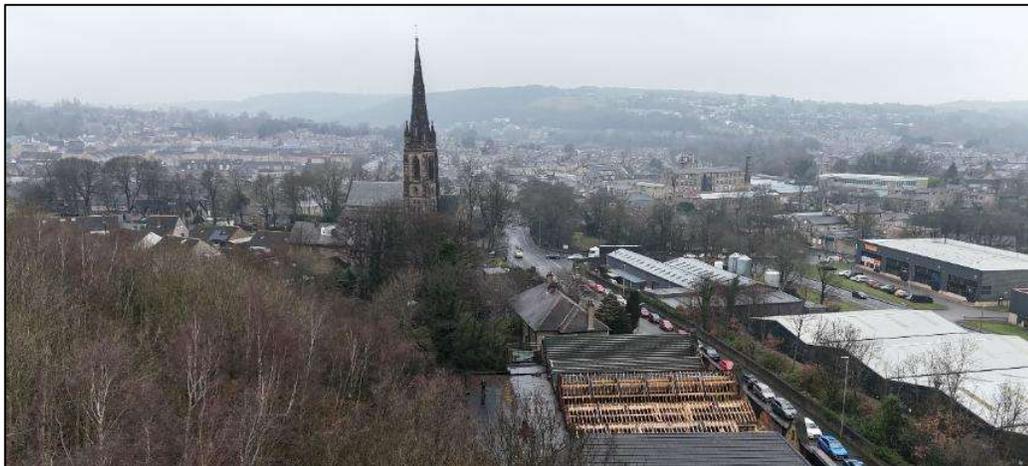
**Plate 2. The surveyed building in the foreground, viewed from the south**

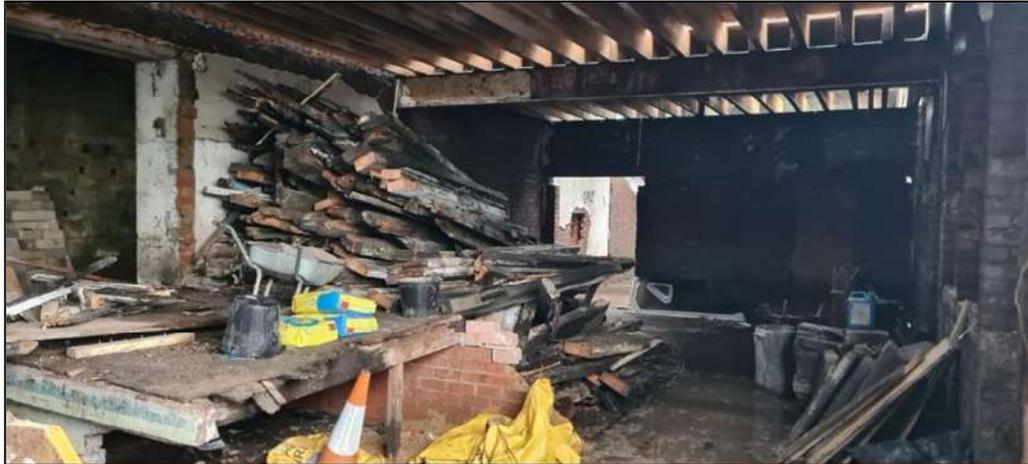
5.2.14 The interior of Section B1a comprised brick walls on the ground floor, with a sump or similar present at the northern end of this area (Plate 13 and 14).

**Plate 13. The southern end of the ground floor**

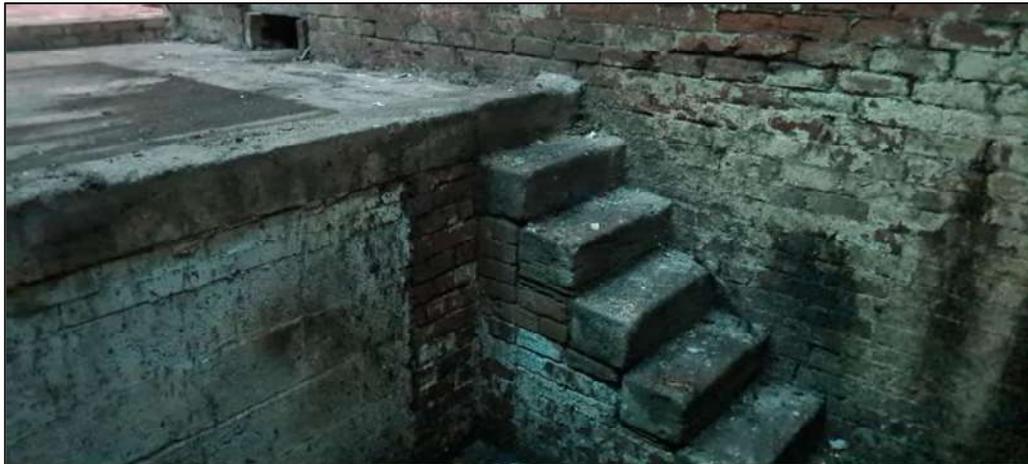
**Plate 14. The sump at the northern end of the ground floor**

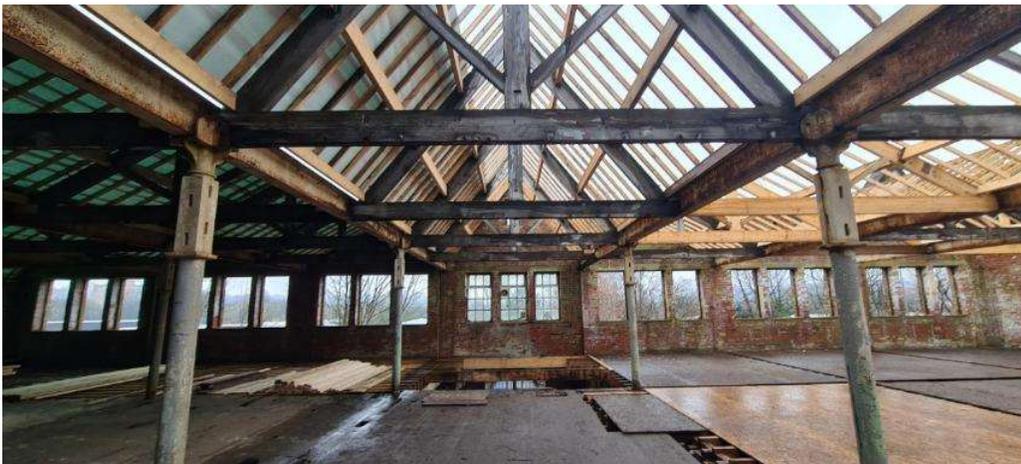
5.2.16 The first floor of B1a comprised metal beams and columns supporting timber king post trusses. The majority of the timber trusses were new but some original timbers were still present (Plate 16).

**Plate 16. The interior of Section B1a viewed from the rear of Section B1a**

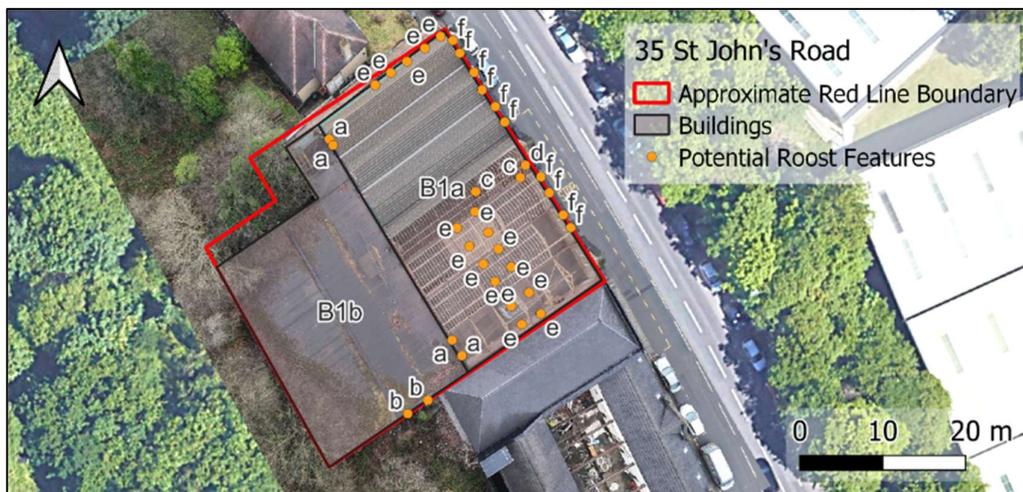
**Figure 4. Potential roof feature locations**

5.2.19 Additional potential roost features were recorded between wooden boards near the main entrance, and between the new floor joists and the brickwork – no significant gap was present between the older joists and the brickwork. The potential roost features are shown in Table 2 and Figure 4 below.

5.2.20 Due to the lack of bats, or signs of bats present within or around potential roost features, it was considered that no roost was present within the building. It was considered most likely that the bat droppings present on the rear internal wall of B1b were deposited by a bat or low numbers of bats in flight. The droppings were expected to be common pipistrelle droppings based on their size and shape, and the location of the building.

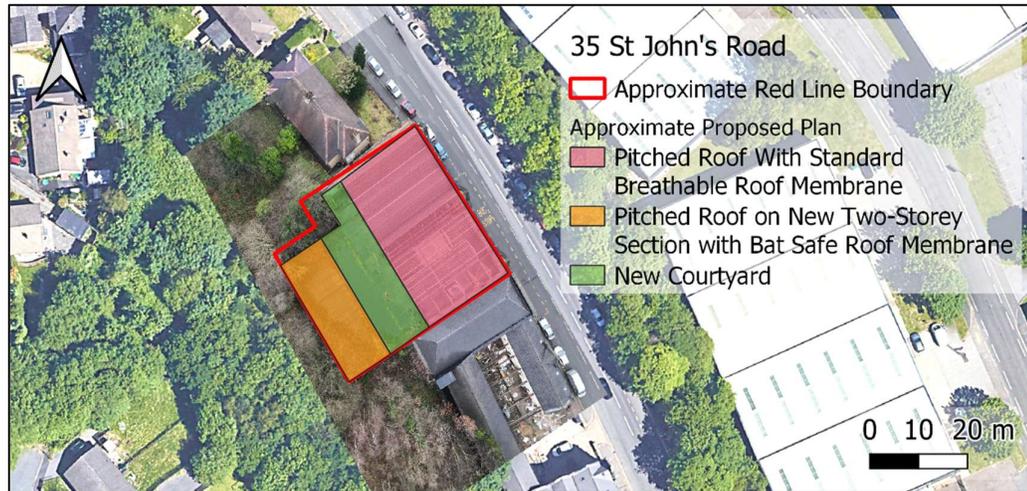
6.3.1 The roofing membrane has already started to be installed on Building 1a, with battens fitted. It was noted that this roofing membrane was not one of the ones listed as safe for use in bat roosts. Given this membrane is located on Section 1a at the front of the property, this is considered much less likely to be used by roosting bats than the area over the roof of the rear building (Section 1b). It is recommended that the roofing membrane installed on the roof of the building to be located at the rear of the site (as shown on Figure 5) is one of the products identified as safer for use in areas with roosting bats. Further information on the issue of bats and roofing membranes is included in Appendix 2.

**Figure 5. Shows the approximate proposed layout including the area where the use of a bat safe roof membrane is recommended**

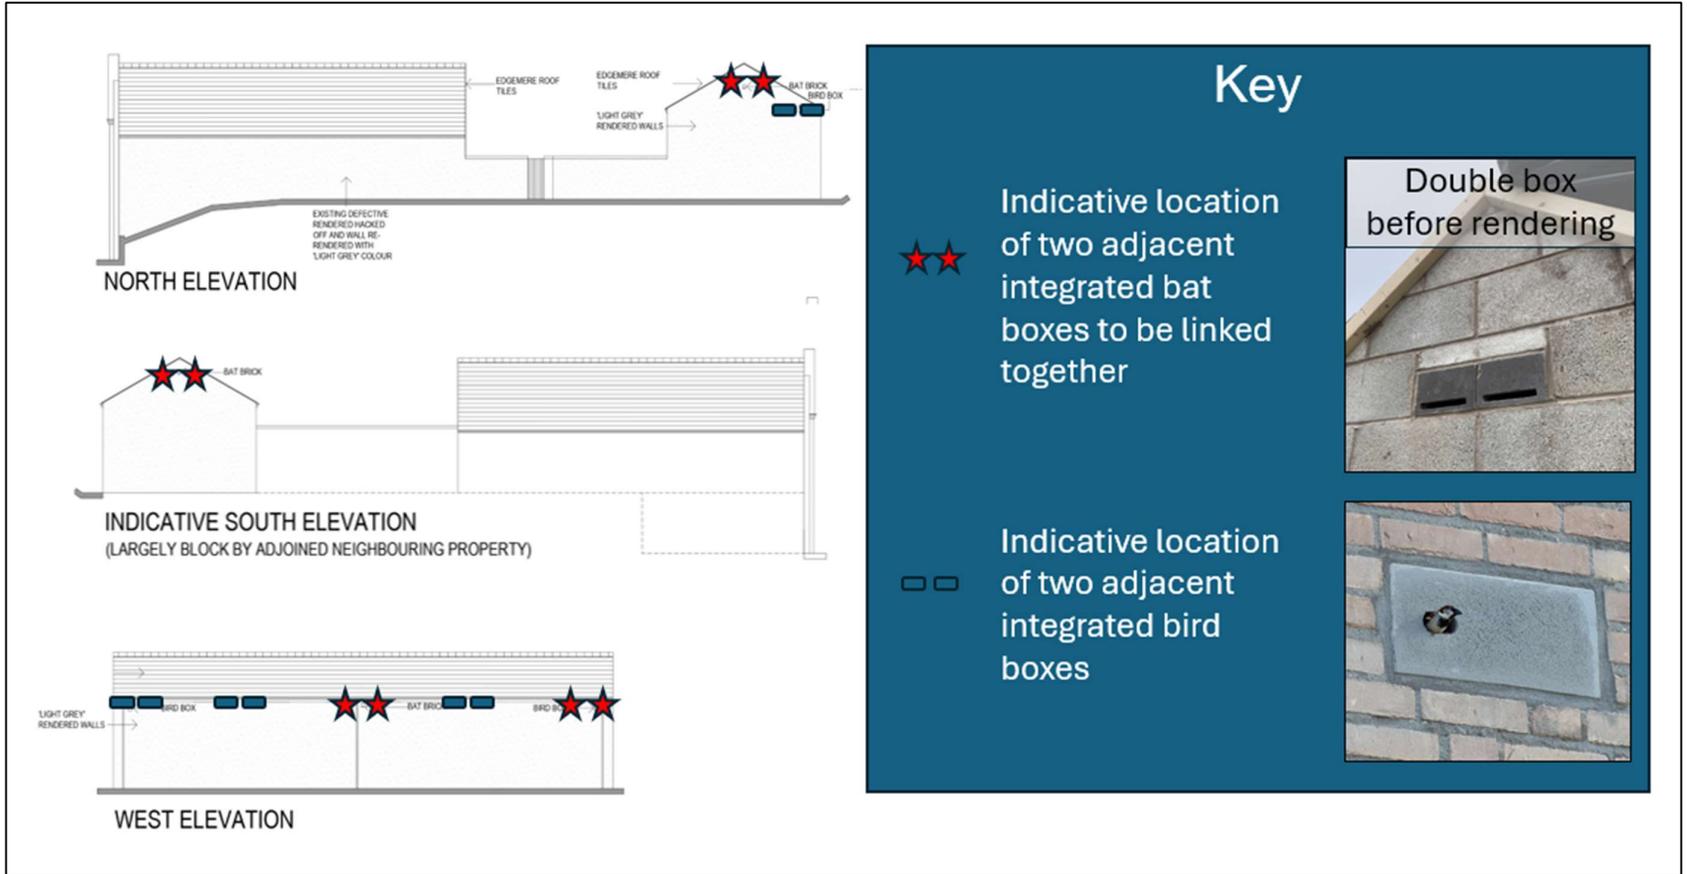
Figure 6. Suitable locations for the proposed bat and bird boxes on the north, south and west elevations

- 6.3.3 To replace the potential bat roost features and confirmed bird nesting opportunities within the building, the number of integrated bat and bird should be increased from three boxes for each species group, to eight boxes per species group. Bat boxes should comprise Vivara Pro UK bat boxes (or similar). The bird boxes should comprise swift bricks such as the S-bricks supplied by Action for Swifts<sup>1</sup>. The boxes should be located in adjacent pairs, with adjacent bat boxes connected internally (as shown in Figure 6).

- 6.3.4 The bat boxes should be located on the rear elevation (west), where they will be facing the woodland, as well as on the north and south facing gables. The bird boxes can be included on the north, east or west elevations. The bird and bat boxes should be located near the wall top on the new two storey section of the building. These elevations are ideal because they will be undisturbed. Boxes should not be located directly above windows. Suitable locations for the proposed bat and bird boxes are shown on Figure 6 overleaf.
