## Addendum Engineer's Report

| <b>Risk Address</b> | <b>5 Westfield Court</b> |
| <b>360 Reference</b> | <b>DLG-SN-22-005272</b> |
| <b>Addendum Report Date</b> | <b>08.01.2025</b> |

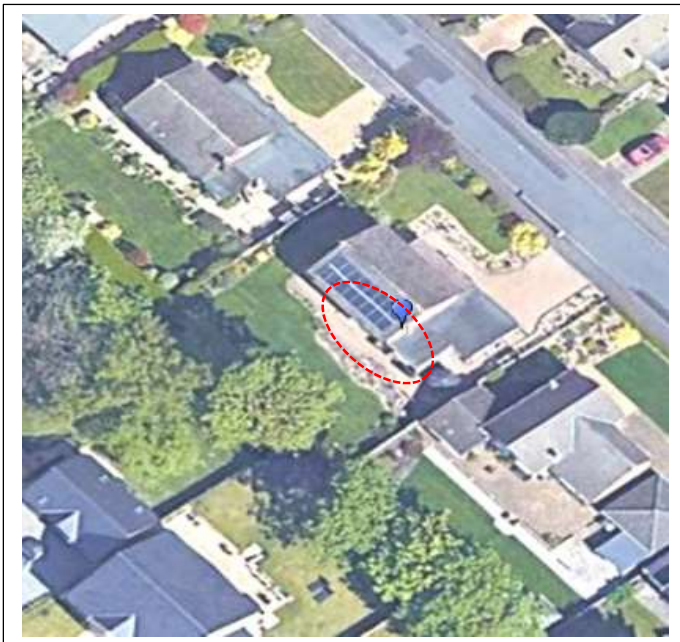
This document addresses damage notified to insurers in relation to cracking orientated towards the rear left-hand side of the house. All directions are stated when viewing the property from the front.

Damage has appeared internally, and externally around the rear and left-hand side of the house. Cracking, up to approximately 5mm wide, is evident. The cracking is stepped / diagonal and tapered, generally increasing in width with height, being orientated towards the rear left of the house.

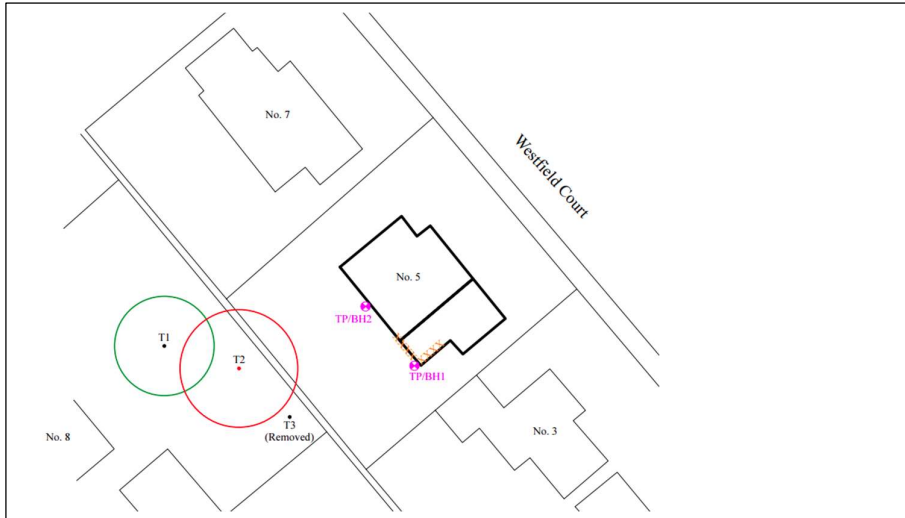
In summary, they recommended the removal of the closest Sycamore tree (T3 – 20 metres tall and 12.7 metres away). The other trees (T1 Sycamore – 17 metres tall and 17 metres away and T2 Oak – 17 metres tall and 13.8 metres away) were recommended to be maintained. All trees are subject to a Tree Preservation Order.

After consultation with the neighbouring owner and the Local Authority, the Preservation Order was lifted and the Sycamore T3 was removed in March 2024.

Due to further movement occurring, a revised Arboricultural Report was provided in January 2025, and this has now recommended the removal of the Oak T2.

It is clear that the rear of the property continues to be affected by significant foundation movement as a result of clay shrinkage due to the moisture demand of the vegetation at the rear, namely the Oak tree T2.

- Remove the Oak tree T2, allow the ground to rehydrate over the winter and undertake superstructure repairs in spring / early summer 2025 – estimated cost of removing Oak tree £3,000. This would be subject to the neighbour's agreement and also would need the Tree Preservation Order to be lifted.

- If consent to remove the Oak T2 is refused, then a root barrier across the rear garden appears to be feasible. This would cut off the Oak roots from the foundations. Estimated cost of barrier £50,000. This would also be subject to a root severance agreement with the Local Authority.
- If a root barrier was not feasible, or a root severance was not agreed, then the only option would be to underpin the rear wall below the influence of the Oak tree roots. Estimated cost of underpinning would be in excess of £100,000.
- For all options, the superstructure damage to the property needs to be repaired and this is estimated at £20,000.

In summary, it is recommended that an application for the removal of T2 is submitted given the further evidence obtained, and that if it is refused, then the root barrier or underpinning solutions are progressed, and solicitors should be instructed to recover the stabilisation costs from the Local Authority.
