Gas Membrane Installation
Validation Report
JP Marsden Construction Ltd
Town End Road
Holmfirth
HD9 1AH

Appendix 1 – Site Survey Sheets

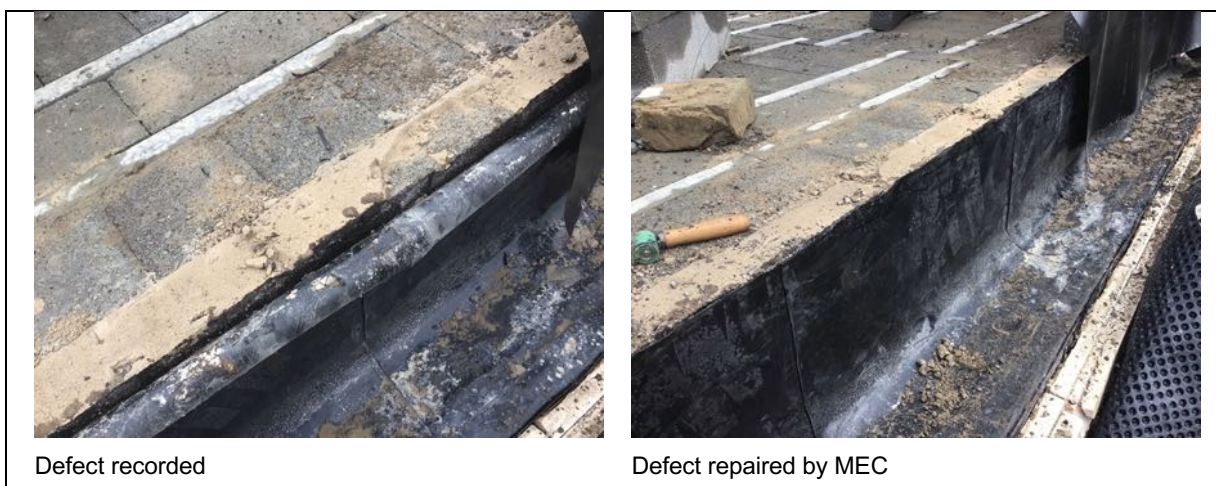
Detailing Sample Photographs

Others Please List: See defects section			
(Section 2, Testing and Inspection Method)			
Leak/Hole Detection	MEC Environmental Ltd carried out a thorough Visual Inspection to the available area at the time of our inspection		
Joint Testing	The surveyor carried out Probe testing as per the method prescribed in ASTM D4437 to all detailing work, detailing work is defined as any part of the installation that includes a joint in the membrane, this includes but is not limited to pipes/ducts, stanchions, wind posts, braces, field seams, masonry abutments, tanking, door thresholds and the like		
Plot Number	(Section 3, Defects List)		Action Required
1no private property	The installers have installed Juta Titantank around the top edge of the pre primed retaining walls and hand welded onto the previously installed tanking prior to the backfill. All joints have been hand welded and sealed. Approx 2m of tanking had come away from the wall due to excess		Repairs completed at time of inspection

material pulling itself down. these have been trimmed, heated and satisfactorily.	
Signed: Dan Squire (TGPV) (NVQ 4)		Date: 24/09/2024
