15 Towngate, Marsden, Huddersfield HD7 6DD
Design and Access Statement / Heritage Statement

Submitted to Kirklees Council on
behalf of Miss Clarke & Mr Leigh-
Jones

March 2025

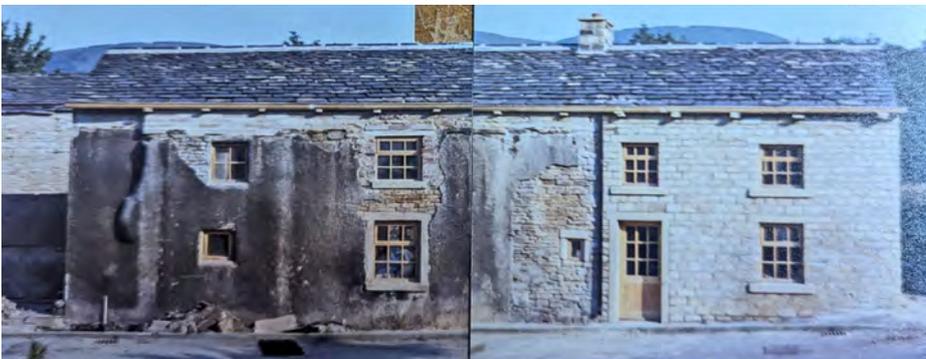
The Towngate frontage of the property in circa 1982, during works. Note the eaves are raised, new opening at first floor and all new windows and doors

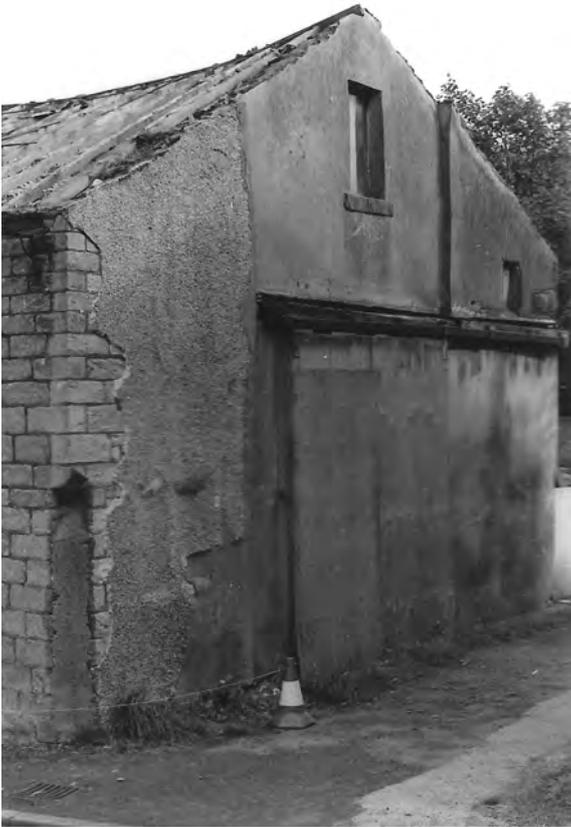
The west elevation prior to refurbishment, circa 1980, with a chamfered corner and large in-filled opening in the gable wall

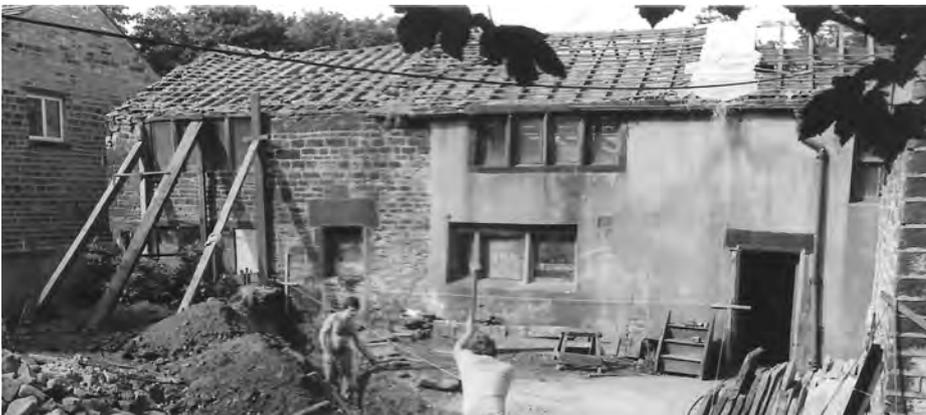
The south / rear of the property in circa 1981, before works. Above: extract with detail of cast iron rainwater pipe and hopper

Several areas of the building require repairs and maintenance work. Gutters are leaking and rainwater goods generally require improvement. Historic photos from before the refurbishment in the 80s show cast iron hoppers and downpipes from the timber gutters. The existing PVC downpipes detract from the listed building and are defective. Hoppers were present before the 1980s works but were removed. Hoppers help to improve the flow of rainwater in heavy rainfall and new cast iron hoppers and downpipes are therefore proposed for the building, in the existing positions.

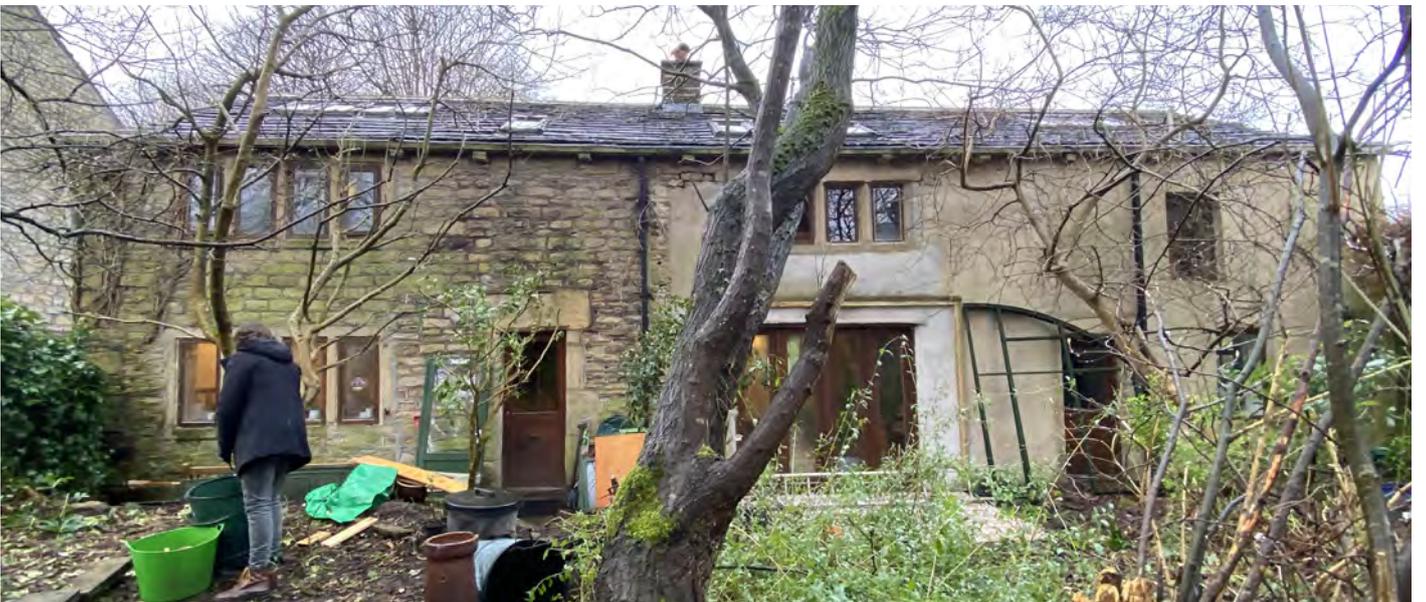
South elevation Rear 5 Feb 2025

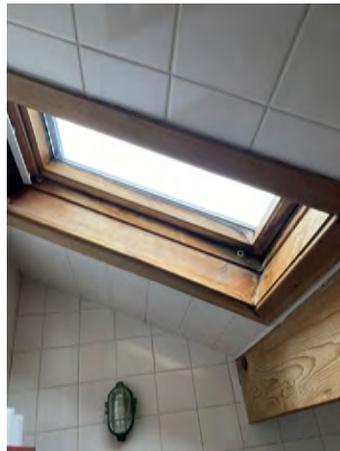
RW 5 (Bathroom)
Double glazed Velux unit

The front door is proposed to revert to a style seen before the 1980s works, with two glazed panels over a single panel. This fits with the sash window style in a more harmonious frontage. To the rear, the minimal approach is maintained, with timber double glazed doors and full size fixed and casement windows are proposed in the existing openings. The Velux roof windows are leaking and like for like replacements are proposed (with the current Velux model equivalent).

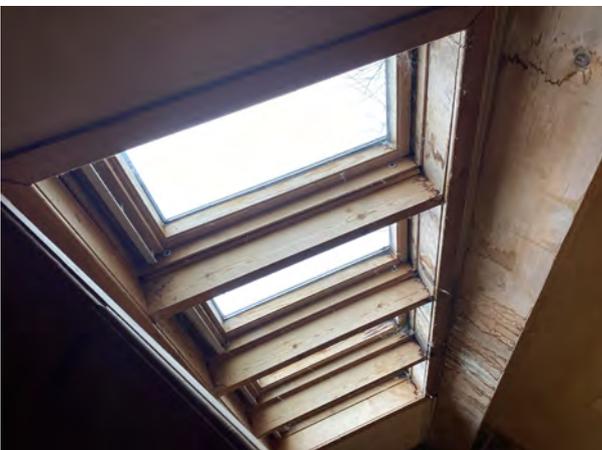
RW 6-9 (Living Space)
Double glazed Velux units

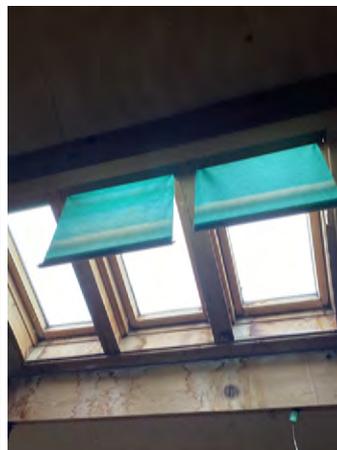
RW 10-12 (Bedroom 2)
Double glazed Velux units

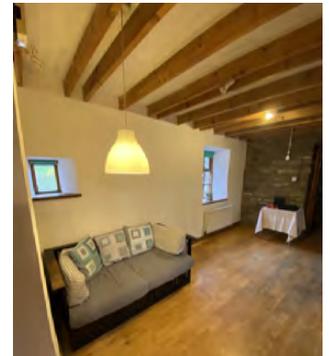
Hall as existing

The proposed staircase returns a stair to the position shown pre 1980, as indicated on the 1980 'existing' plan, before refurbishment. The design makes best use of the hallway space, returning the full height living space to the 1981 design. The stairwell is created with new trimmer beams to carry the first floor cut joists. The winder design works with the existing windows and limited headroom to arrive at the first floor balcony overlooking the double height space. A cut stringer support under the treads allows the treads to meet the distortions in the front wall.

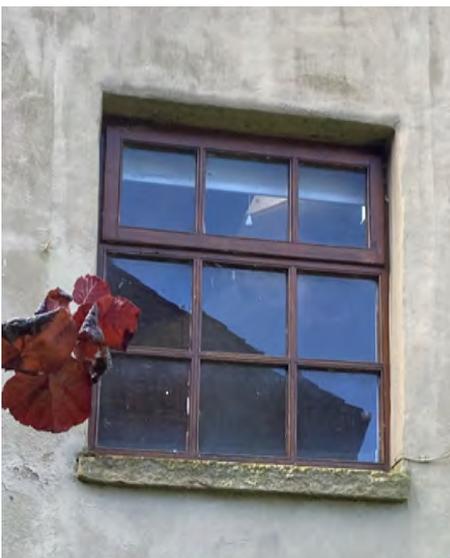
Existing - awning windows in the side and frontage

We are of the opinion that, for the frontage, new double glazed timber sash windows, with limited glazing bars, offer a suitable balance between the modern interior of the 1980s, the historic external walls of the property and the local context. The surrounding conservation area has many examples of this type, and whilst the sash period style proposed is more Late Victorian than the earlier origin is of 15 Towngate, there is photographic evidence of this style having been installed at the building pre-1980. Reverting to earlier periods and smaller panes etc risks becoming pastiche and incongruent with the modern interiors. Small openings will remain as fixed timber windows with double glazing replacement. Use of slim(16mm) double glazing units will limit the overall change in profile. New timber sashes are an opportunity to enhance the significance of the listed building. Double glazed, spiral balance sashes are suggested to suit the narrow openings. Sage green timberwork is proposed externally as a more harmonious tone than the current brown stain.
