# Arboricultural Impact Assessment

**WC-421.1a**

30, Oxford Road, Dewsbury WF13 4LL

| <b>Report type:</b> | Arboricultural Impact Assessment |

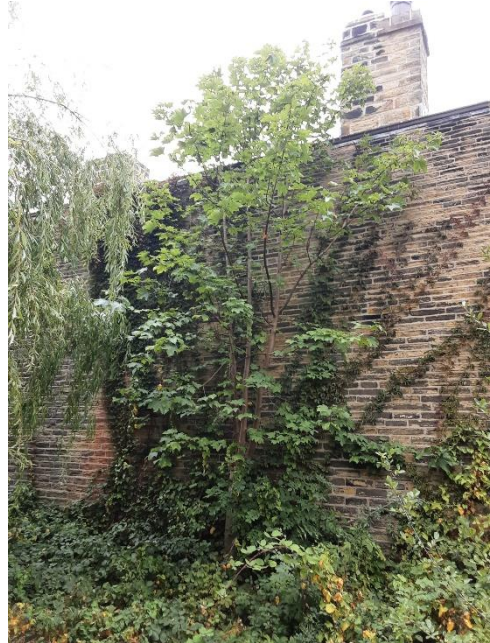
***Plate 10: T010***

- 4.1.1. The development proposals do not directly necessitate the removal of trees from the site.
- 4.1.2. However, T002, T003, and T010 are all self-seeded category C trees of low-quality, which are growing from the bases of boundary walls. Removal of these trees is therefore recommended to mitigate future damage to the walls.
- 4.1.3. G005 is a category C group of trees, which historically has been maintained as a hedge. Due to a lapse in management these trees now encroach upon the existing building. G005 is therefore recommended to be partially removed.
