STRUCTURAL DESIGN PHILOSOPHY The George Hotel, Huddersfield

Client: GMI Construction
Project Name: The George Hotel, Huddersfield
Report Title: Block A – Structural Design Philosophy
Report Author: James Hendry
Document ref: 00.24363-ACE-ZZ-ZZ-T-S-0004
Date: April'25

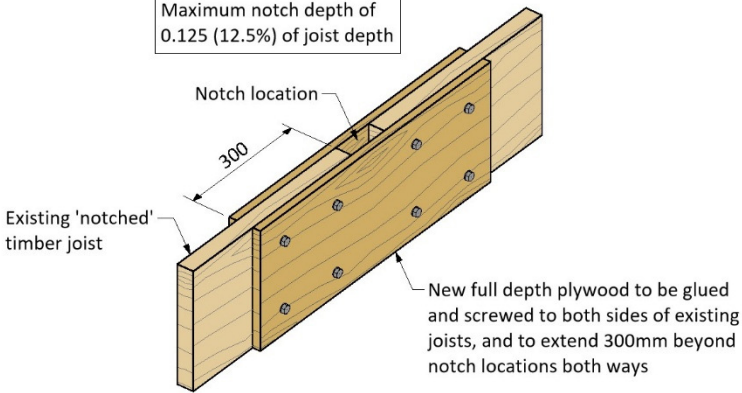
- 3.2.1. A timber survey was undertaken, with a subsequent report produced by Floyd Consulting dated 04/02/2025. The report examined the condition and arrangement of timber elements at all previously exposed points across every floor level.
- 3.2.2. In addition to documenting the condition and geometry of the existing floor joists, the report highlighted a significant number of post-construction service installations (notching of joists). This has inevitably weakened the overall structure, and there are also areas where further investigation is required to confirm sufficient end bearing condition.
- 3.2.3. Refer to Figure 3 below for examples of heavily notched joists.

Figure 3 – Heavily Notched Joists (30-40%)

Notes	Isometric View
<p><u>Localised Repair Detail at Notch Locations:</u></p> <p>Maximum permitted notch depth is 0.125 x joist depth.</p> <p>Where notching is identified (following removal of ceilings or floorboards), a full depth plywood plate shall be glued and screwed to both sides of the affected joist. The plywood plates should extend a minimum of 300mm beyond the notched area in both directions.</p> <p>Fixings to be staggered and installed in accordance with best practice for timber strengthening.</p>

<p>Maximum notch depth of 0.125 (12.5%) of joist depth</p> <p>Notch location</p> <p>300</p> <p>Existing 'notched' timber joist</p> <p>New full depth plywood to be glued and screwed to both sides of existing joists, and to extend 300mm beyond notch locations both ways</p>
