# Gynn Lane, Honley

## River Condition Assessment Report

Report Ref. ER-7732-04B

Vivly Living

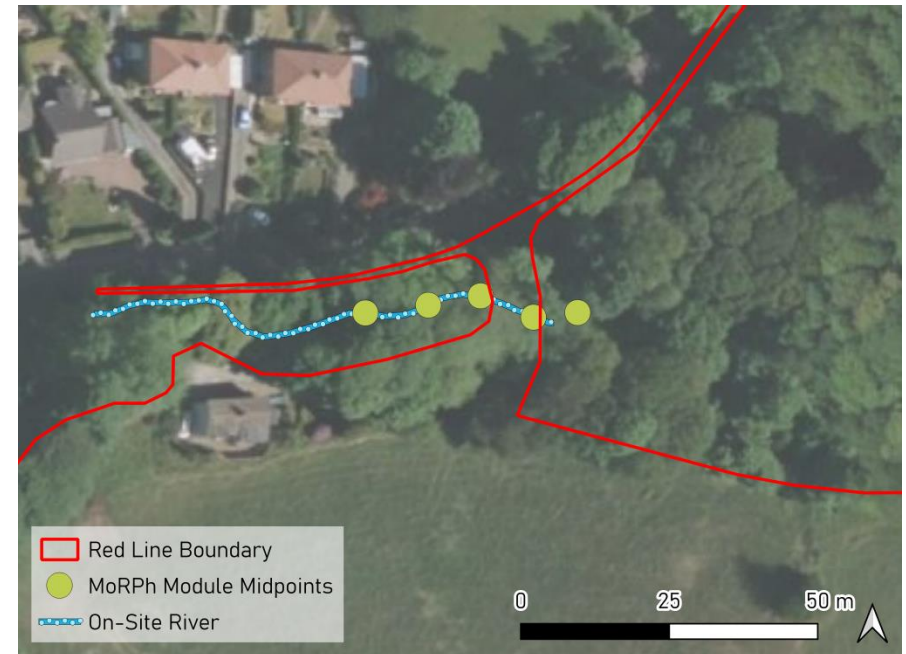
**Figure 2** MoRPh survey sites on Ludhill Dike.

24. The majority of the length of the watercourse appears generally natural, with a mixture of steeply sloped to vertical bank faces. Reinforcement generally relates to the culvert, bridge and pipe outflow. The riverbed appears free of artificial reinforcement throughout, and no other artificial features were observed within the channel.

26. The bank faces are comprised of earth sediment where visible, with reinforcement associated with culvert, bridge and pipe outflow being of cemented laid brick. Vegetation comprises mosses, grasses, short and creeping herbs and scrub, with some small trees.
27. Trace amounts of the Non-Native Invasive Plant (NNIP) Himalayan balsam were observed on the left bank top in modules 4 and 5.
