GeoShield Verification Report 01

PROJECT REFERENCE: GEO104074

PROJECT: Dewsbury Hospital

SPECIFICATION: Verified in accordance CIRIA 735.

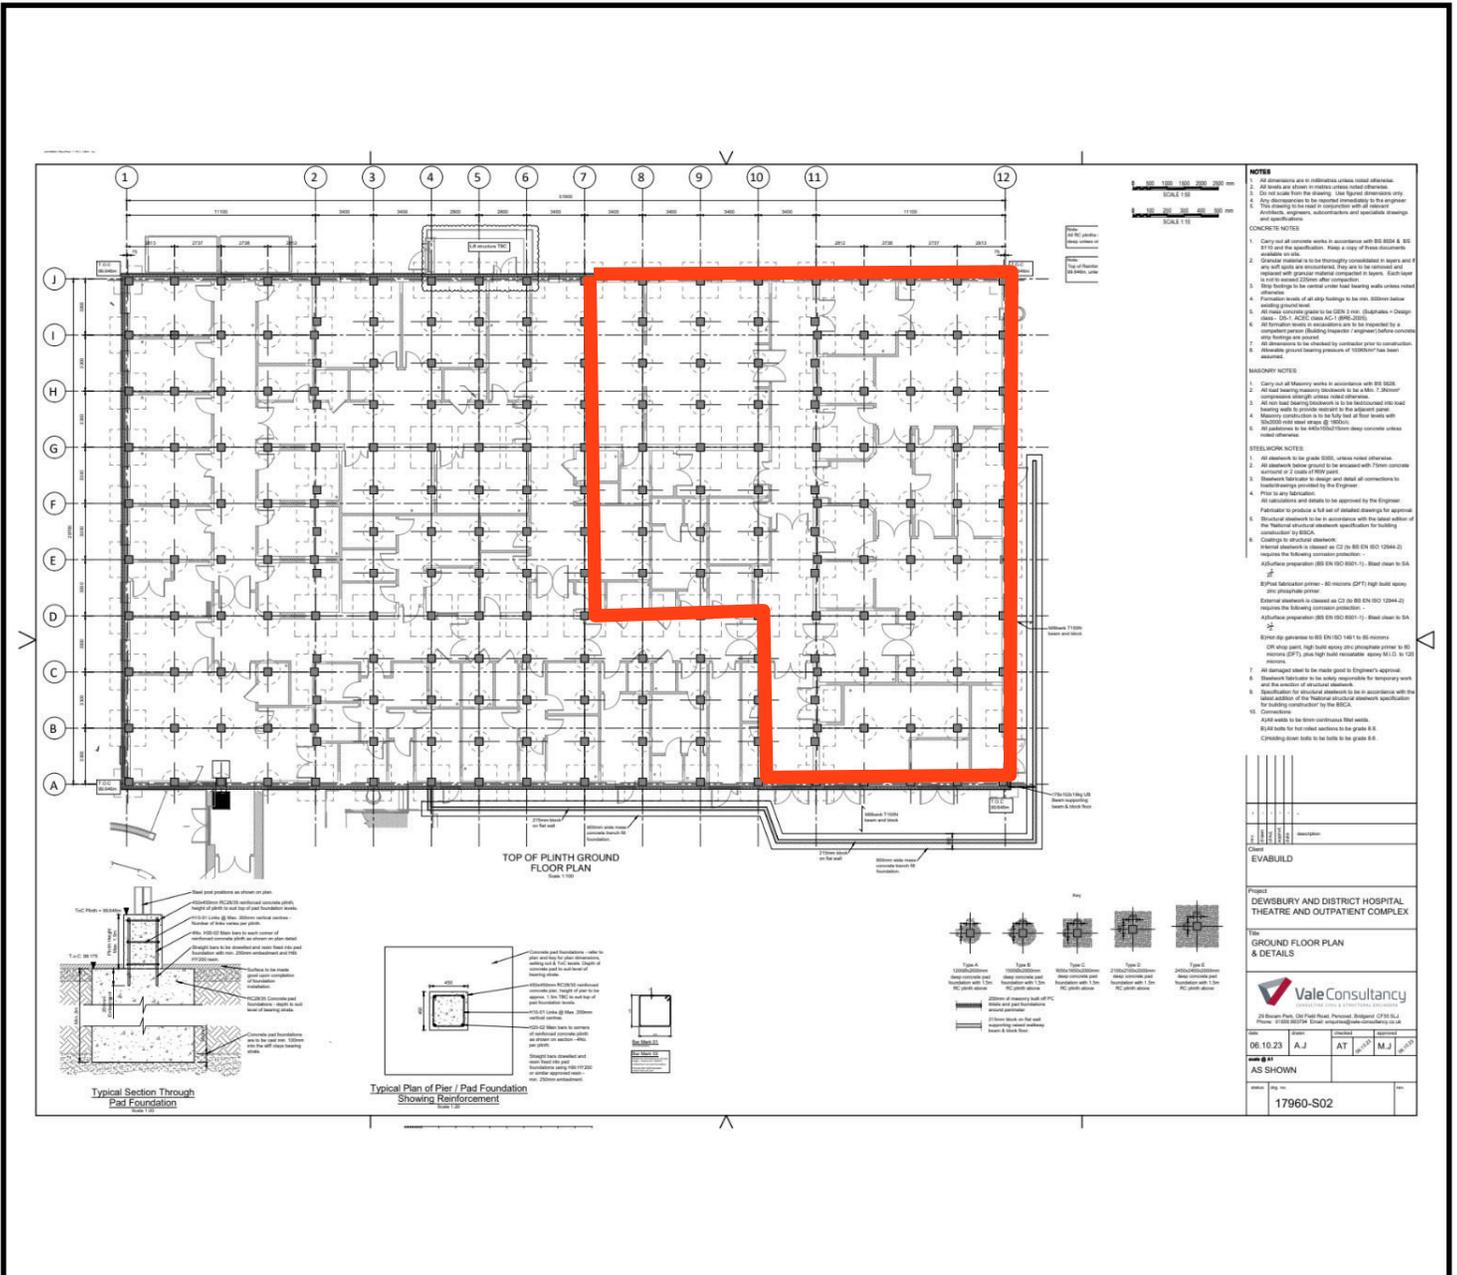
Verification Layout

This is an overview of the proposed site layout plan where the area outlined has been verified this report.
