**Structural Appraisal of Buildings B, C, D & G,
Turnbridge Mills, Quay Street,
Huddersfield, HD1 6QT**

RCE6909

Rev	Date	Description	By
-	30-01-25	Initial issue	PR
A	13-03-25	<i>`Comment on possible proposed development of Buildings B & D` section added</i>	PR
B	17-03-25	Minor amendments	PR
C	16-04-25	Minor amendments	PR

21st January 2025

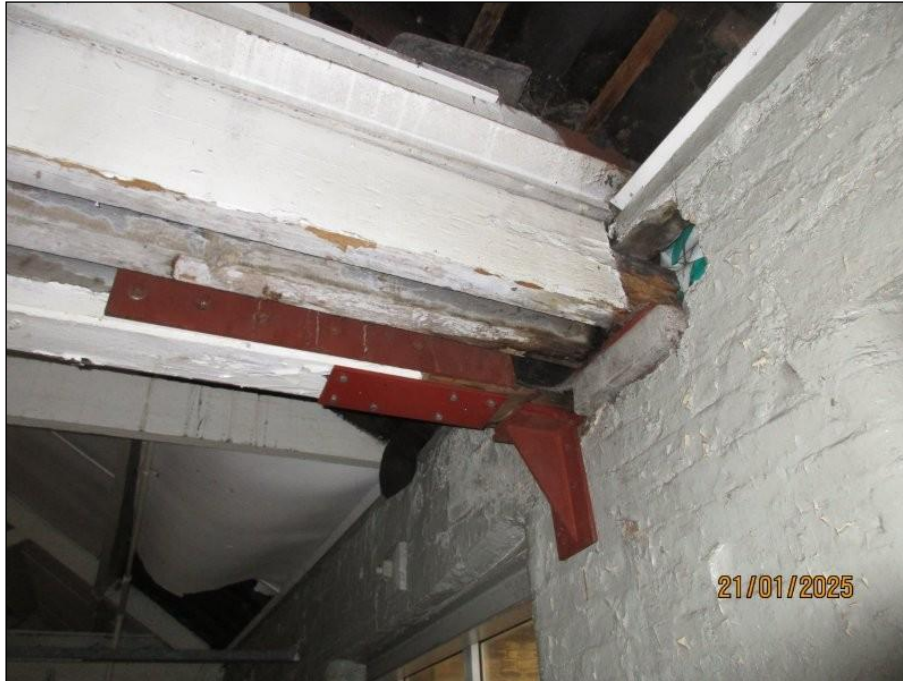
Photograph 8

Several repairs have been historically made to the roof. It appears that the gutters have probably not been well maintained, and that water ingress has caused the truss ends to rot. Some of these trusses are now in danger of collapse. Some of the truss ends are currently supported by props.

Major works to the roof are required. To properly repair the roof, it is estimated that approximately 50% of the roof is removed and replaced.

It is recommended that a full timber and damp survey is undertaken by a suitably qualified and experienced specialist to ensure that the extent of the rot is treated. It may be necessary to incorporate additional steel shoes into the structure.
