**NorthWest
DrainServices**

Inspection Report

Project Name: Burn Rd 290125
Start Date: 29/01/2025
Client: Wiggett Construction Ltd
449 Middleton Road
Chadderton

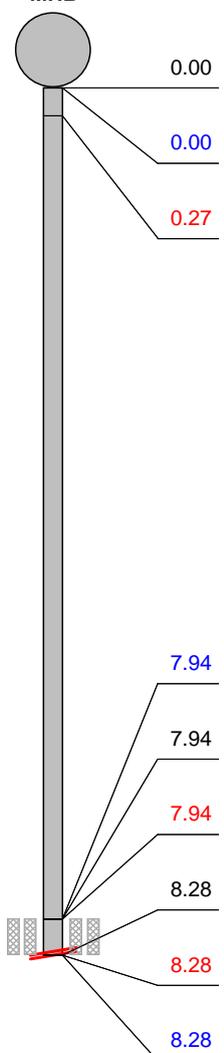
Scale:	1:72	Position [m]	Code	Observation	MPEG	Photo	Grade																																																						
<div style="display: flex; align-items: flex-start;"> <div style="flex: 1;"> <p style="margin-bottom: 5px;">Depth: m</p> <p style="margin-bottom: 5px;">MHB</p>

<table><tr> <td style="width: 10%;">0.00</td> <td style="width: 10%;">MH</td> <td style="width: 40%;">Start node, manhole, reference: MHB</td> <td style="width: 10%;">00:00:00</td> <td></td> <td></td> </tr><tr> <td style="color: blue;">7.94</td> <td style="color: blue;">S01</td> <td style="color: blue;">LXEB Defective lining, external bulge at 8 o'clock, start</td> <td style="color: blue;">00:02:00</td> <td style="color: blue;">MHAX_20 aded6e-64 83-4bcf-90</td> <td></td> </tr><tr> <td style="color: blue;">8.28</td> <td style="color: blue;">F01</td> <td style="color: blue;">LXEB Defective lining, external bulge at 8 o'clock, finish</td> <td style="color: blue;">00:03:18</td> <td></td> <td></td> </tr><tr> <td style="color: blue;">8.28</td> <td style="color: blue;">SA</td> <td style="color: blue;">Survey abandoned: DUE TO DEFECTIVE LINER</td> <td style="color: blue;">00:03:22</td> <td style="color: blue;">MHAX_30 988d4e-da bc-4fd3-ab</td> <td></td> </tr></table>

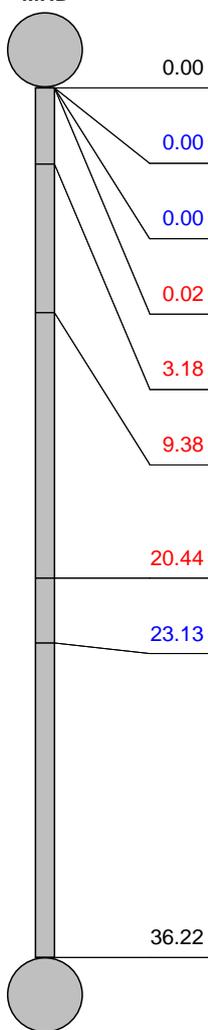
Scale:	1:314	Position [m]	Code	Observation	MPEG	Photo	Grade																																																															
<div style="display: flex; align-items: center;"> <div style="text-align: center; width: 15%;"> <p>Depth: m</p> <p>MHD</p>

<table><tr> <td style="text-align: right;">0.00</td> <td>MH</td> <td>Start node, manhole, reference: MHD</td> <td>00:00:00</td> <td></td> <td></td> <td></td> </tr><tr> <td style="text-align: right;">0.02</td> <td>B</td> <td>Broken pipe from 7 o'clock to 5 o'clock</td> <td>00:00:04</td> <td>MHDX_07 d47304-f1 1e-4cef-a6</td> <td></td> <td>4</td> </tr></table>
