GeoShield Verification Report 1

GEO105226

European Screeding Ltd
New School Building, North Huddersfield Trust
School,
Woodhouse Hall Road,
Huddersfield,
HD2 1DJ

New School Building - Infills

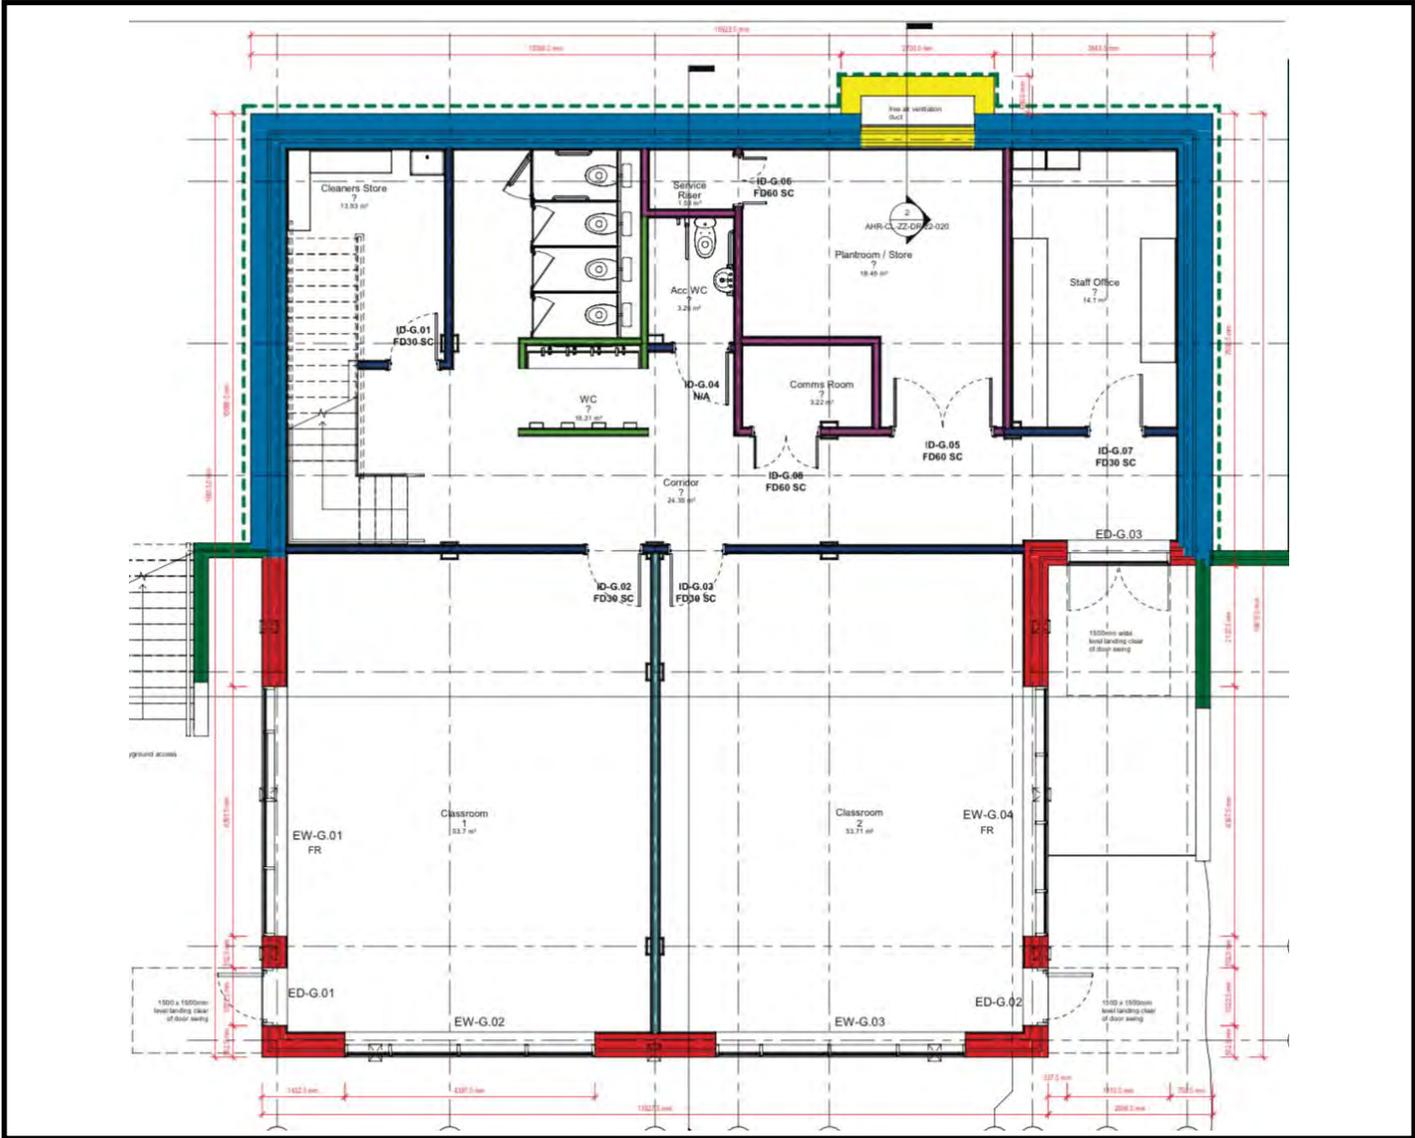
The image above shows a plan layout of the new school building where the verification inspection took place on site today.

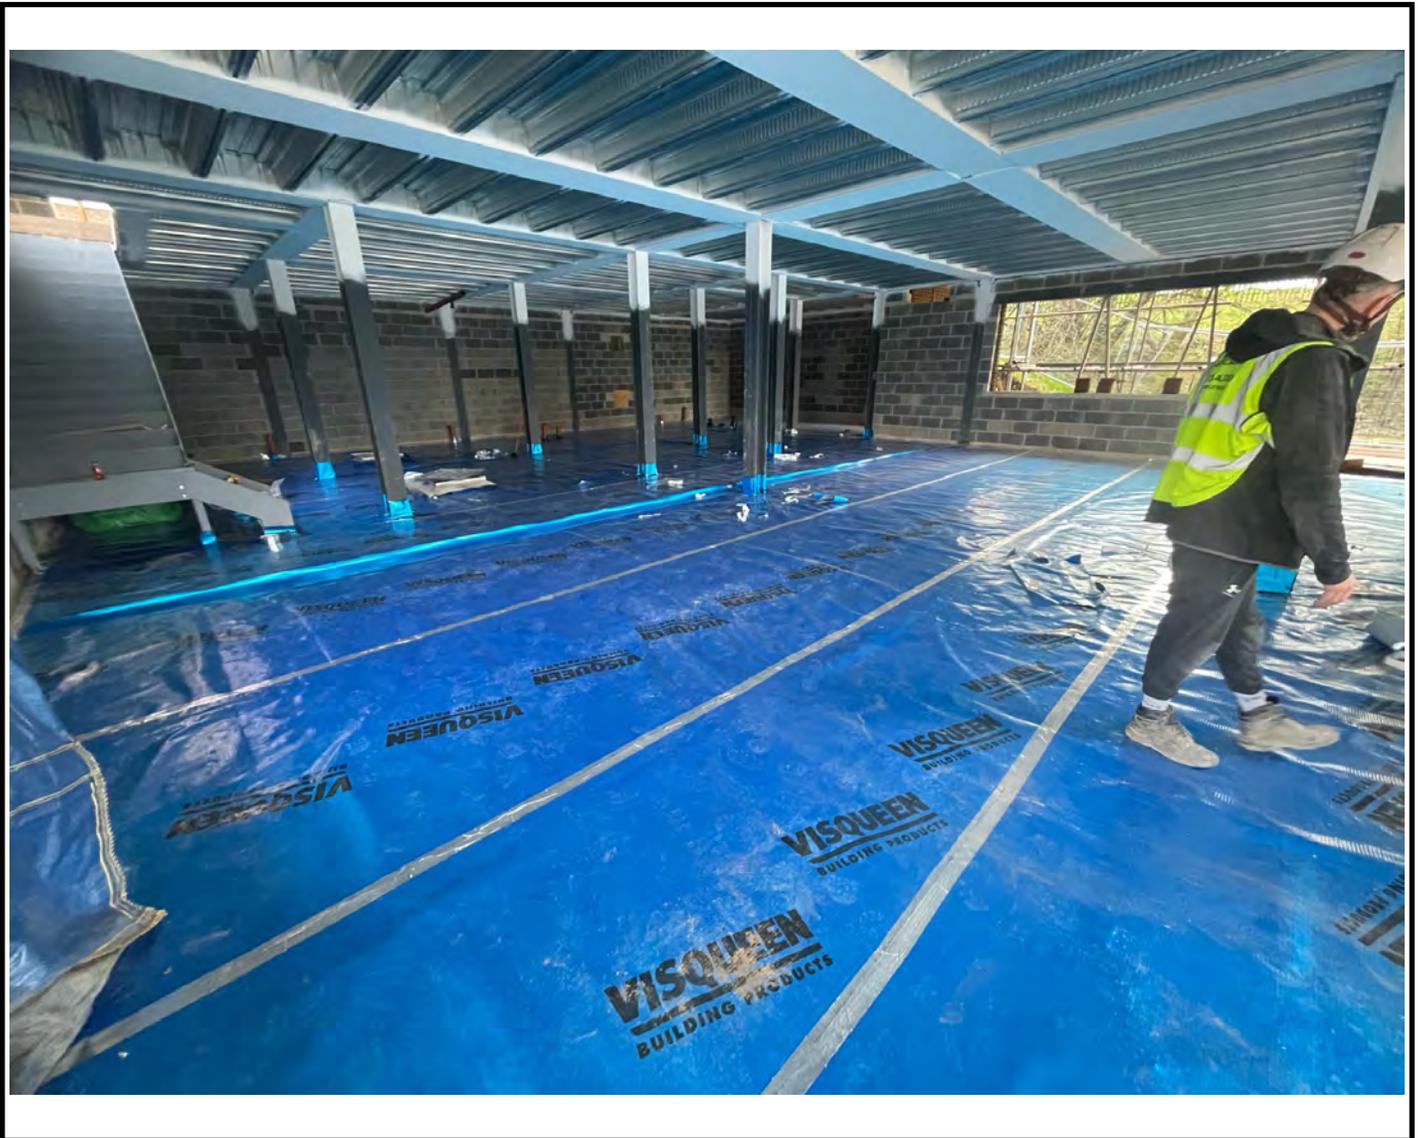
The photograph above displays an overview of the area where today's verification inspection took place on site.
