# Tree Survey

26 Botham Hall Road  
Milnsbridge  
Huddersfield  
HD3 4RJ

A 'visual tree inspection' was undertaken on Monday 14<sup>th</sup> July 2025 at 26 Botham Hall Road at the request of the owners.

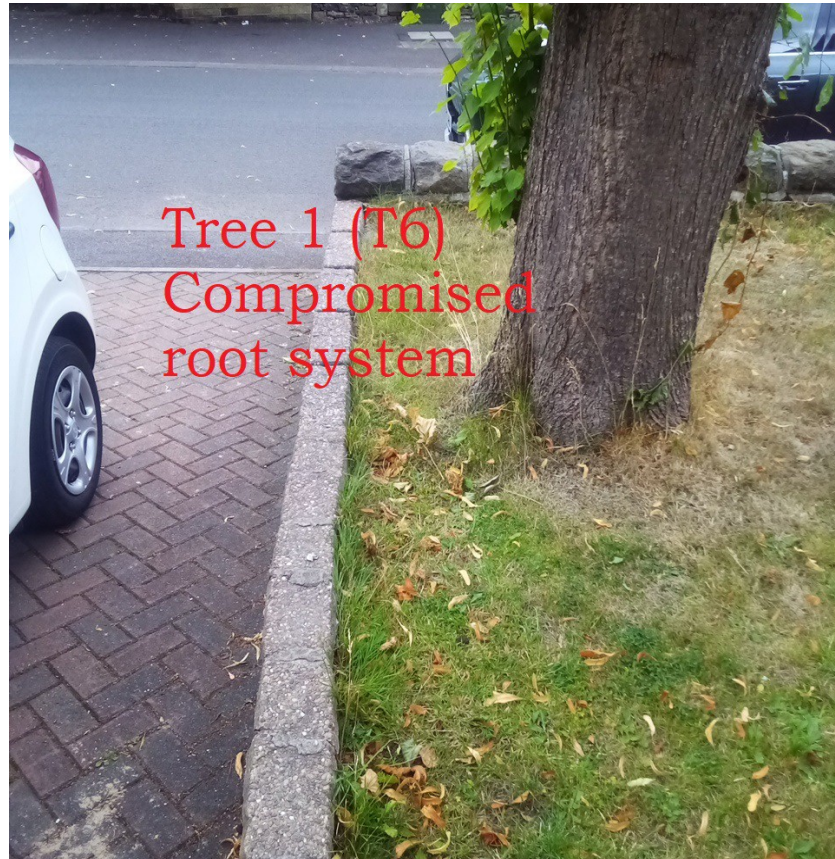
A recent branch failure is evident, with the pieces stacked in the corner of the garden. Diameter was measured as 13cm. The fractured wood appears very brittle and dessicated, despite not having been 'deadwood'.

T1 (T6)  
area of  
recent  
branch loss

**Recommendation:** Removal of the tree.

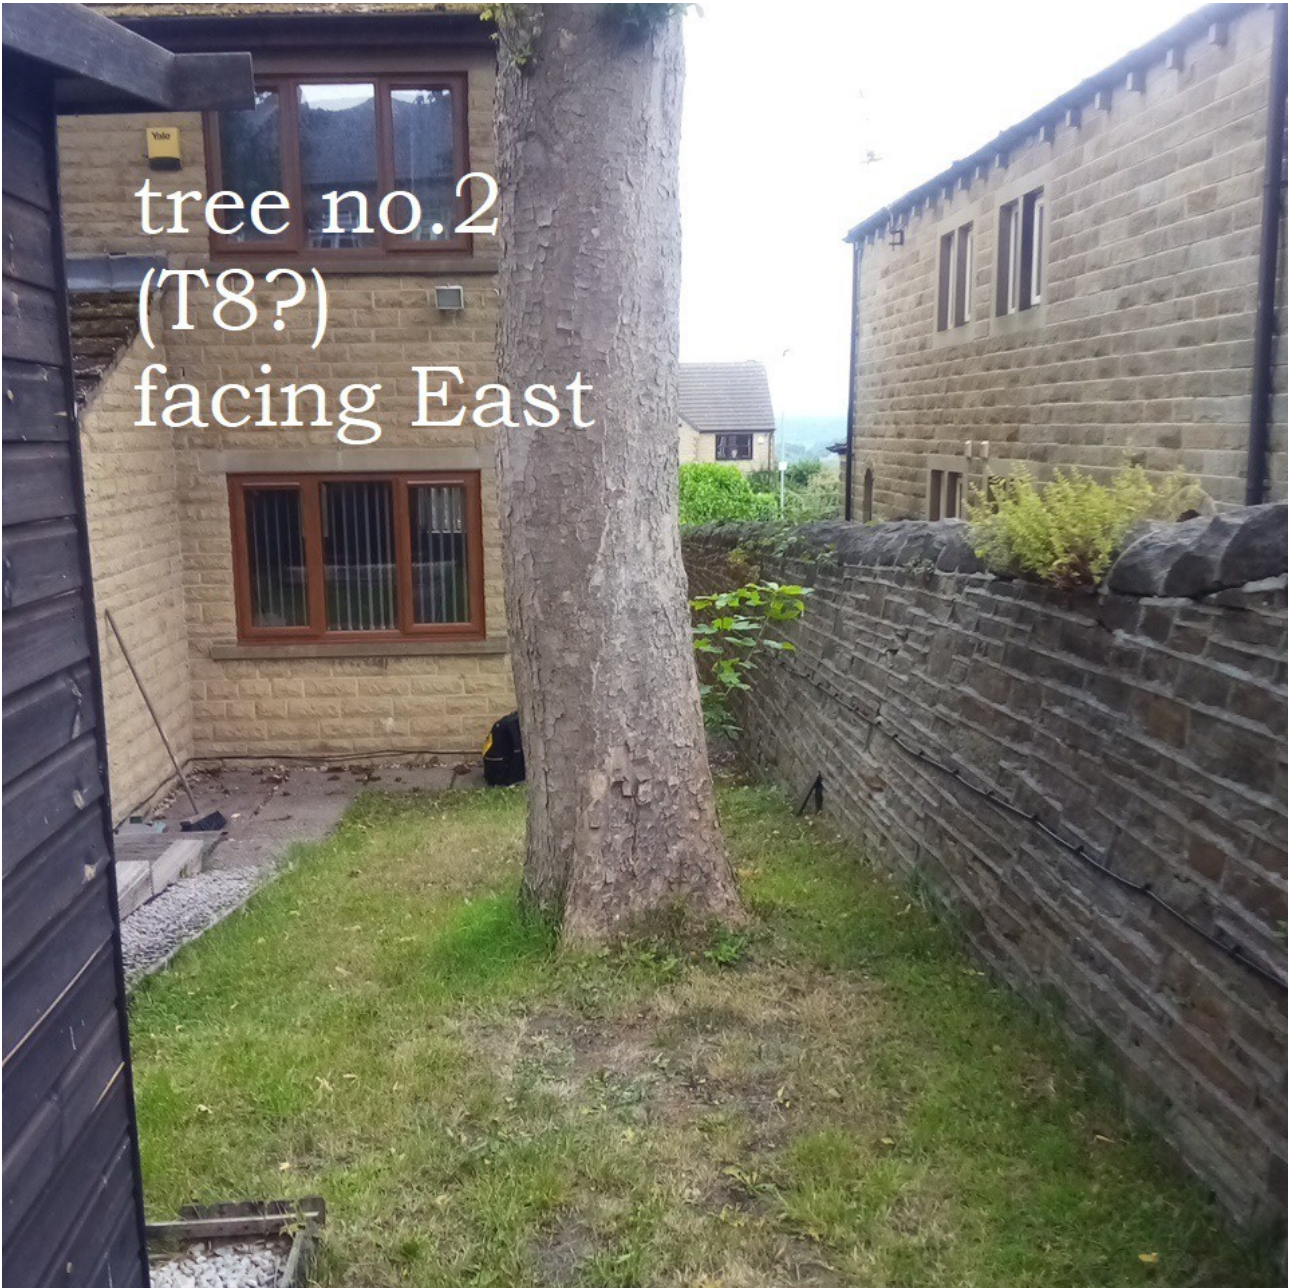
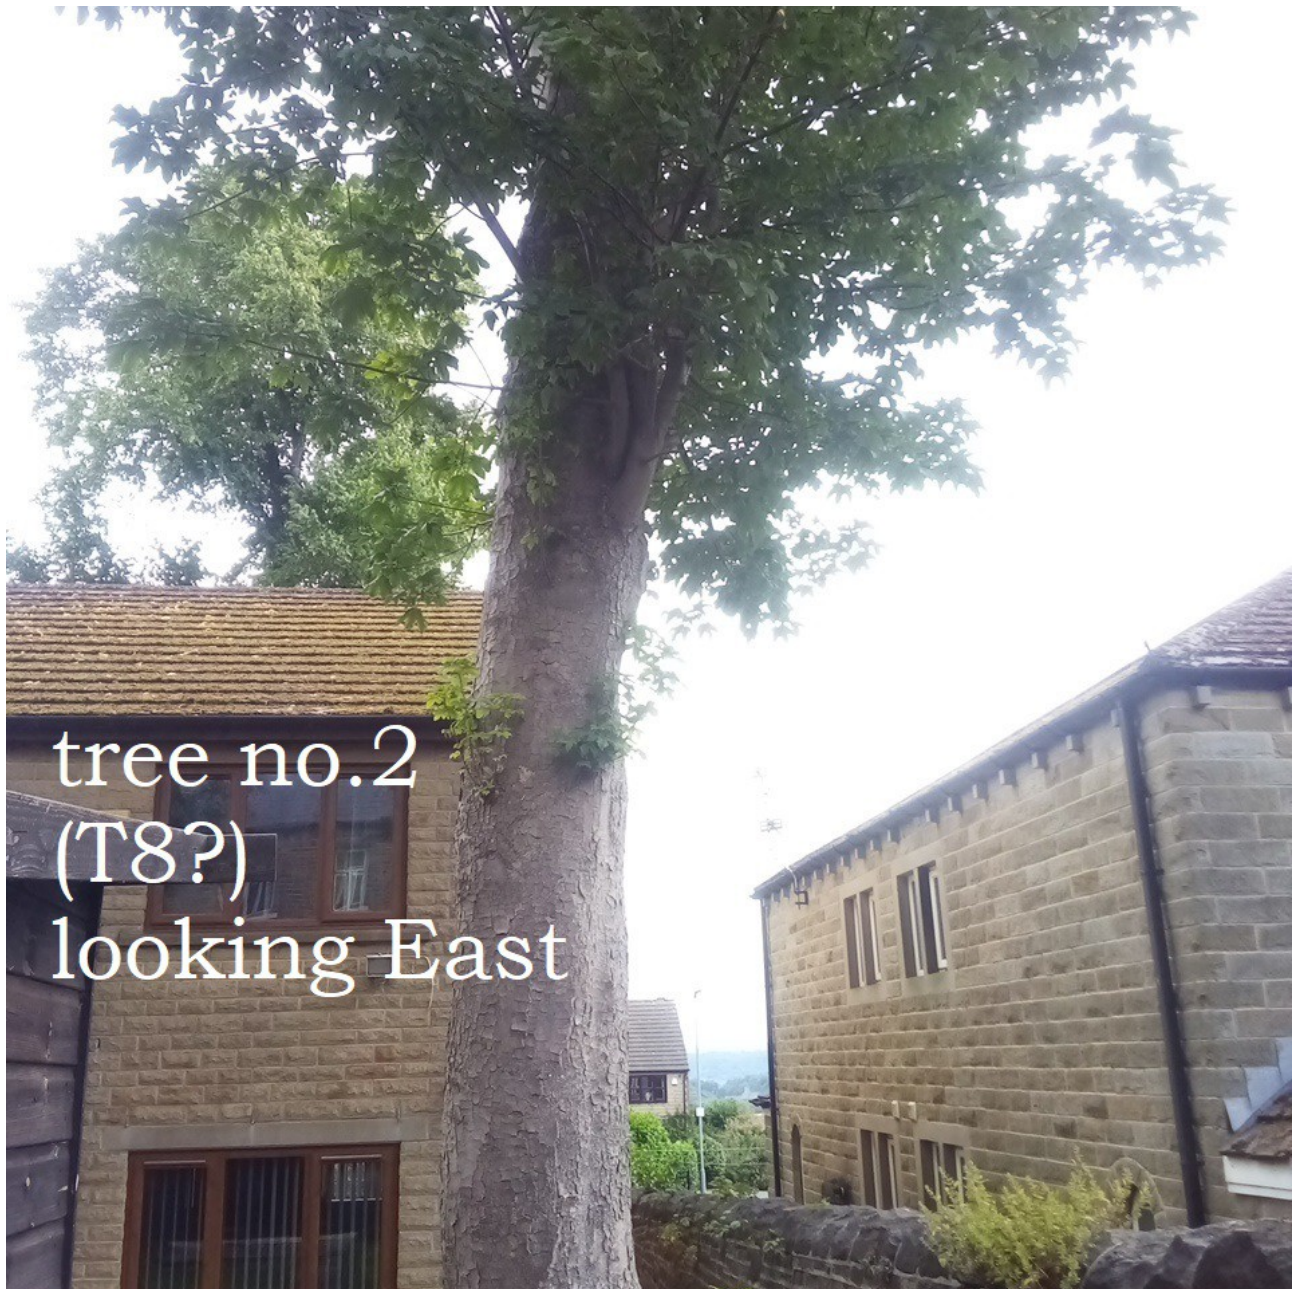
tree no.2  
(T8?)  
facing East

**Features / Defects / Observations:** The crown is almost wholly weighted to one side – towards the neighbouring property to the South. The stem / trunk also has a slight lean.

**Summary:** Although in reasonable vigour, the tree is imbalanced and is outgrowing its position. There are concerns that if it structurally fails then considerable damage would likely occur. The partial damage to the root system during construction may yet have a detrimental impact on the overall structural integrity of the tree.

**Recommendation:** Removal of the tree.

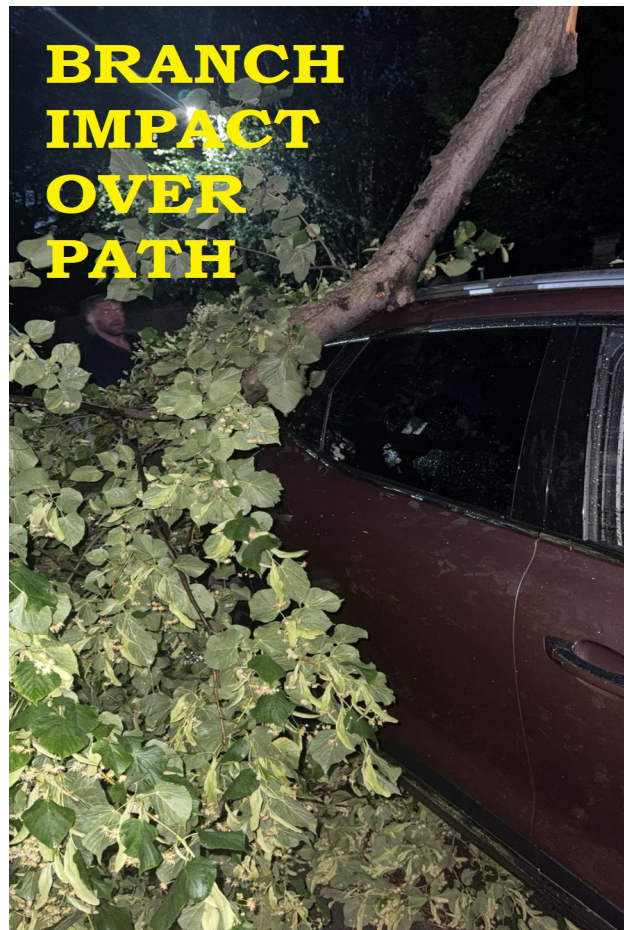
**SEVERE DENT ON CAR CAUSED BY BRANCH FALLING  
FROM LIME TREE ASJACENT TO HIGHWAY AT 26  
BOTHAM HALL ROAD**

**THIS TREE HAS A HISTORY OF SUMMER BRANCH  
DROP**
