# Tree Condition Survey & Management Work Recommendations

SITE: 54 Mount Road, Marsden, HD7 6HP

Ref: NWTC/RG002

**NORTH WEST TREE CONSULTANCY LTD**

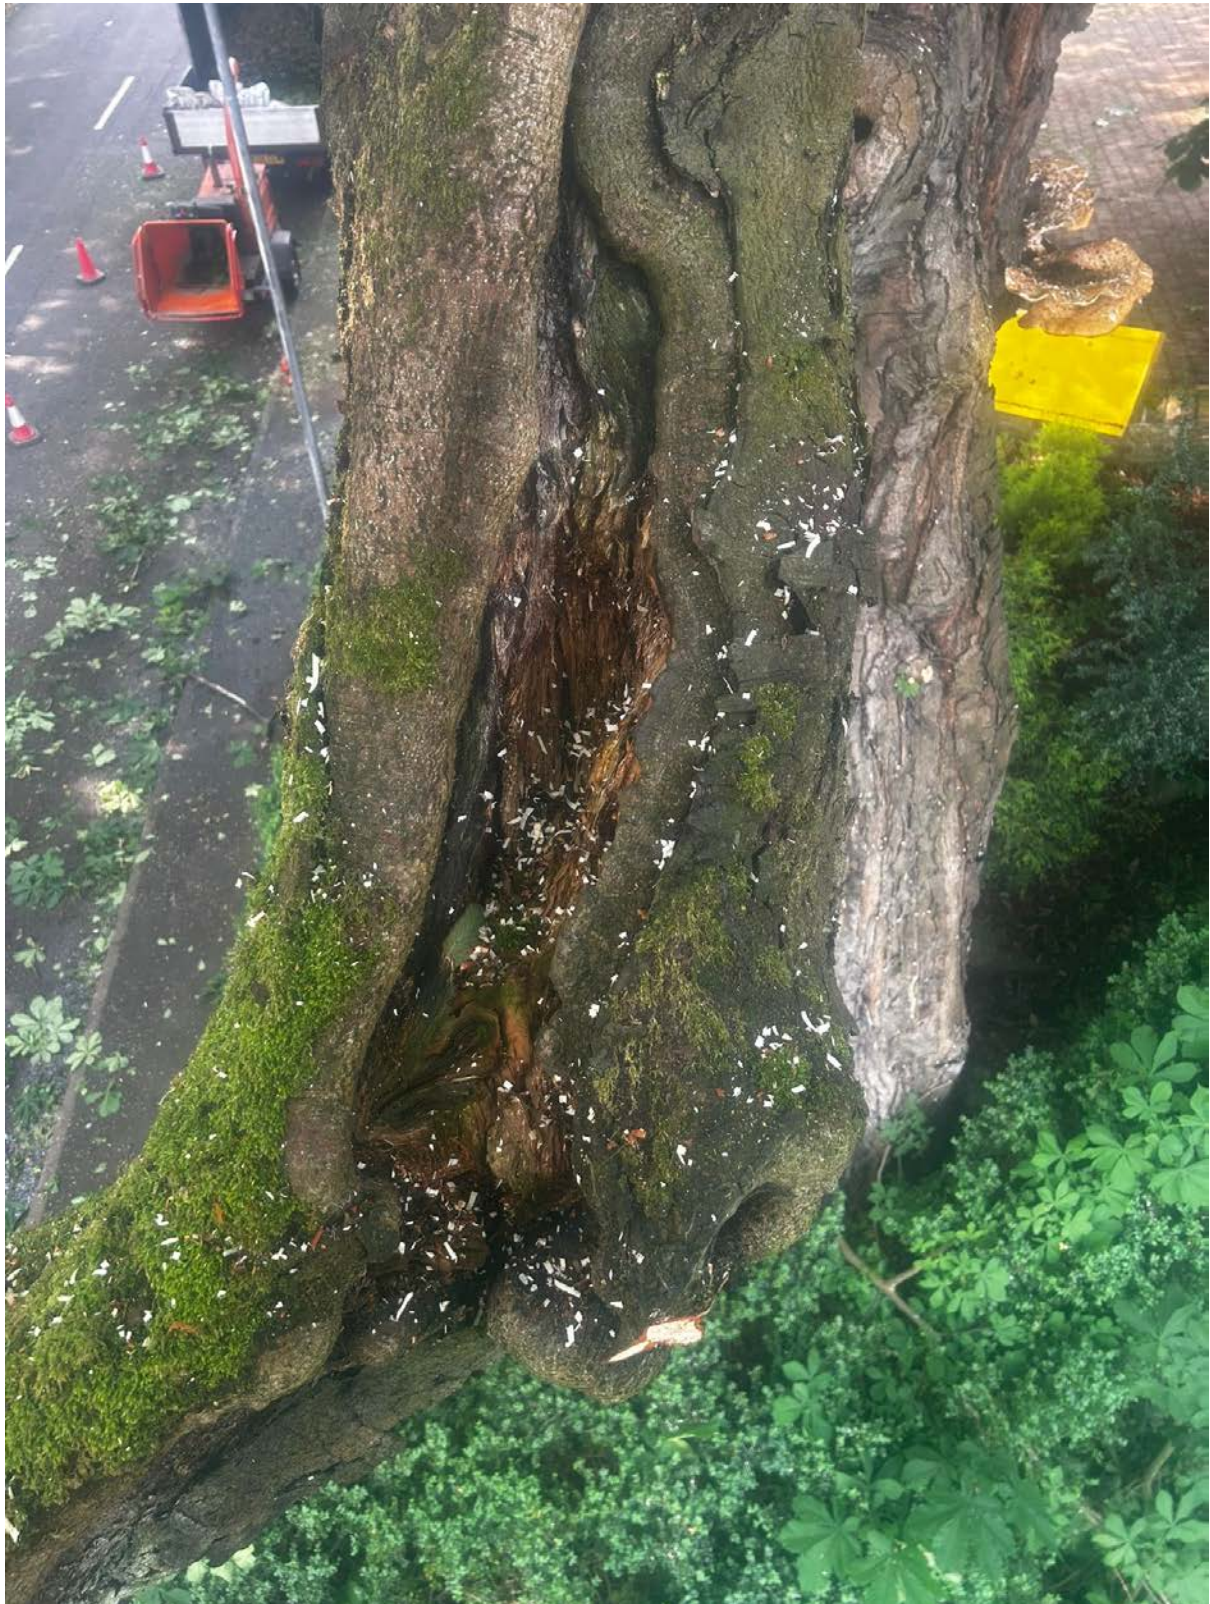
Photograph 5: Large seam of decay on lateral limb overhanging public footpath and pavement.

| Ref. | Species | Description | Measurements | Survey Notes | Overall Condition | Inspect Period | Recommendations |
|---|---|---|---|---|---|---|---|
| T1 | Horse chestnut<br>( <i>Aesculus hippocastanum</i> ) | Owned by the client.<br>Target # - dwelling.<br>Target # - Pedestrians.<br>Target # - Traffic. | Height (m): 15<br>DBH (mm): 820<br>Life Stage: Mature<br>Life Exp.: < 10 Years | A mature specimen of poor structural condition. Large seams of decay present on main stem and primary ascending stems and lateral limbs. Exudates visible at lower trunk consistent with Pseudomonas syringae. FFB to upper trunk identified as Cerioporus squamosus, approximately 5m from ground level on north stem quadrant. Overall vitality is fair for species. Dead wood present throughout crown with max diameter estimated at <50mm diameter. | Poor | 18 Months | Fell Tree and replace.<br><br>Timescale: 12 months |
