**Project Name: Huddersfield Open Market**

Paint & mortar analysis

October 2021

Ref: 2021/22 [rev.1]

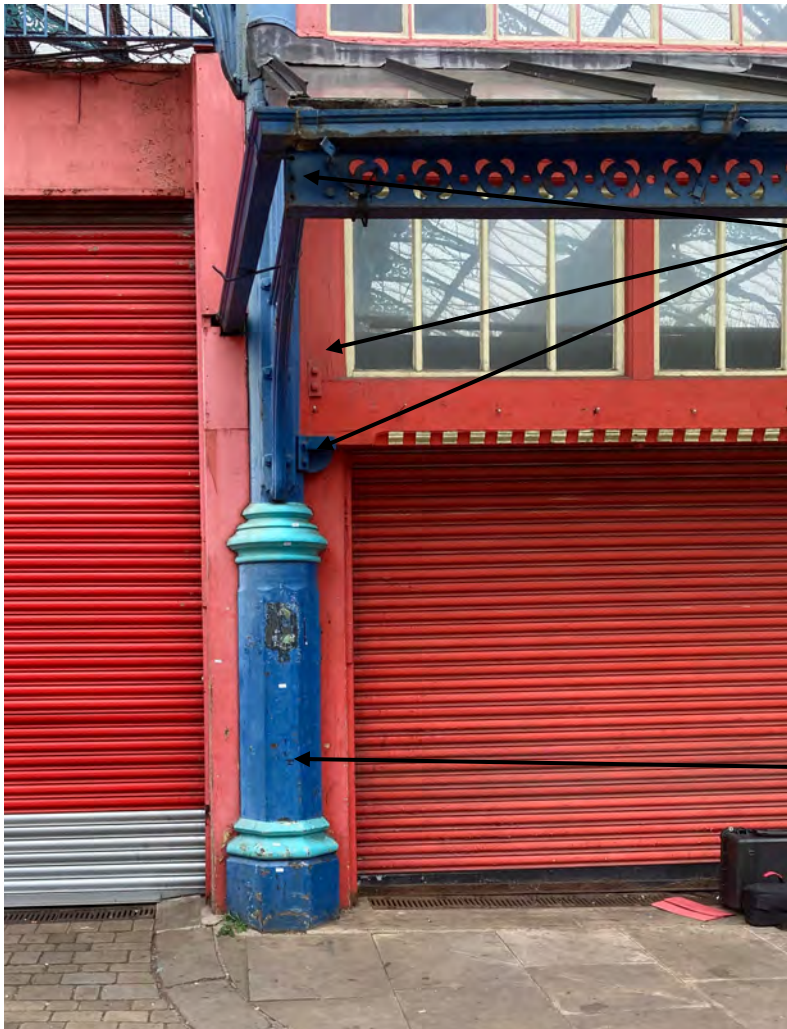
Samples 6 – 17:

- red painted door frame & window frames.
- Cream glazing bars and dentils.
- Blue painted fixing bracket, guttering & pierced girder

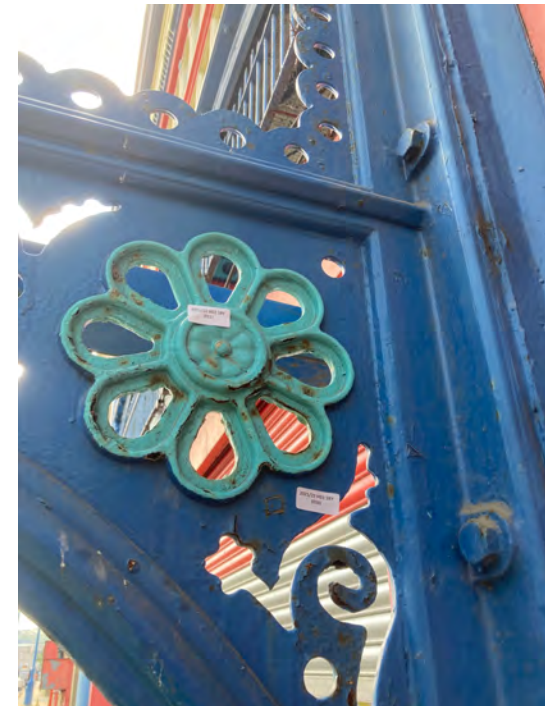
Samples 10 & 11

- Decorative iron spandrel and inset turquoise flower

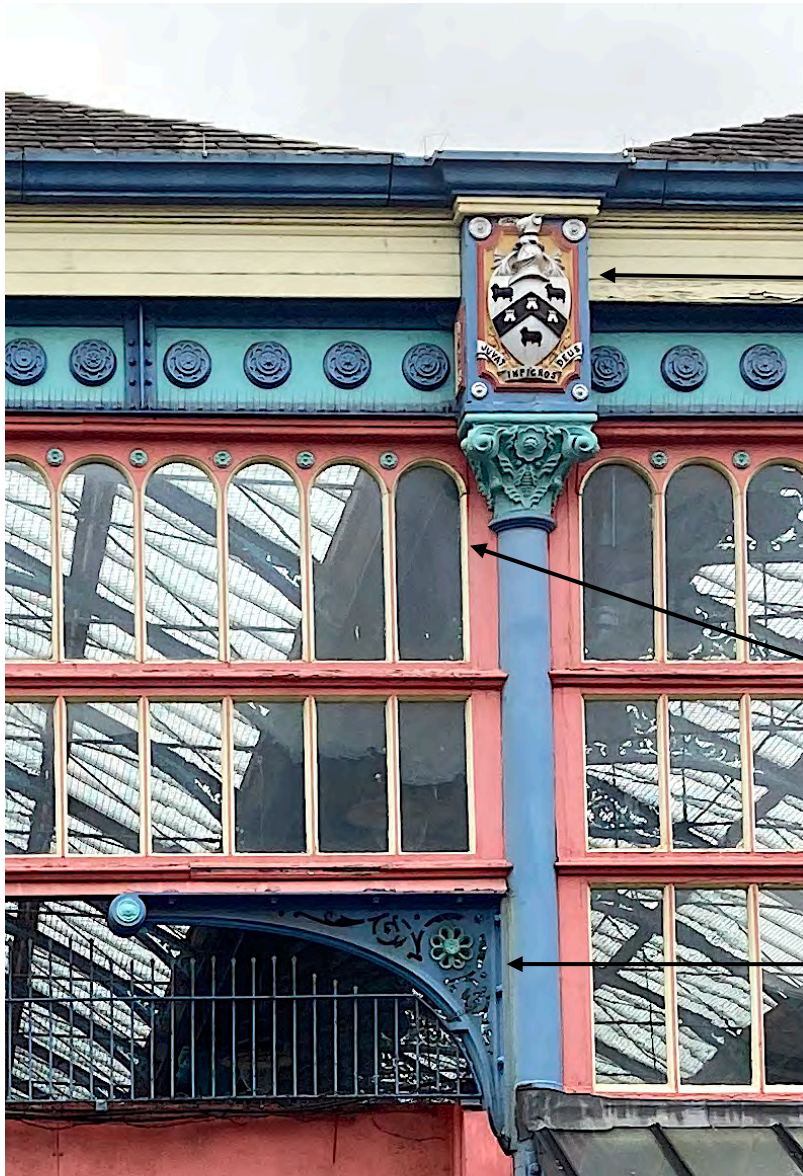
Samples 31– 53:

- Cream fascia
- Blue gutter
- Frieze & roundels
- Column capital
- Armorial & frame

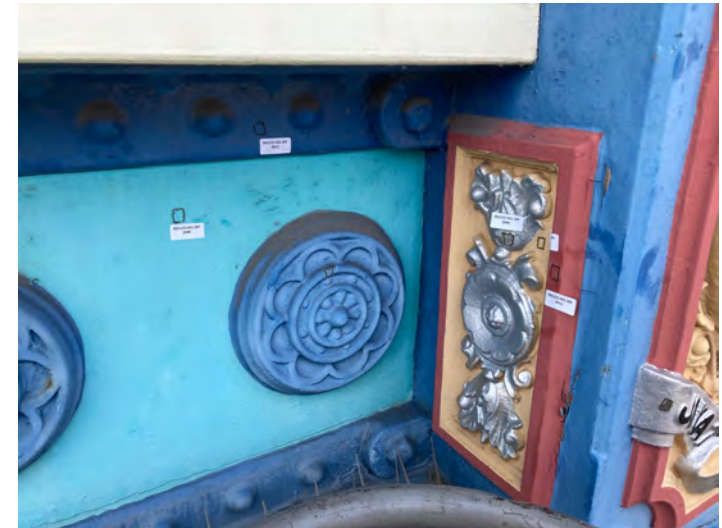
Samples 48 – 53:

Image of the armorial side panel and adjacent frieze with blue painted roundels.

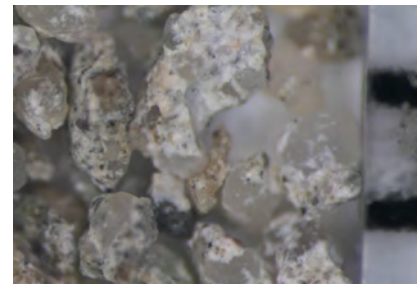
Sample 4: aggregate

- ii) Samples 3 and 4 were removed from the hard 'ribbon' re-pointing applied relatively recently (possibly during the 1980 restoration or even later). This is a hard and inflexible Ordinary Portland Cement (OPC) overlying the original lime mortars defined here as samples 5 and 6.

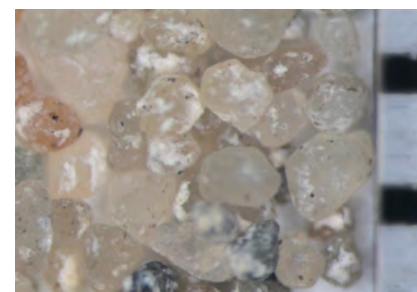
Sample 5: aggregate

- iii) Samples 5 & 6 are early mortars that lie beneath the later OPC ribbon pointing. Both are lime based, with sample 5 defined as a hydraulic lime and sample 6 as non-hydraulic. Presumably both samples were applied at different periods and may represent an example of earlier repair or repointing. In both cases a mix ratio of approx. 4 parts aggregate to one part binder was used with an average aggregate grain size of 0.5 – 1.0mm.
