Condition Survey Report

Denby Lane, Grange Moor.

Ref: HDC/ENG/DENBY LANE/FINAL

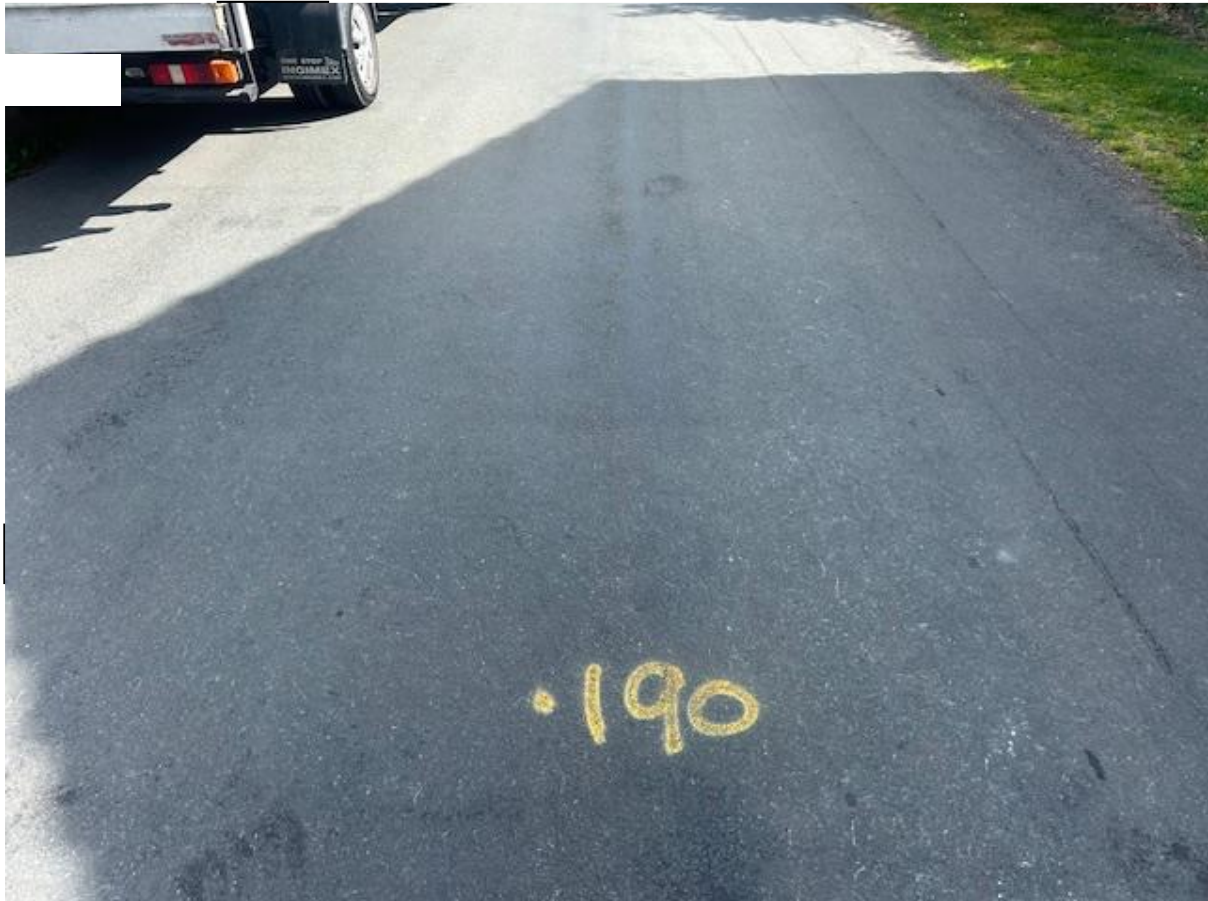
Comments – trench reinstatement along southern flank of Denby Lane.
