Mine Entry Interpretive Report

9 RILEY LANE, KIRKBURTON, HUDDERSFIELD, HD8 0RZ

Our reference: 51001424330002
Your reference: FUS11682TBE

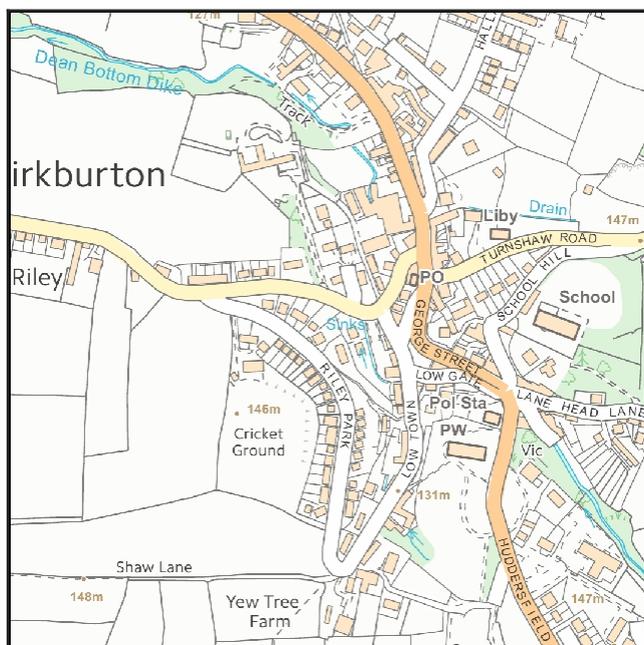
Approximate position of property

The possibility of subsidence damage to the garden areas/other buildings is very small but should not be discounted completely.

In our opinion, the main building (as shown on the plan) is not at risk of coal mining subsidence damage from the subject mine entry. This is because it is not within the area of possible ground movement.
