**Ground Investigation Report** [intrusive]

Land to rear of 141 Toftshaw Lane, Bradford

<b>Project Number</b>	20529
<b>Report Number</b>	001
<b>Revision</b>	V01 – Issue for information
<b>Date Issued</b>	05 September 2025 (V01)

Soil and Structures Ltd were instructed by Belinda Starky (the Client) in July 2025 to prepare an intrusive Ground Investigation Report (*this Report*) for a parcel of land to the rear of 141 Toftshaw Lane, Bradford (*the Site*)

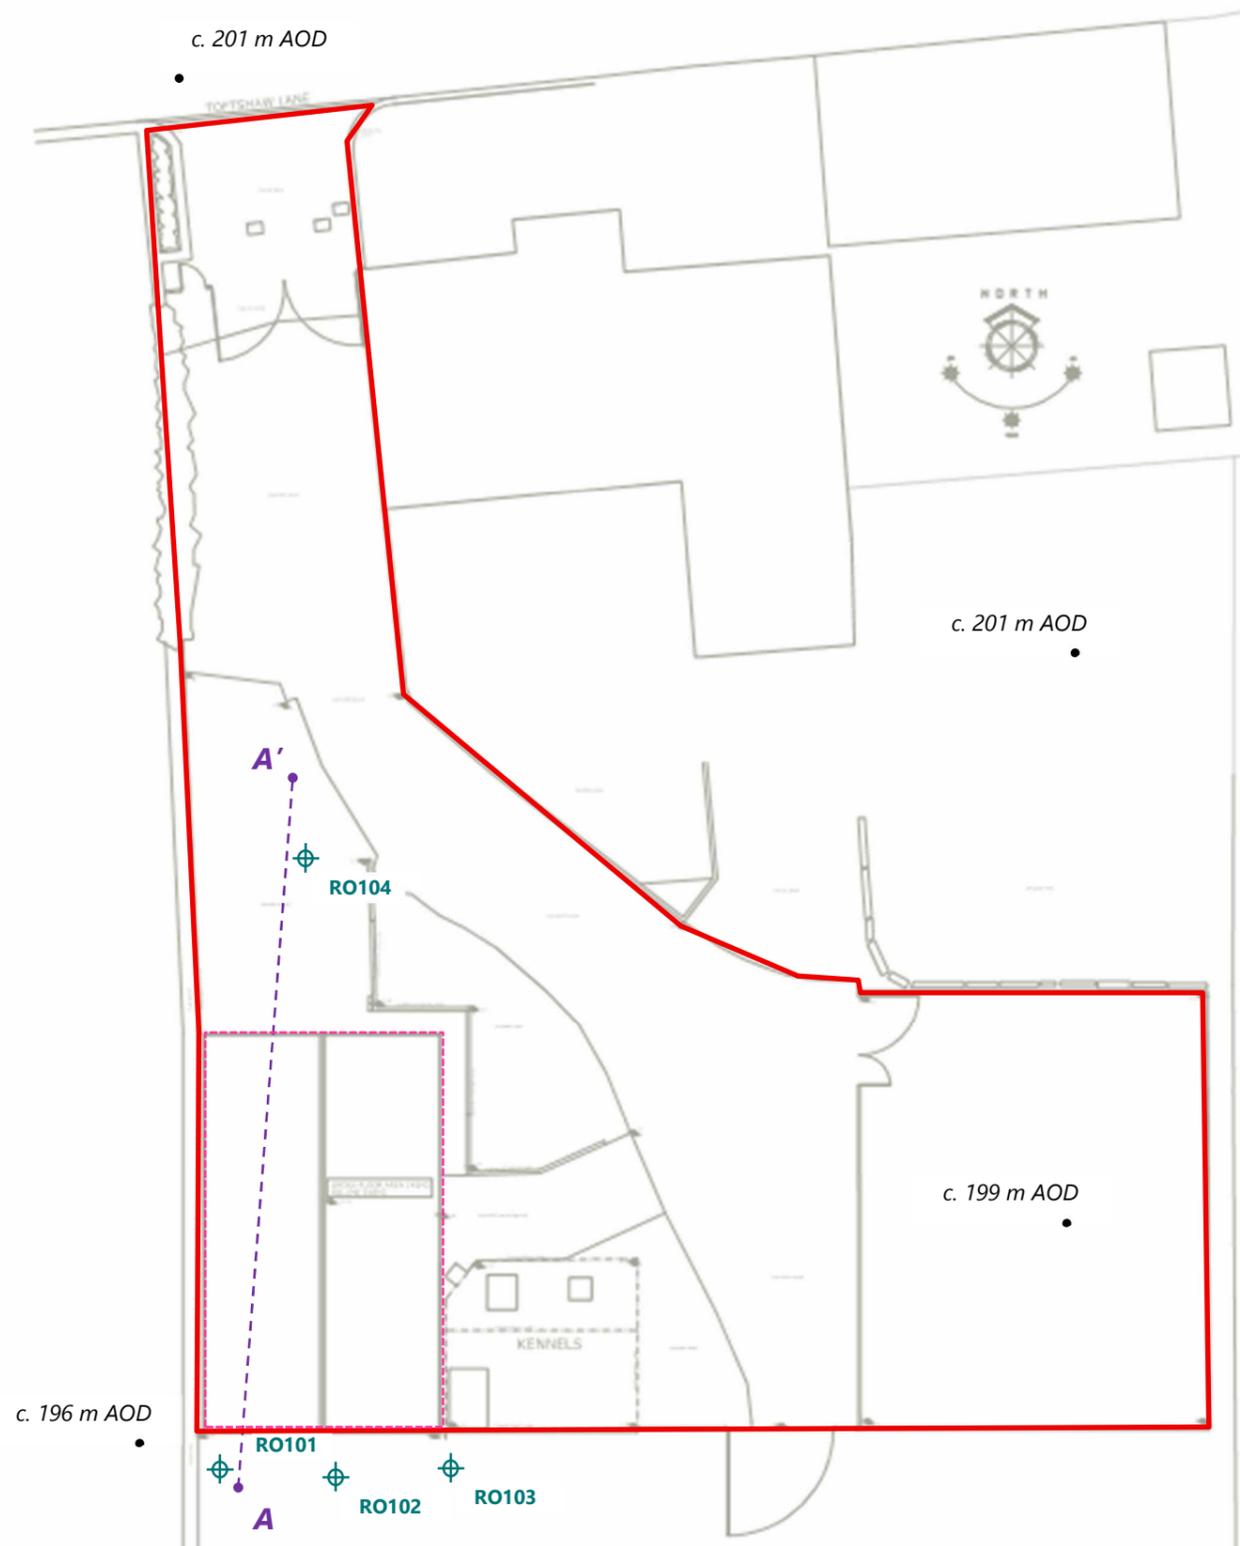
**5.0 Ground Model – Plan**

**Revealed ground conditions:** The intrusive investigation undertaken on Site broadly confirmed the anticipated conditions with one variation and five observations

- > **Observation 2:** Within the rotary boreholes, the intact bedrock was suggested to be sandstone and siltstone dominated sequence of rocks with typically 'slow/hard' drilling conditions.
- > **Observation 3:** No evidence of coal mine workings was recorded within the Blocking Coal seam (4 boreholes across the Site; flush returns and intact drilling in all locations) or within 22.6 m of the ground surface within RO101 (where deeper seams within the geological sequence may have been encountered, e.g. Top Lousey).
- > **Observation 4:** No evidence of potentially harmful or polluting material was encountered on the surface of the Site or within the exploratory holes, e.g. stained flush arisings.
- > **Observation 5:** Groundwater was inferred at a depth of 9.6 m of the ground surface within RO101 based on the water holding at this depth.

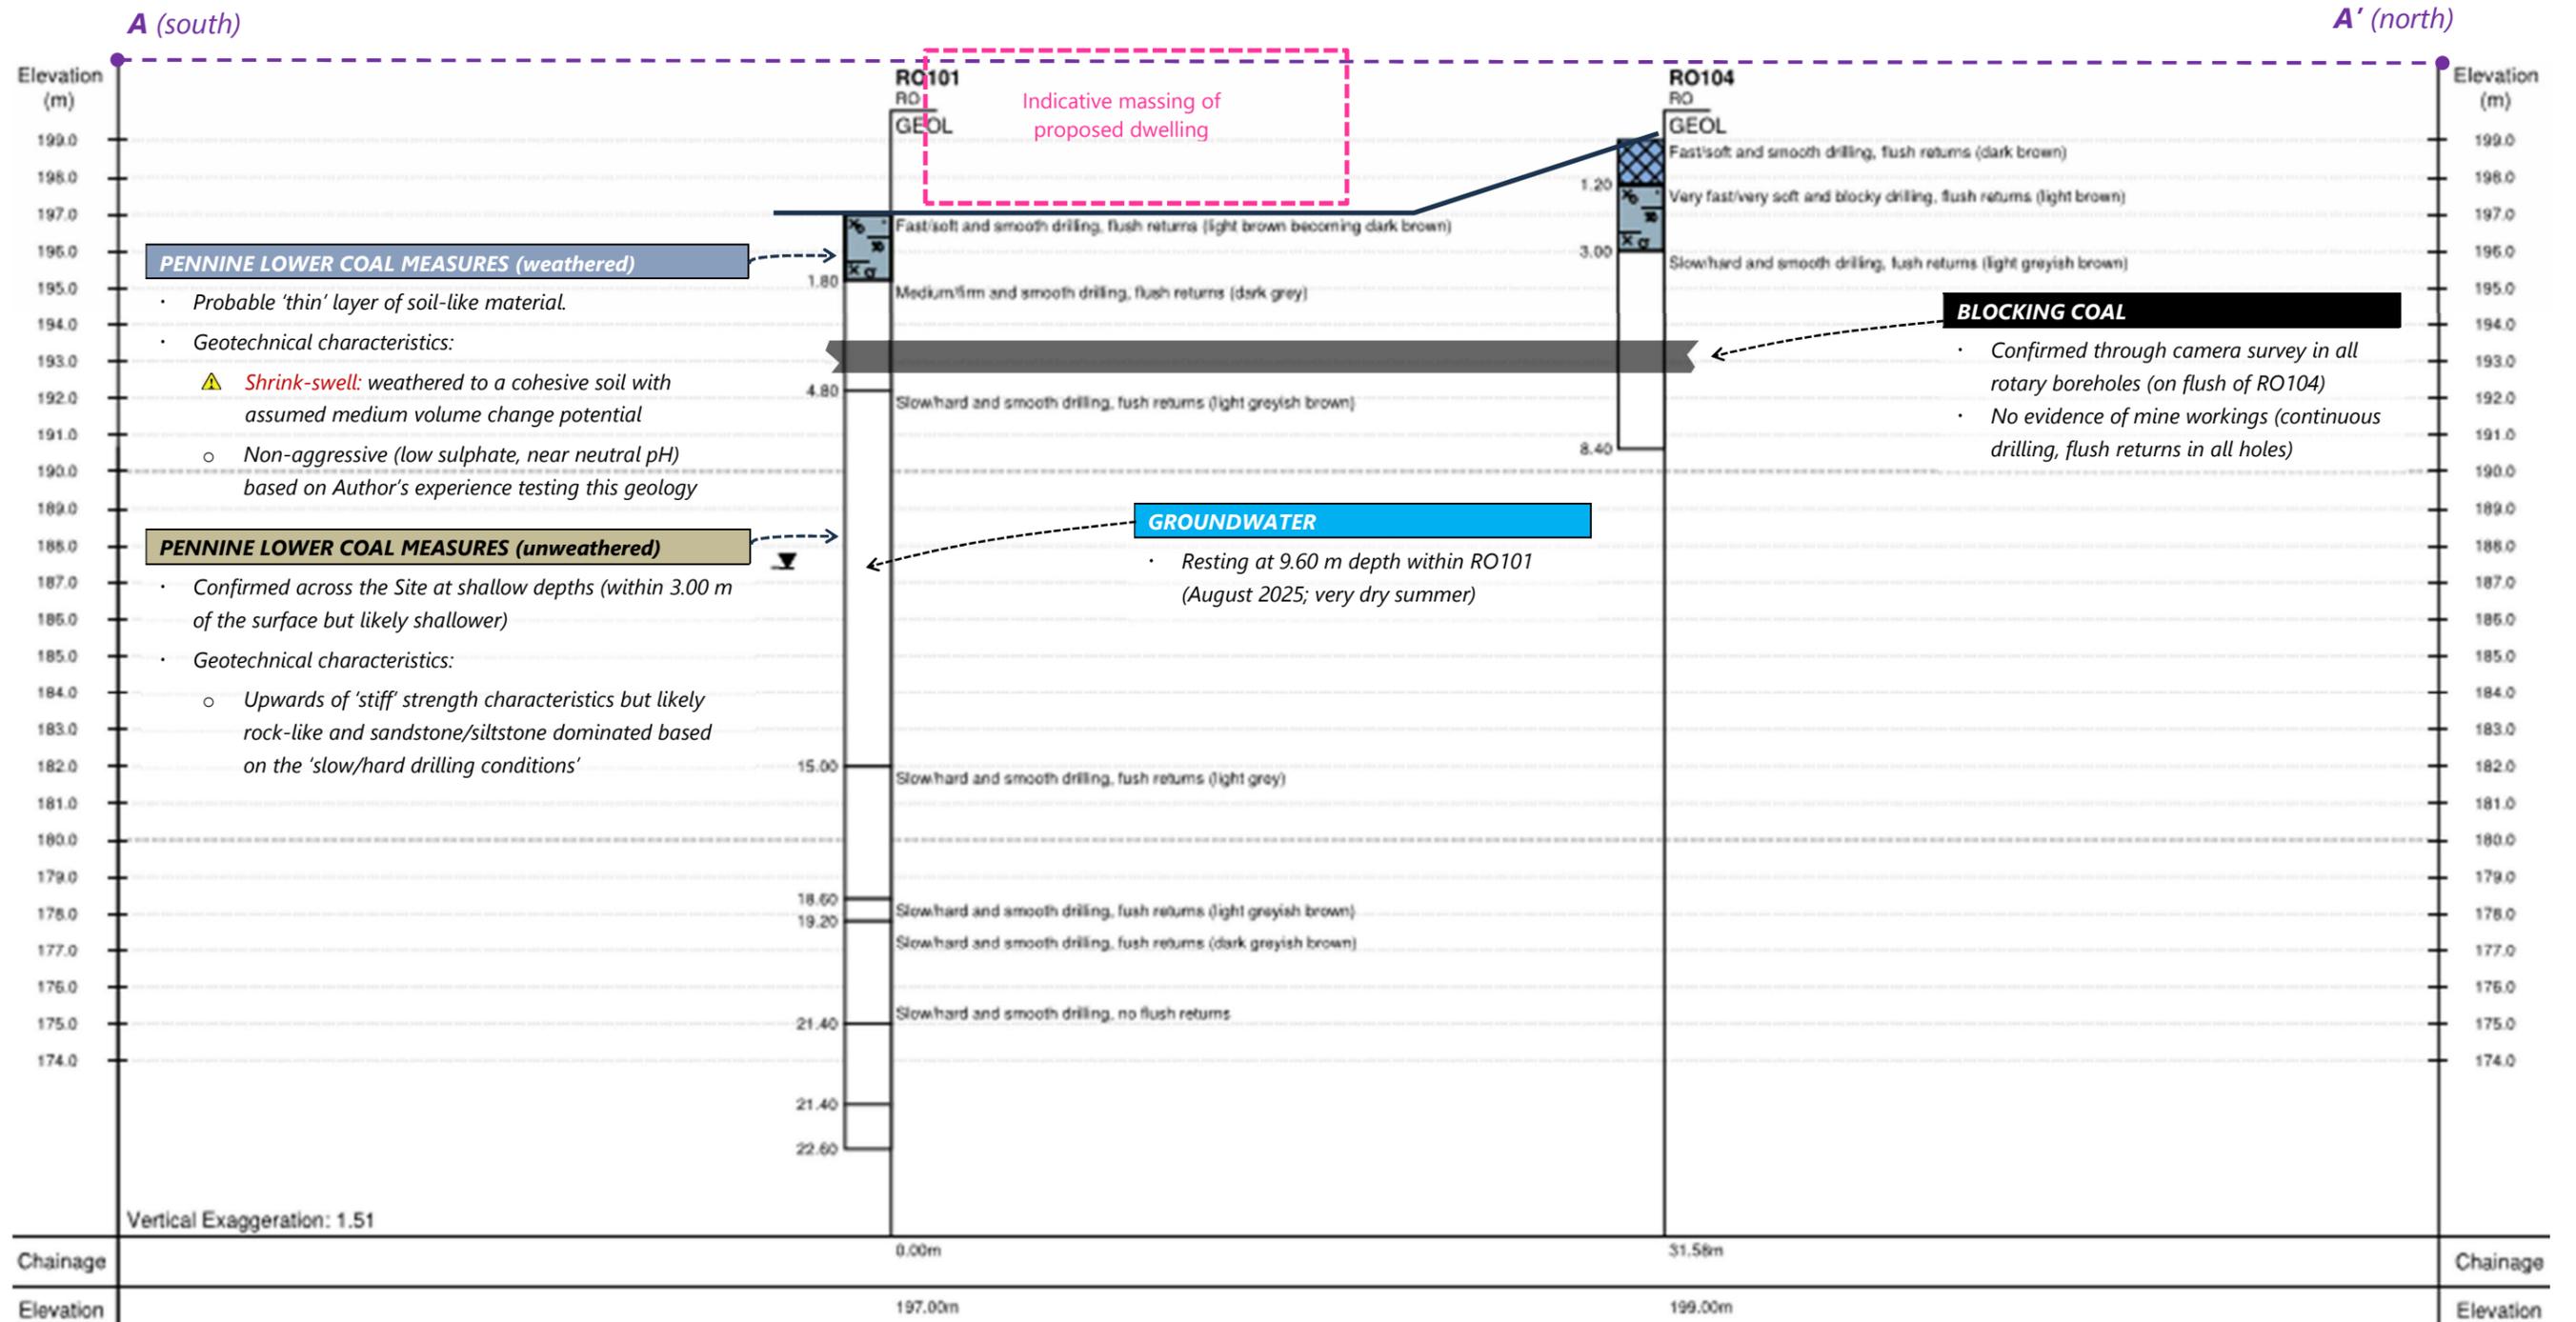
5.0 Ground Model – Profile

As noted within Section 3.0, this coal seam was inferred to be the Blocking Coal based on its recorded thickness and bituminous presentation. This was a variation to the anticipated ground conditions given the coal seam was anticipated to be present at depths of between 10 to 15 m depth based on the outcrop position and the depth of the nearby mine entry (ref. 419429-011).

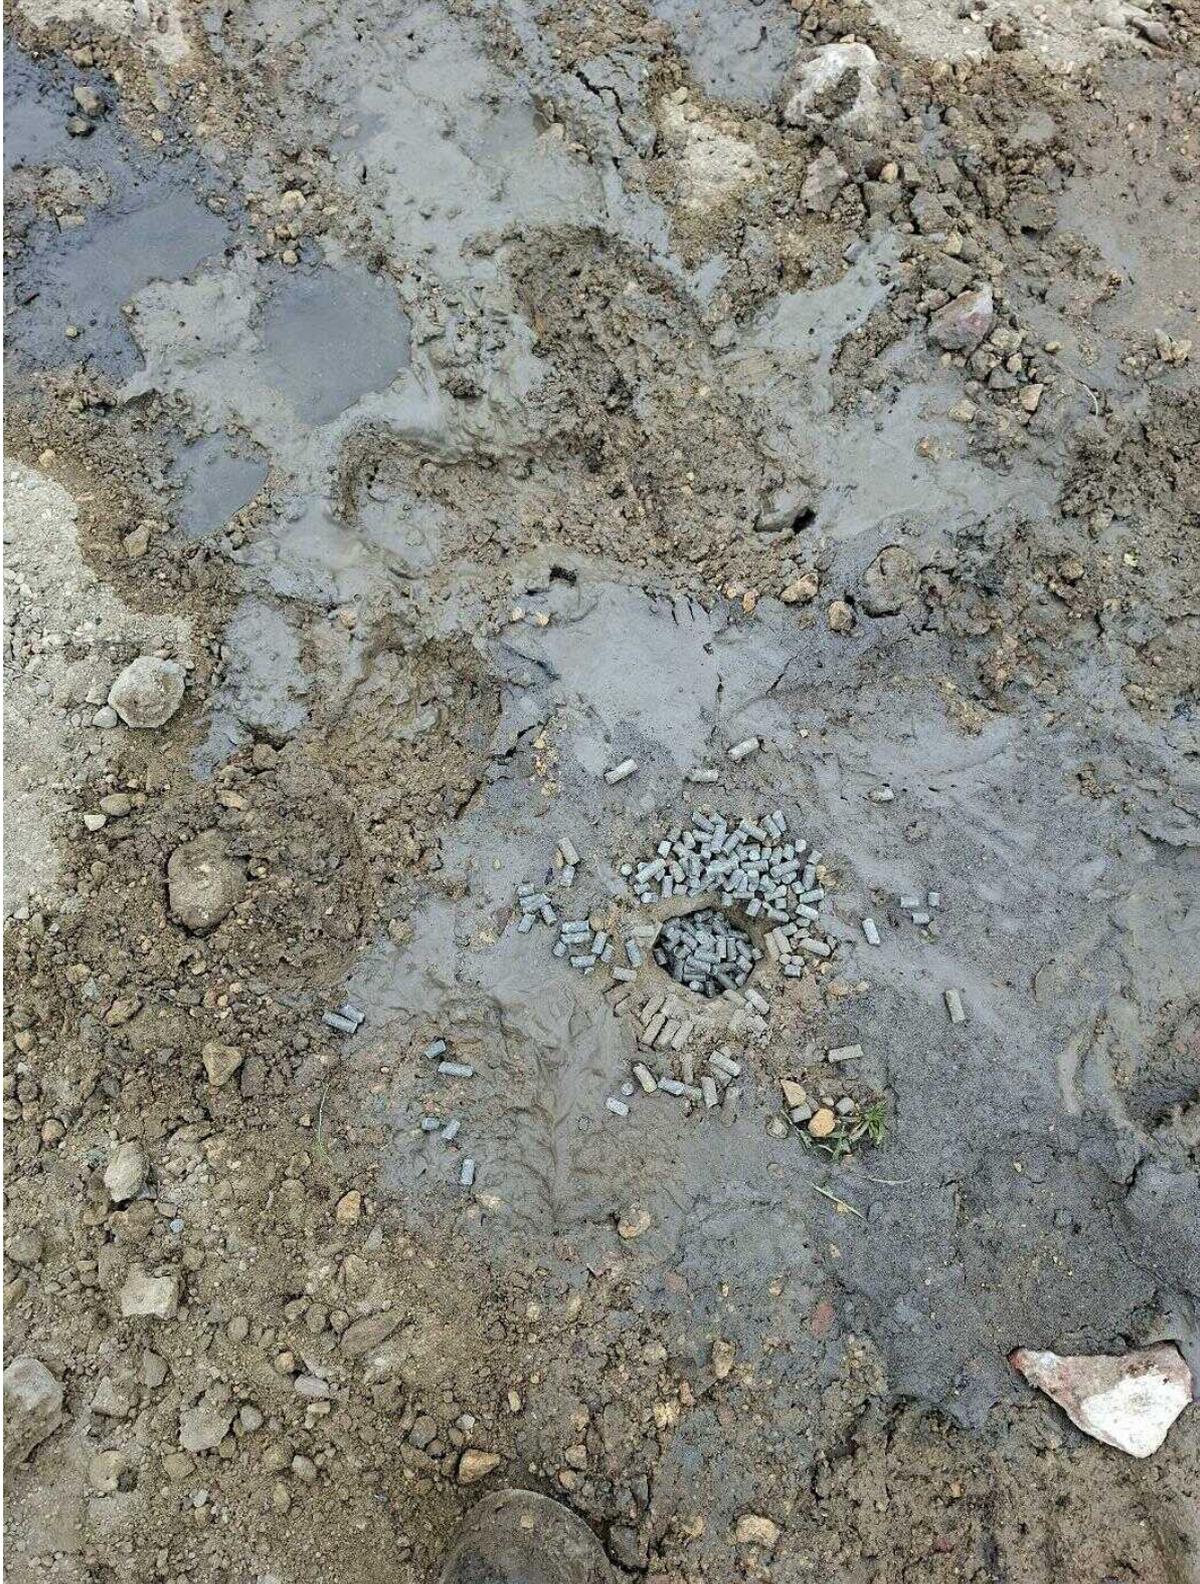
**Remarks**  
 PURPOSE: Profiling deeper strata beneath the Site to inform assessment of coal mining related risk.  
 TERMINATION: Target depth achieved - engineer decision. LOCATION: Surveyed using freeware on Site. GL: Estimated off Satellite imagery. STABILITY: Stable. GROUNDWATER: Encountered. OTHER: No evidence of potential harmful or polluting material. IN-SITU TESTING: Down-the-hole camera.

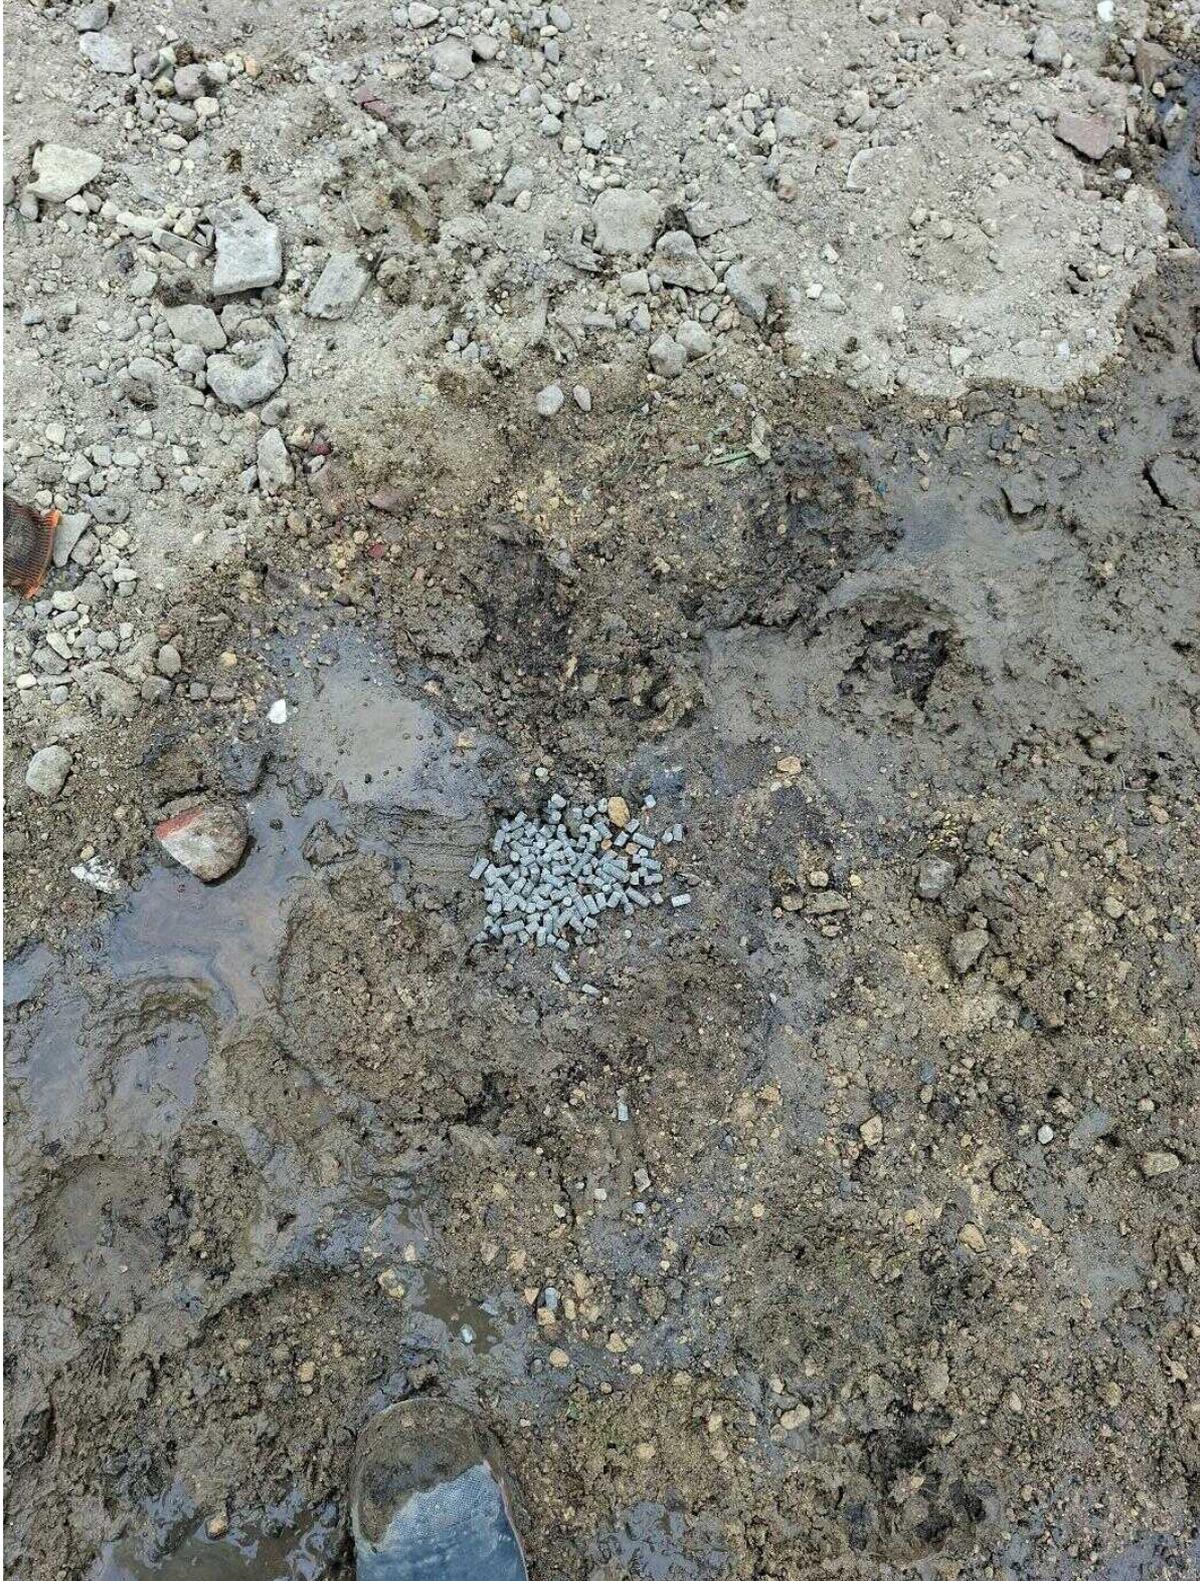
PURPOSE: Profiling deeper strata beneath the Site to inform assessment of coal mining related risk.  
 TERMINATION: Target depth achieved - engineer decision. LOCATION: Surveyed using freeware on Site. GL: Estimated off Satellite imagery. STABILITY: Stable. GROUNDWATER: Undetermined - water flush in hole.  
 OTHER: No evidence of potential harmful or polluting material. IN-SITU TESTING: Down-the-hole camera.

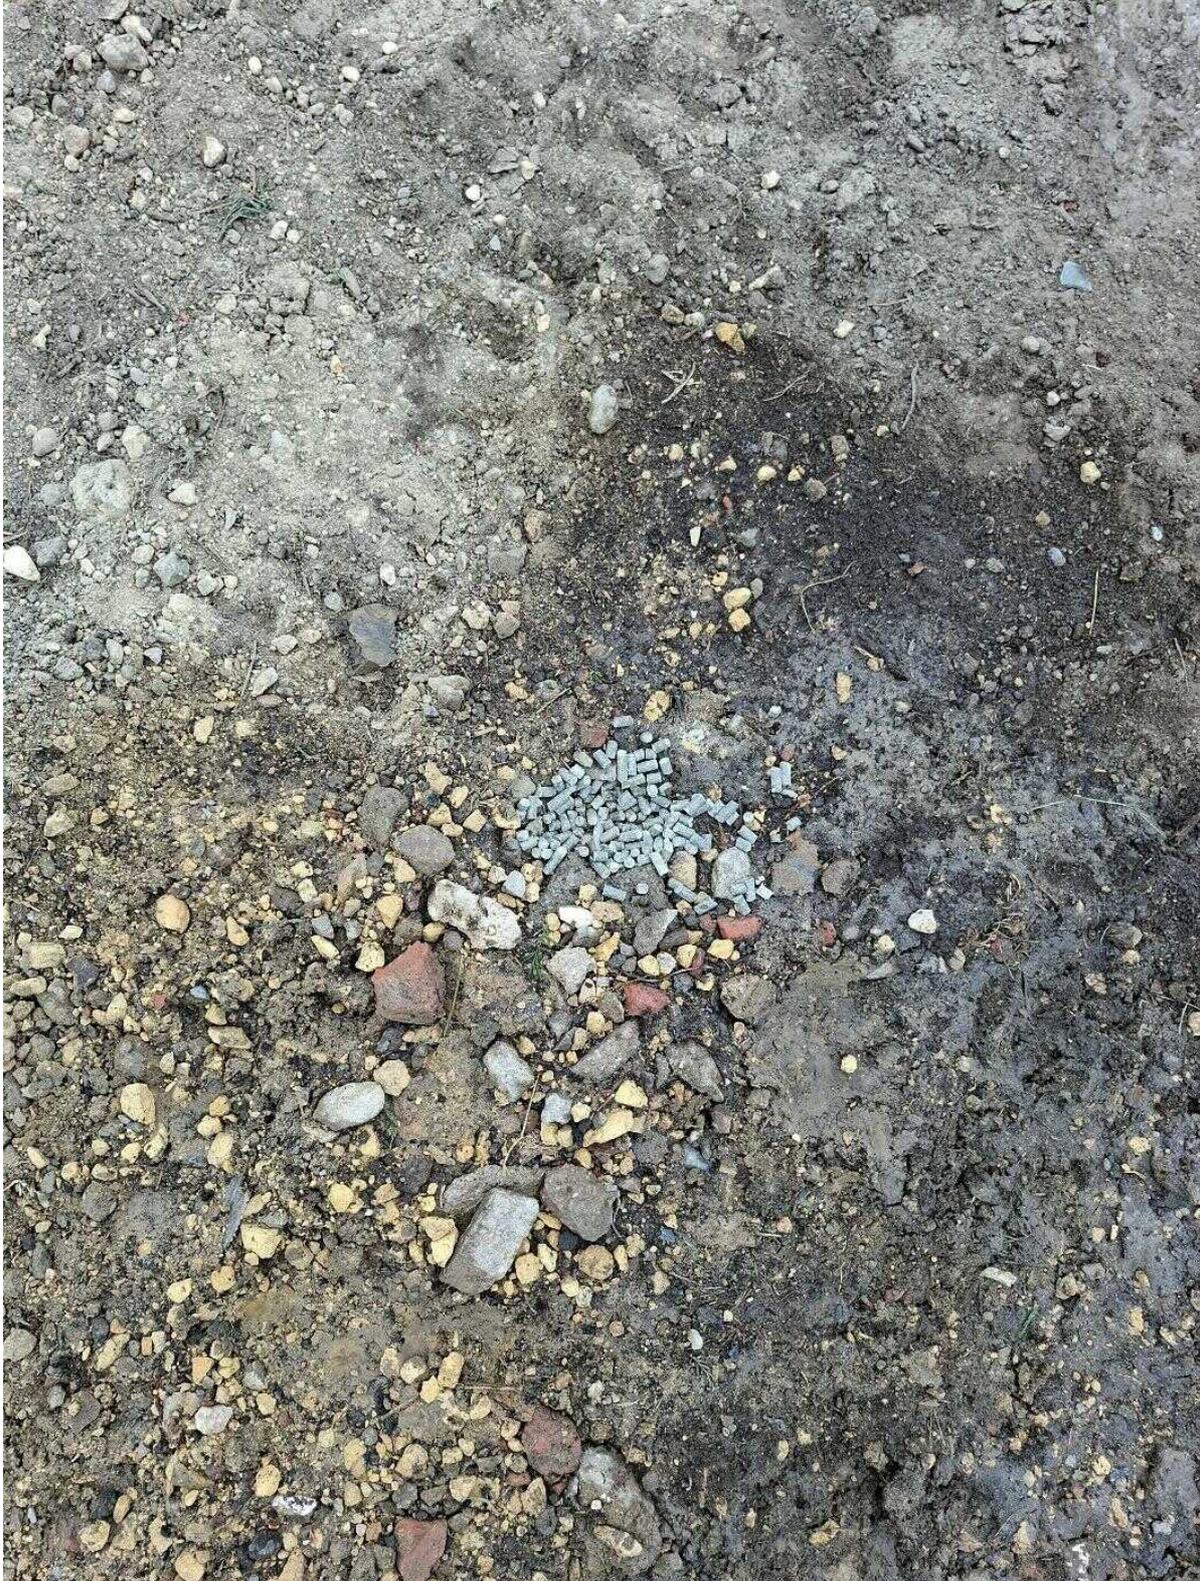
<b>Remarks</b> PURPOSE: Profiling deeper strata beneath the Site to inform assessment of coal mining related risk. TERMINATION: Target depth achieved - engineer decision. LOCATION: Surveyed using freeware on Site. GL: Estimated off Satellite imagery. STABILITY: Stable. GROUNDWATER: Undetermined - water flush in hole. OTHER: No evidence of potential harmful or polluting material. IN-SITU TESTING: Down-the-hole camera.	<b>Method, Plant, Stability, Dimensions</b> 0.00 - 4.80m RO Stable	<b>Logger</b> RB/LU
---	--	------------------------
