Roof A Platform 4 Columns Context

Huddersfield Station

Roof A - Column Pre-emptive Interventions Proposals Sketchbook

151667-TSA-30-MVL3-SK-S-006 Rev P03

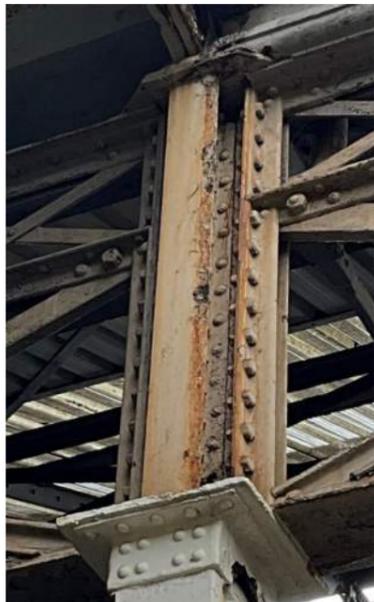
C1 - Upper Column Corrosion (1 Location)

The upper column section within the depth of the longitudinal trusses at the junction of Roof A and the start of roof B was visibly corroded to the outside flange on the exposed edge. This is likely due to the roof junction detailing which may have resulted in rainwater runoff down this column.

This isolated detail has been reviewed and the section loss is deemed to be insignificant to the required capacity of the column from a structural perspective.

In line with the conservation objectives of this project, this element will be retained and repainted with no further intervention beyond the surface and edge treatment noted below.

Works should be undertaken to restore the corrosion protection system to prevent further deterioration and in line with Network Rail Guidance NR/L3/CIV/040 (Specification for the use of protective coating systems) as per the rest of the structure.

Blast clean surface corrosion back to bright steel. Sharp edges to be ground back to 2mm min thickness as per NR/L3/CIV/040. Apply paint treatment as per surrounding structure.

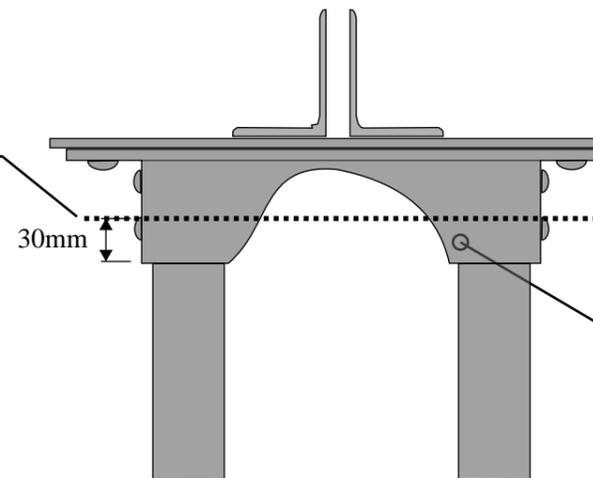
Limit of section loss from which intervention required.

As above, various conditions of the horizontal plate are present, and shot blasting is expected to cause further section loss where the remaining steel is thin.

Where the section loss of the plate is less than 30mm from the original plate profile at narrowest and minimum 3mm of thickness of plate remains, plate to be prepared and treated as per surrounding structure. Where section loss is above these limits, implement below detail.

Blast clean surface corrosion back to bright steel. Sharp edges to be ground back to 2mm min thickness as per NR/L3/CIV/040. Apply paint treatment as per surrounding structure.

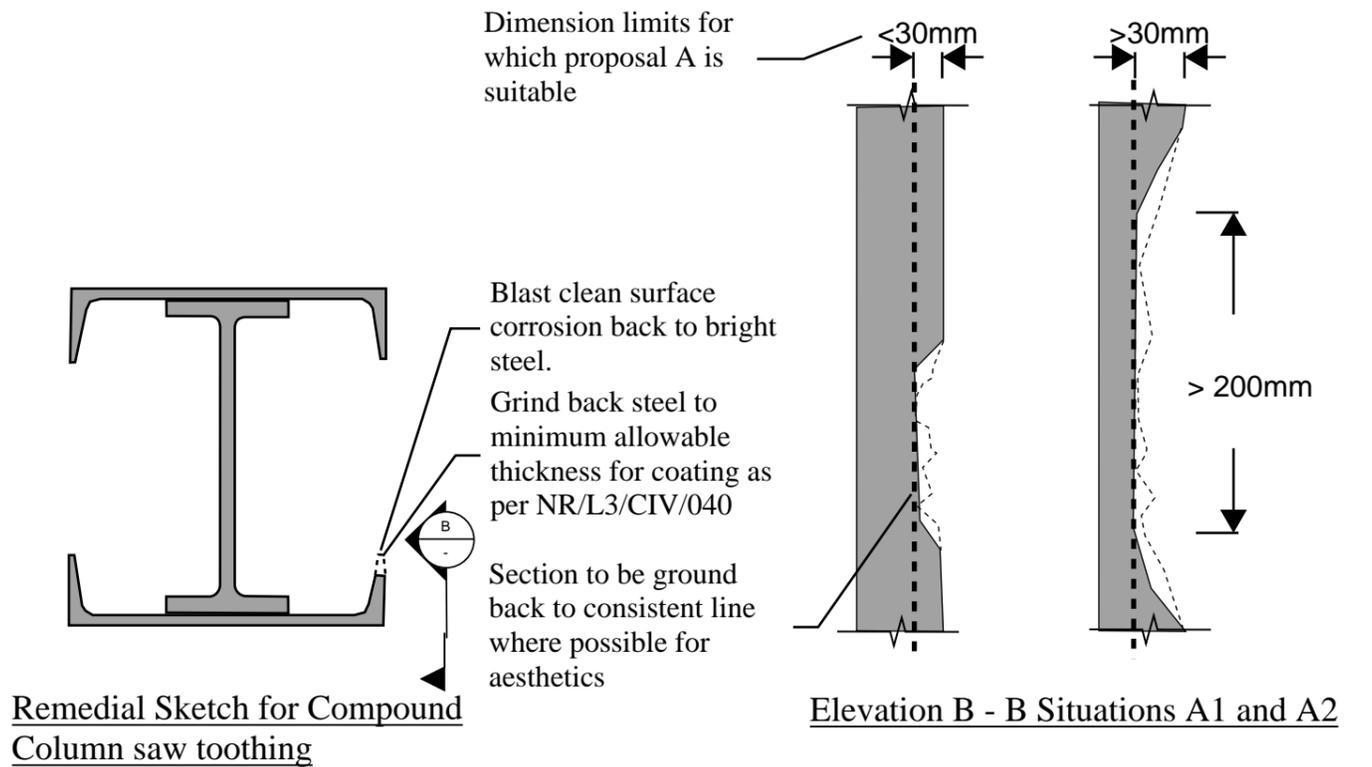
Proposal A: Section loss in line with Aesthetic limit

This detail has been reviewed and the overall column is deemed to have sufficient capacity to resist the design loads despite the anticipated section loss to the channel section flanges.

For reference we have conservatively assumed the channel flange in question has completely corroded to 50% of its original length (from 76mm down to 38mm) and the remaining flange has lost 2mm thickness to both faces (from 9.5mm down to 5.5mm).

Works should be undertaken to restore the corrosion protection system to prevent further deterioration as per the rest of the structure.

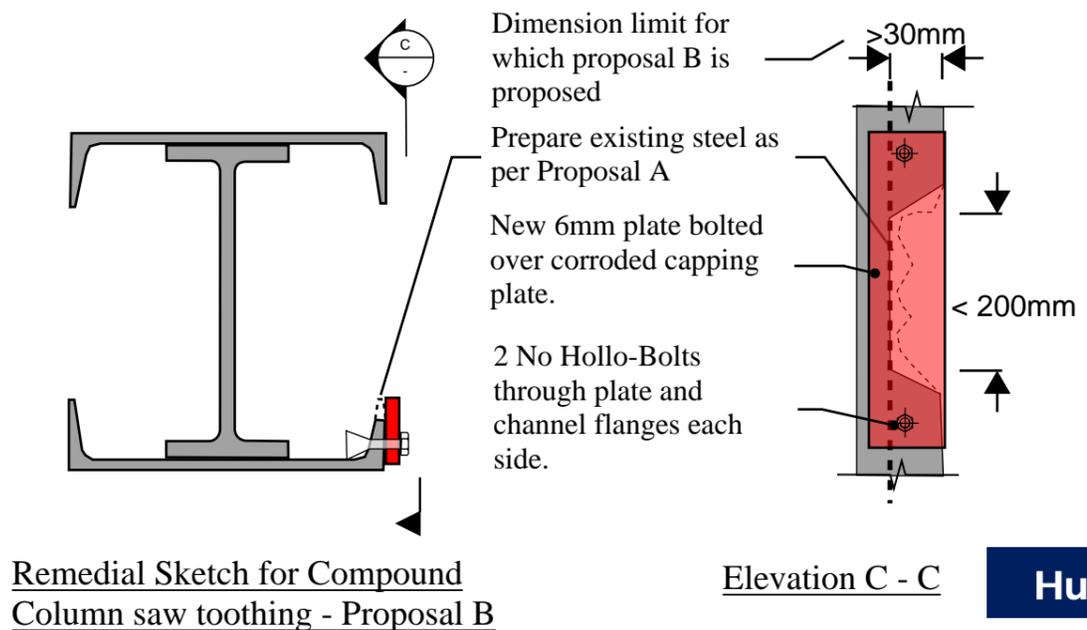
Proposal B: Section loss fouls proposed Aesthetic limit

In line with the conservation objectives of this project, the proposed intervention is only considered whereby the corrosion has a significant aesthetic impact on the form and lines of the existing structure. As such, where extent of the section loss is localised to a length of less than 200mm and above a limit of section loss depth of 30mm against the original line of the structure, a cover plate is proposed to maintain the line of the existing structure. Where section loss is less than 30mm from the original line of the structure or where the section loss is over 30mm but consistent along a longer length of the column, then no additional plate is proposed and the structure is to be ground back to a consistent line.

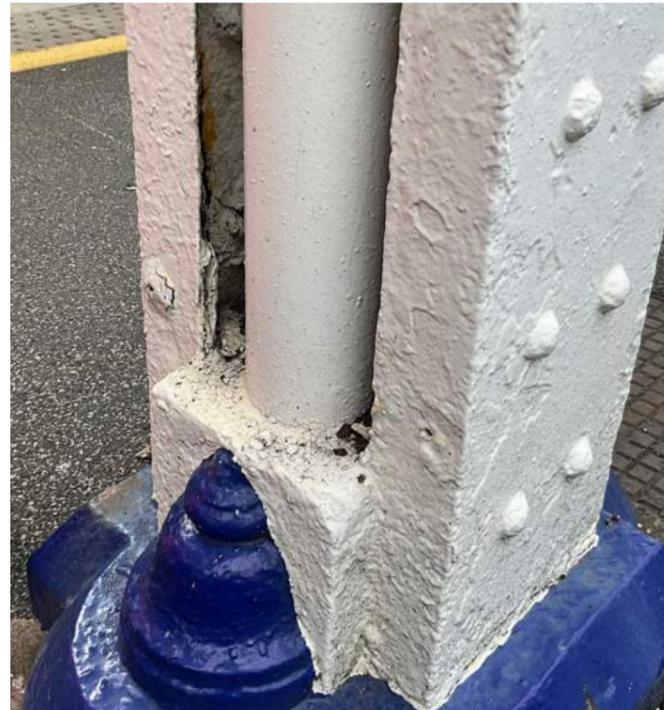
Uncorroded foot detail

The condition of steelwork below the likely early concrete encasement and behind decorative cast iron detail to base of column is unknown. Should works be identified to be required in this area the outline works principle would be as follows:

- Cast iron encasement to be removed and likely early concrete encasement to be broken out to enable works
- Works to strengthen column section undertaken as required.
- Cast iron encasement reinstated as per original detail where possible and concrete encasement reinstated in new concrete as per original.
