# Water Street Holmfirth

Condition Survey and Remediation  
Statement rev 3

December 2025

Project number 2501

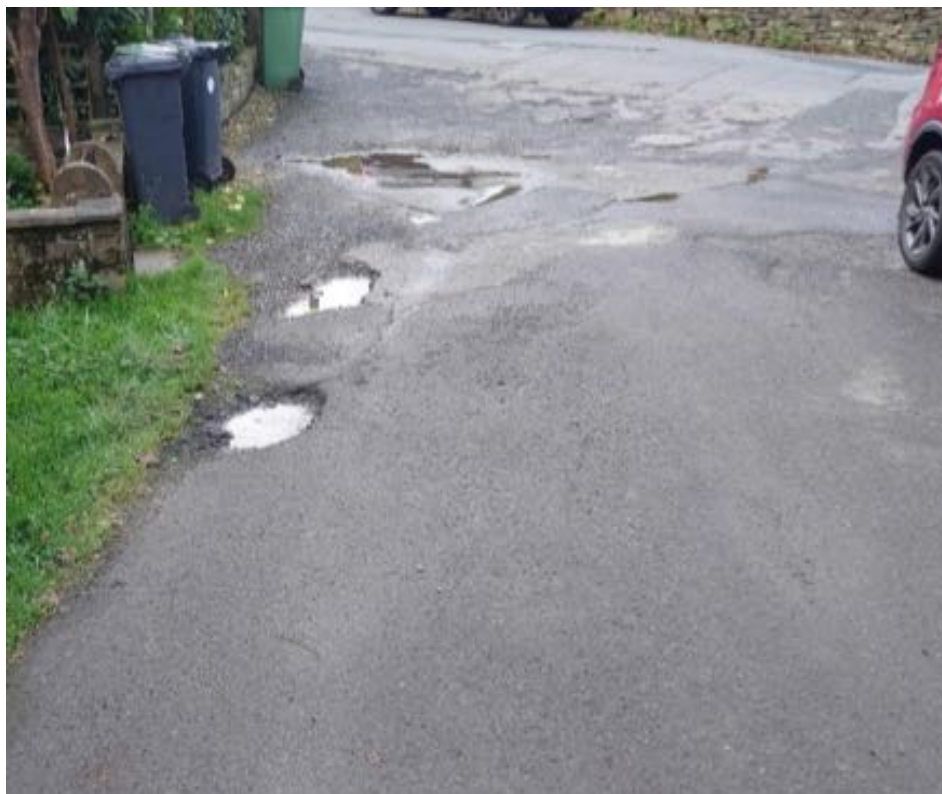
*Figure 73 Dam Head location BP*

- 2.5.1.2 The bituminous carriageway exhibits extensive statutory undertaker trenches and patching, multiple potholes, and several uneven areas. Residential frontages join directly onto the carriageway, typically via grass verges. The overall carriageway condition is poor.

- 2.5.1.3 The single lane track comprises two wheel-tracks separated by a grassed central area, measuring approximately 3 m in width. Multiple potholes are present, with evidence of informal repair attempts using various materials. Some residential properties are accessible from the track and utilise edging for delineation. The overall track condition ranges from fair to poor.

- 2.5.1.4 The statutory undertaker boxes are worn and exhibit bitumen patches, with at least one box partially buried within the track surface. Overall, they are in poor condition.

- 2.5.2.3 Worn, damaged, or buried statutory undertaker equipment should be renewed. Whilst repair and replacement remains the responsibility of individual statutory undertakers, consideration should be given to contacting them to request renewal.
