Ground Investigation Report [intrusive] and
Remediation Strategy

4a Bridge Street, Batley

Project Number	20549
Report Number	001
Revision	V01 – Draft for comment V02 – Issue for information
Date Issued	19 January 2026 (V01) 04 February 2026 (V02)

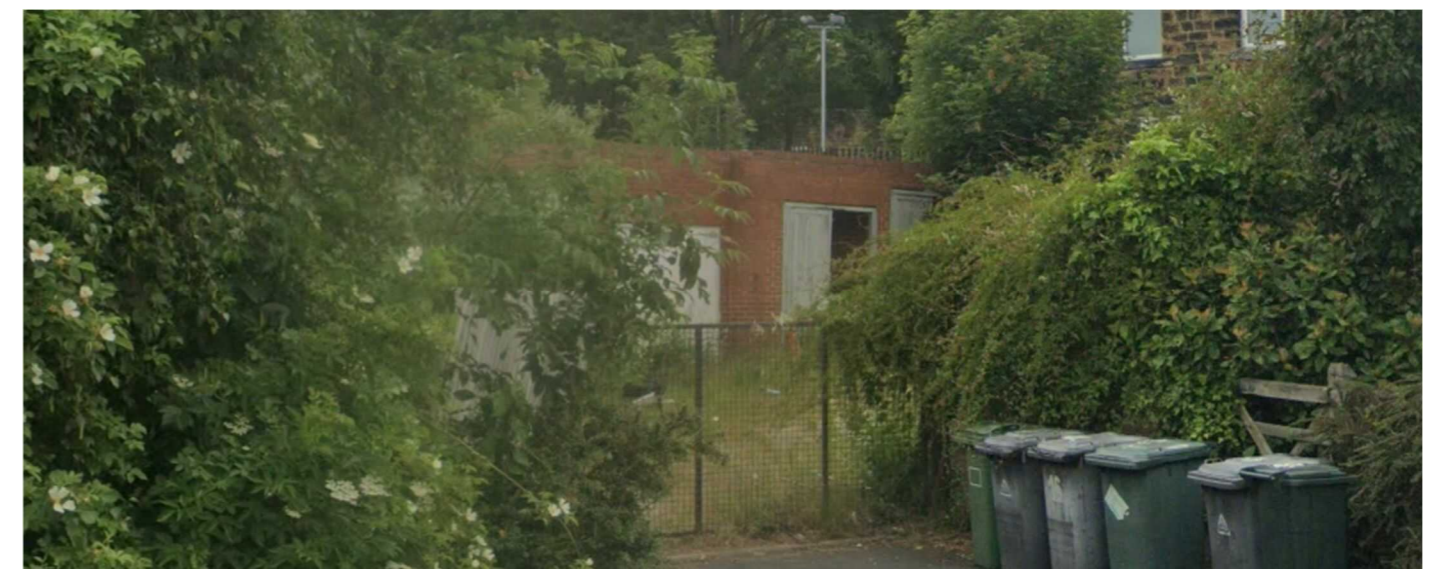
Figure 2: Screenshot of Google Streetview™ from June 2023

> **The second phase:** occurred between c. 1890s and 2010s when the Site was developed for a parcel of land with small outbuildings (lock-ups) that was either associated with the place of worship immediately west of the Site or else the terrace properties that were developed at this period. These outbuildings were ultimately developed / expanded to include the full length of the Site's western boundary with a yard area to the front – *Figure 2*.

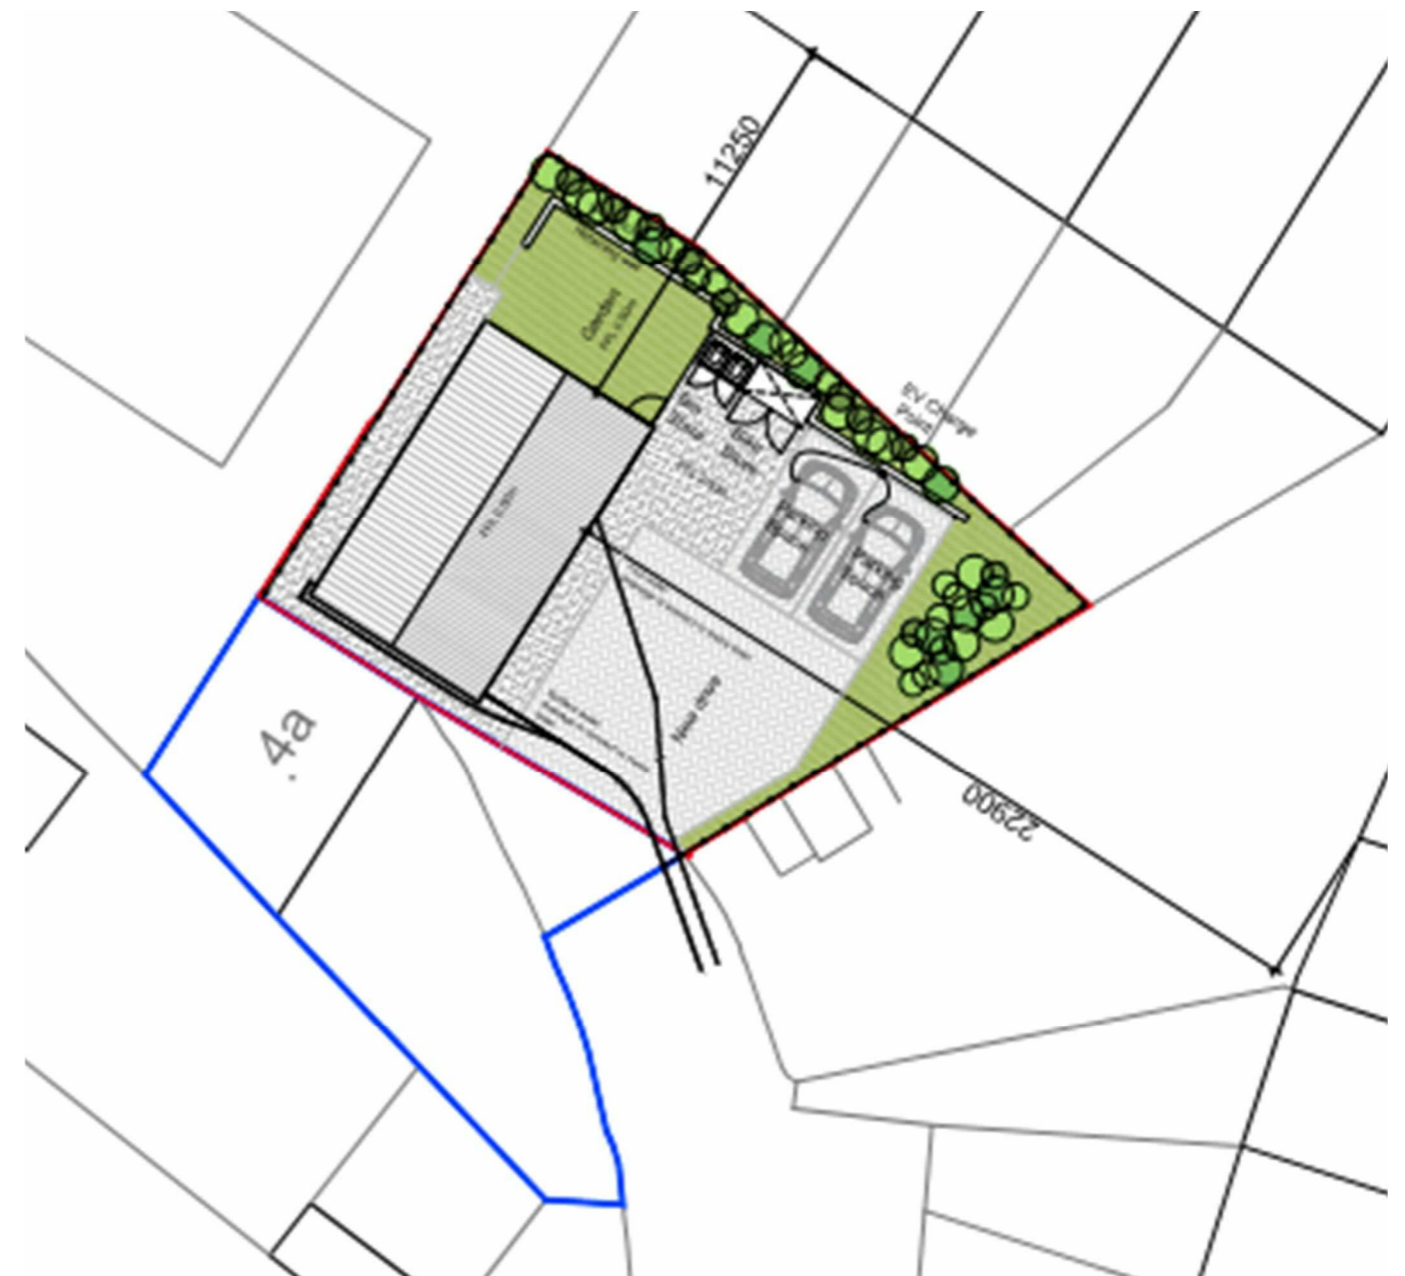
Figure 4: Extract from appended development plan illustrating areas of soft landscaping

On this basis, it is recommended that, where residual thickness of Made Ground are present within the formation of the new soft landscaping areas, a 'cover system' is employed to reduce the likelihood of end user of the Site being exposed to this material (breaking all potential pollutant linkages apart from vapour inhalation for which there is no evidence on Site).

Further details relating to the cover system are presented within Section 8.0
