DEMOLITION OF EXISTING DWELLING AND ERECTION OF 4 DWELLINGS

11 WOOD STREET, SKELMANTHORPE HD8 9BN

APP NO: 2024/62/91934/E

Construction Management Plan

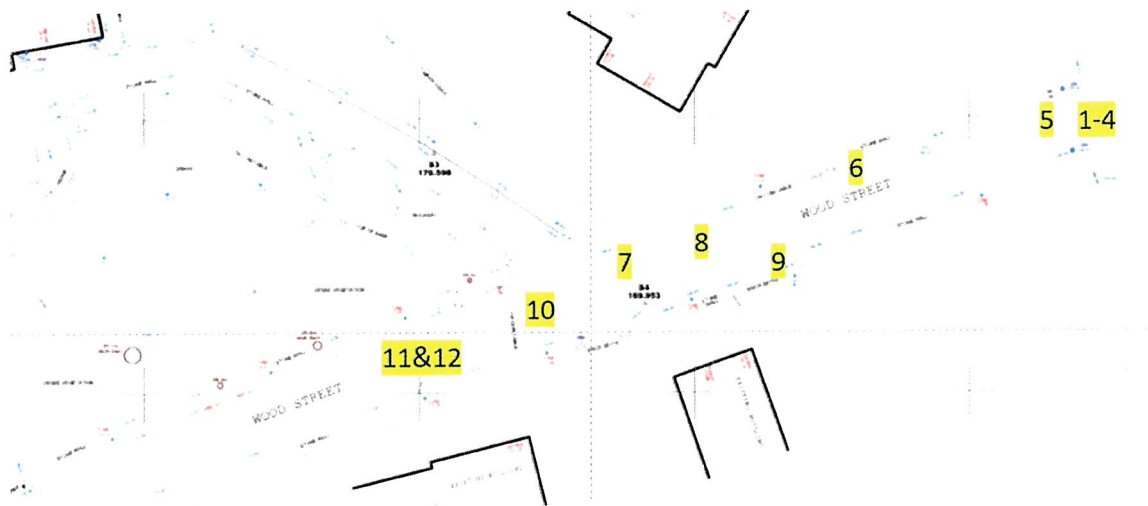
Location of photos-

Wood Street has general signs of wear along the site boundary and entrance, however it must be noted that at the junction, Wood Street onto Station Road there is a great deal of very heavy wear along with a number of potholes. The footpath is also in a poor state, it appears the top coat as laminated off in places.

Below is a series of photos and plan showing the general condition of the road surface, the numbering is cross referenced on the plan.

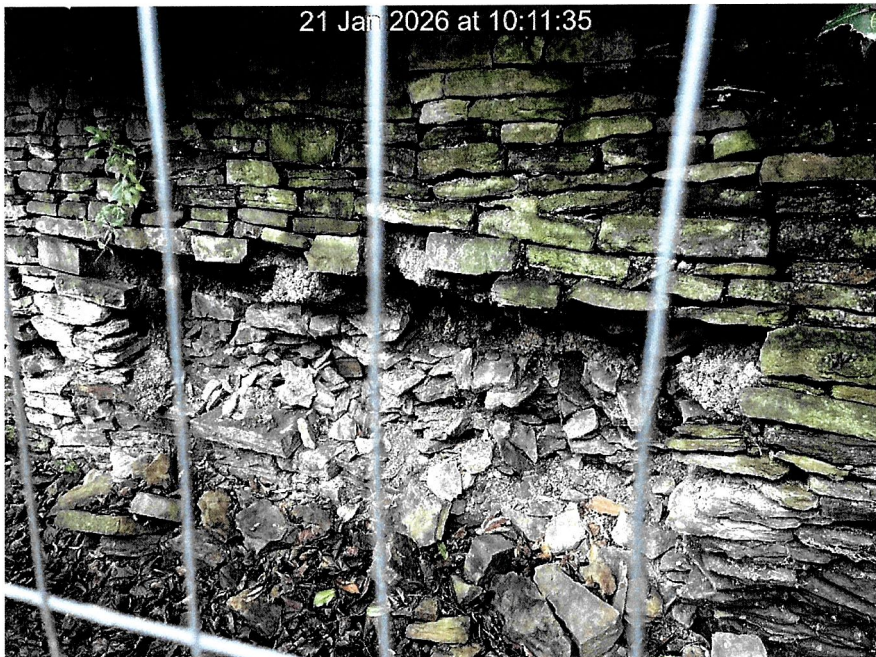
Wall collapse, poor masonry work evident in bonding.

Wall has been pushed out by tree roots.

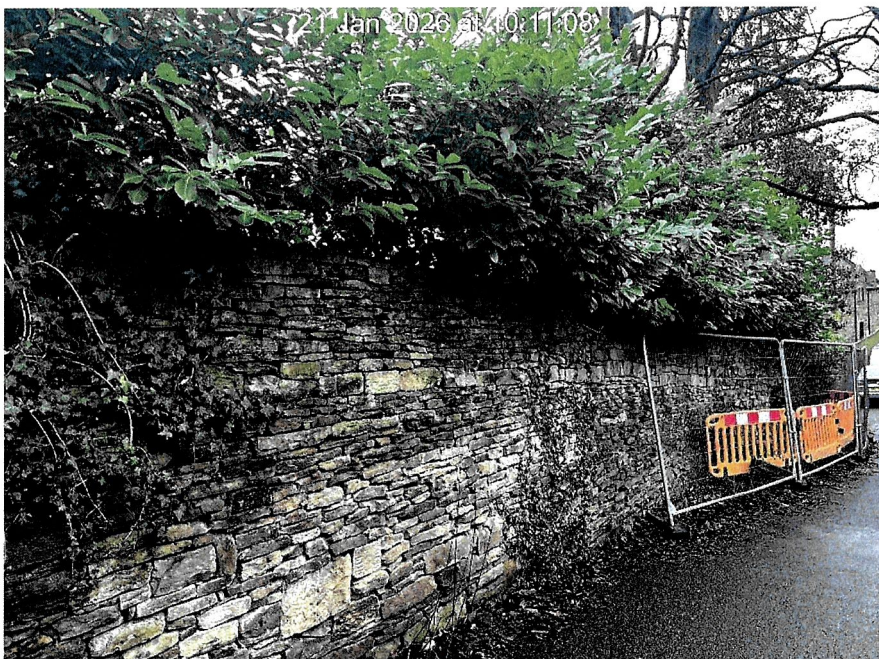
It must be noted that the boundary wall on Wood Street is in a very poor condition. The construction is in a Dry Stone walling method, however the wall has been very poorly constructed in areas, there is a lack of bonding or use of ‘jumpers’ in some areas.

Example of rebuilding.
