Netherwood Farm, Marsden

Bat Survey Report

15th April 2026

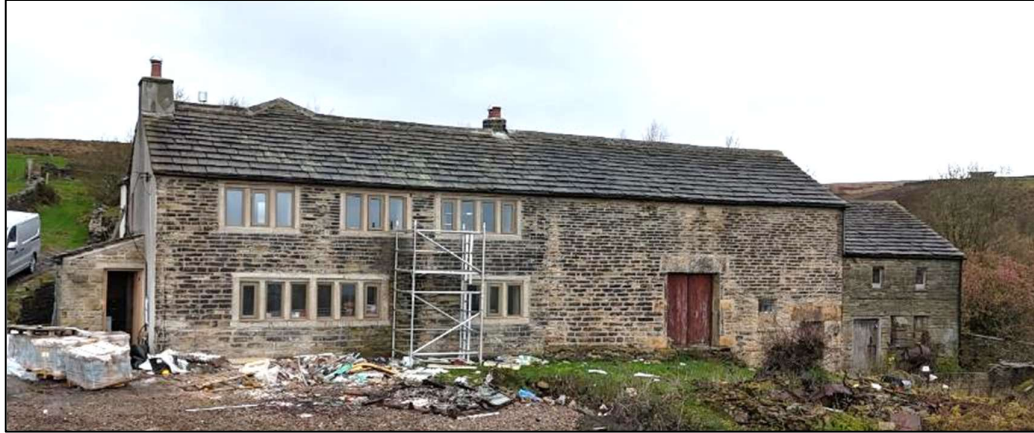
Plate 4. The building viewed from the east

5.2.1 The building comprised a two-storey, L-shaped farmhouse with an adjoining barn (Plate 4 and 5). It was arranged primarily on a north–south orientation, with a west-extending wing. The roof was covered with York stone slates and incorporated multiple

- 5.2.2 A single-storey lean-to extension was present at the southern end of the building, while a smaller stone extension was attached to the northern end of the barn. The windows had a mixture of uPVC and wooden frames. The barn doors were timber, set within wooden frames. Guttering was mounted on wooden fascia boards along the length of the building, with the exception of the gable ends. The verges at the gable ends had been pointed with mortar.

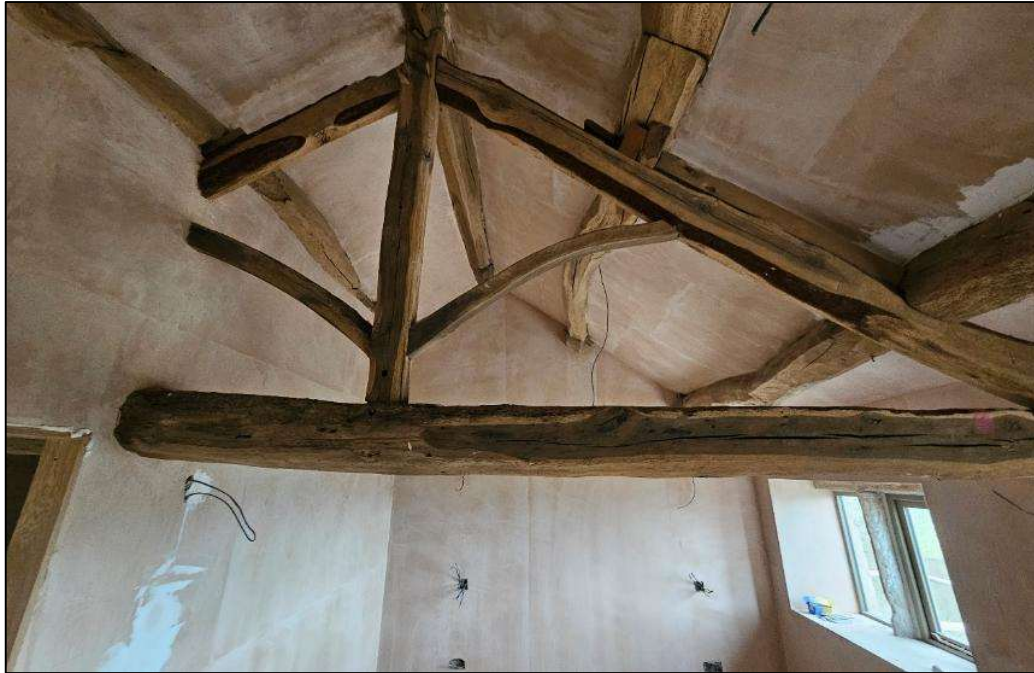
Plate 6. Interior of the farmhouse

- 5.2.3 The farmhouse was undergoing renovation at the time of inspection. The internal ceilings had been vaulted, and the ceilings and walls had been plastered since the 2017 inspection (Plate 6). The roof structures of both the farmhouse and barn were supported by king post trusses, rafters, and purlins (Plate 7).
