## Huddersfield Station

Roof A - Truss Pre-emptive Interventions Proposals Sketchbook

151667-TSA-30-MVL3-SK-S-007 Rev P03

06 October 2023

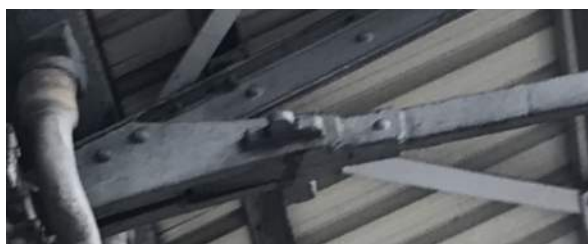
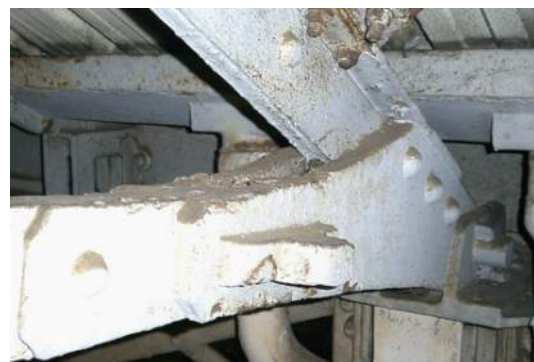
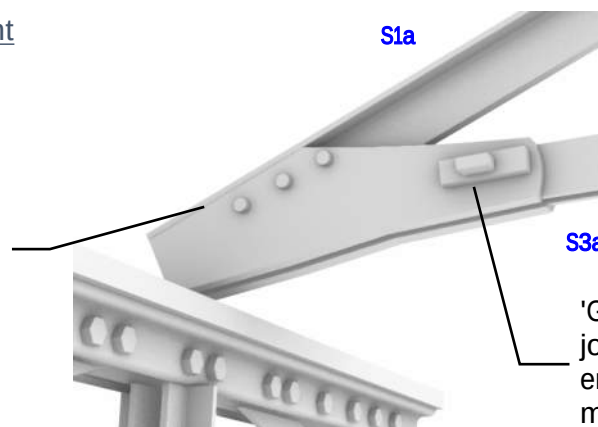
The following proposals aim to maintain these load paths under an assumed deterioration scenario within the inner plates of S1a, whilst also satisfying the requirements of the main works scheme (replacement top chord bolts required for strength).

Deterioration to the outer plates is not considered: there is no evidence to suggest that damage has occurred.

3No. rivets assumed in load transfer - i.e. no end bearing assumed for S1a

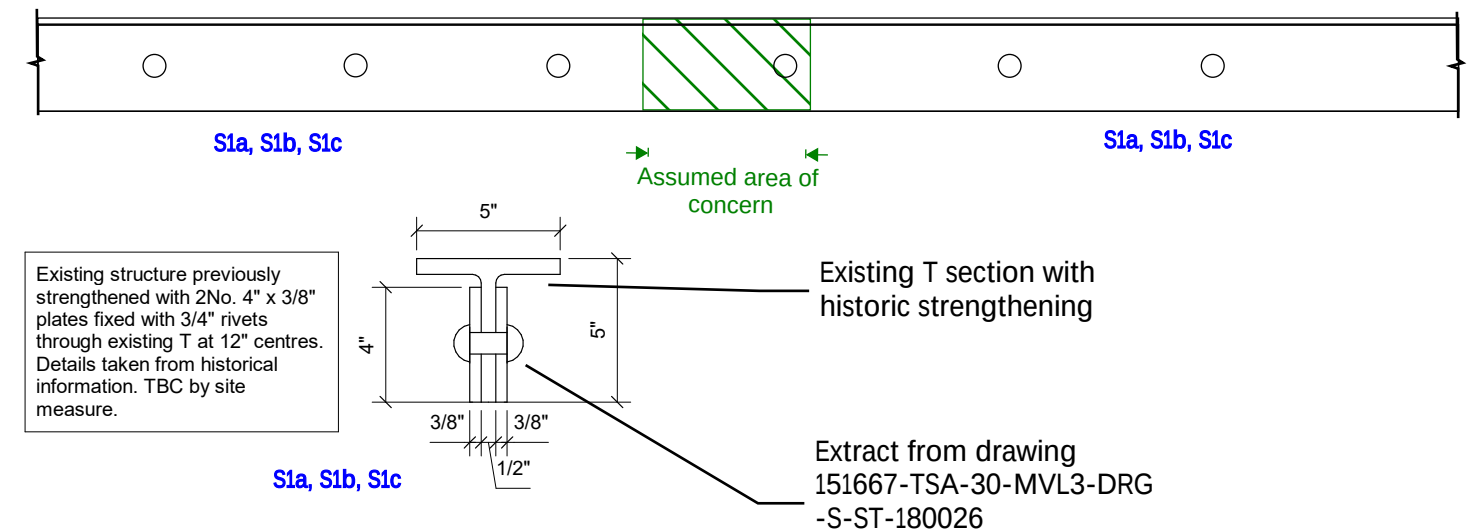
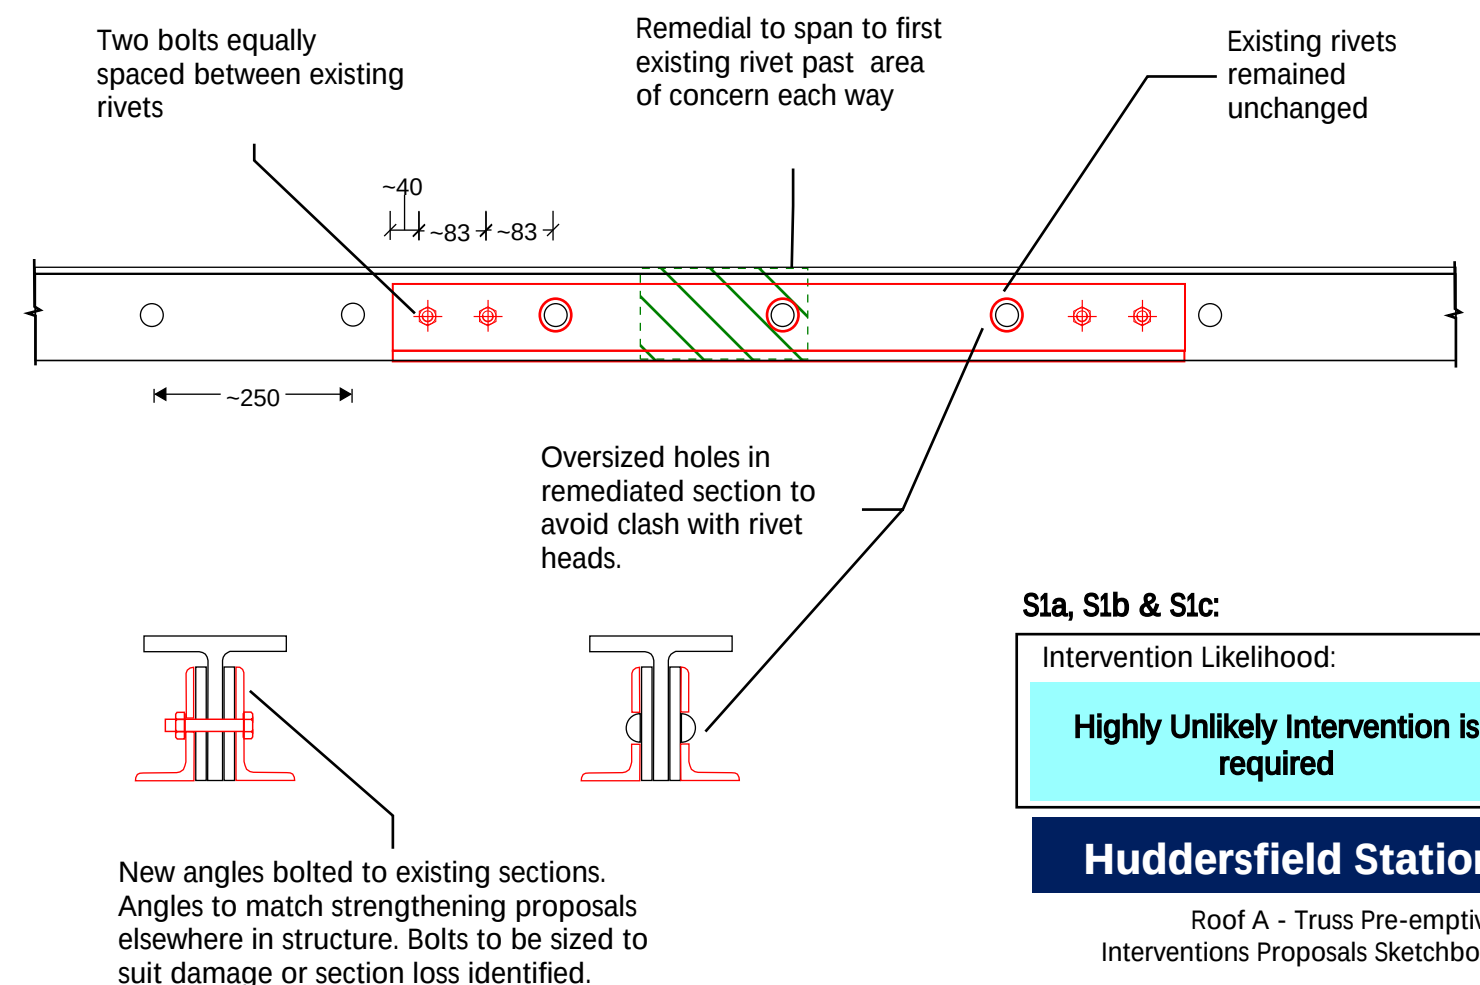
### S1a, S1b & S1c:

These elements have been strengthened historically and in some locations are being further strengthened as part of the main works package. The sections appear to be in reasonable condition given their sheltered nature directly under the existing roof finishes and therefore the likelihood of significant corrosion or section loss being identified during the blast cleaning process is deemed to be low.

Should remedial works be identified as required during the works a notional deterioration scenario is shown opposite, conservatively assuming full plate section loss. The remedial proposal is to strengthen the sections in a complementary fashion with the strengthening proposals already agreed in discrete locations (see drawing extract below). No temporary works are assumed to facilitate this remedial: the existing elements are being supplemented by additional structure and the temporary case does not make the condition weaker than existing.

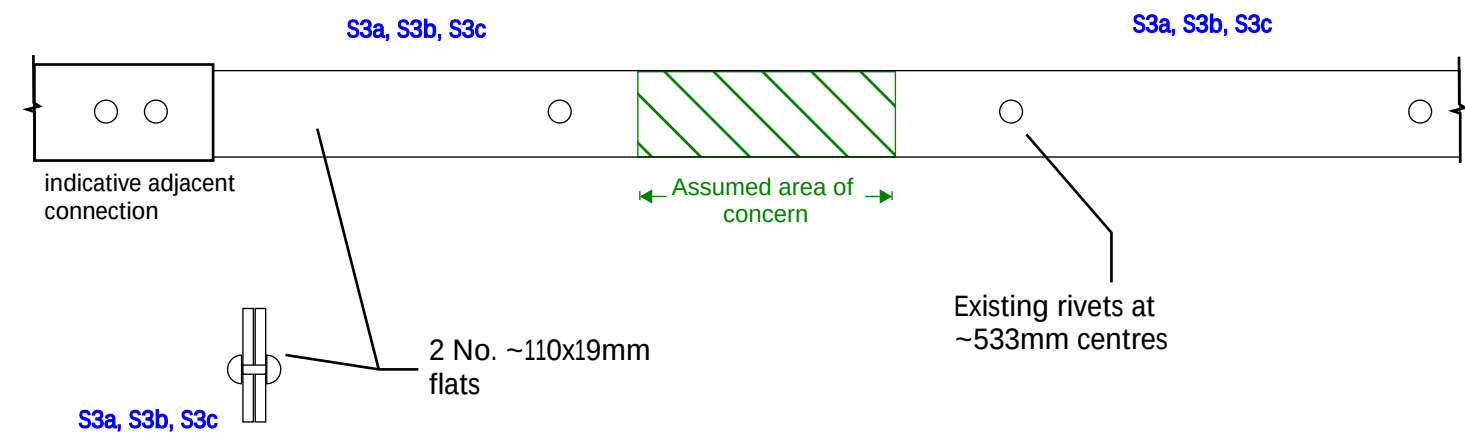
Elements S3a, S3b and S3c

The sections appear to be in generally reasonable condition with the exception of a small number of locations where water has penetrated between the riveted sections causing corrosion between the plates forcing them apart, commonly referred to as birds mouting. Away from these isolated details, it is anticipated that the likelihood of excessive corrosion or other defects including cracking is low.

Should remedial works be identified as required during the works a notional deterioration scenario is shown opposite, conservatively assuming full plate section loss.

The proposal is to remediate in a similar manner to the existing compound section of flat plates. This will be done by drilled through existing rivets and fixing an additional flat side plate of matching depth to the affected lengths.

Bolts to be fixed through existing rivet holes. Plate thickness and bolt sizing to suit extent of defect.

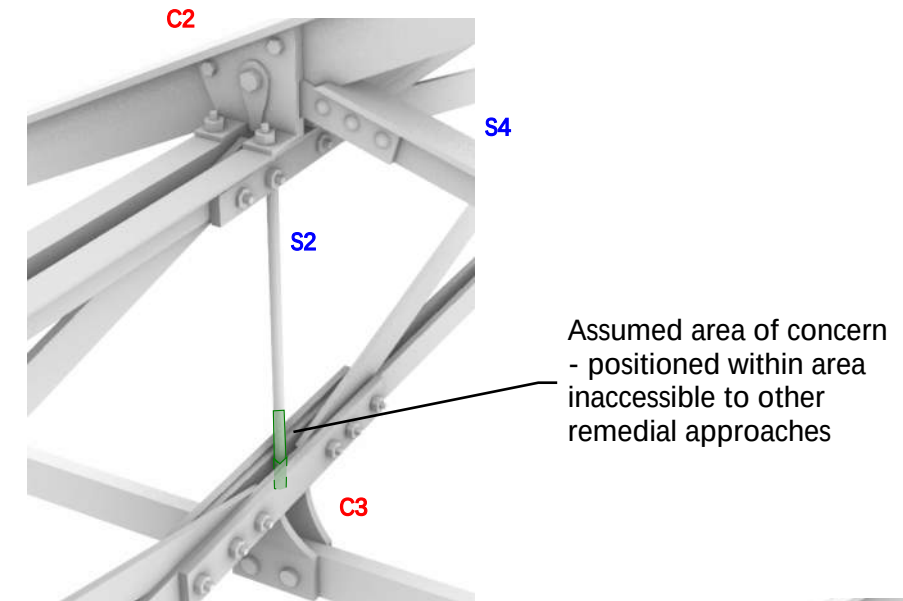
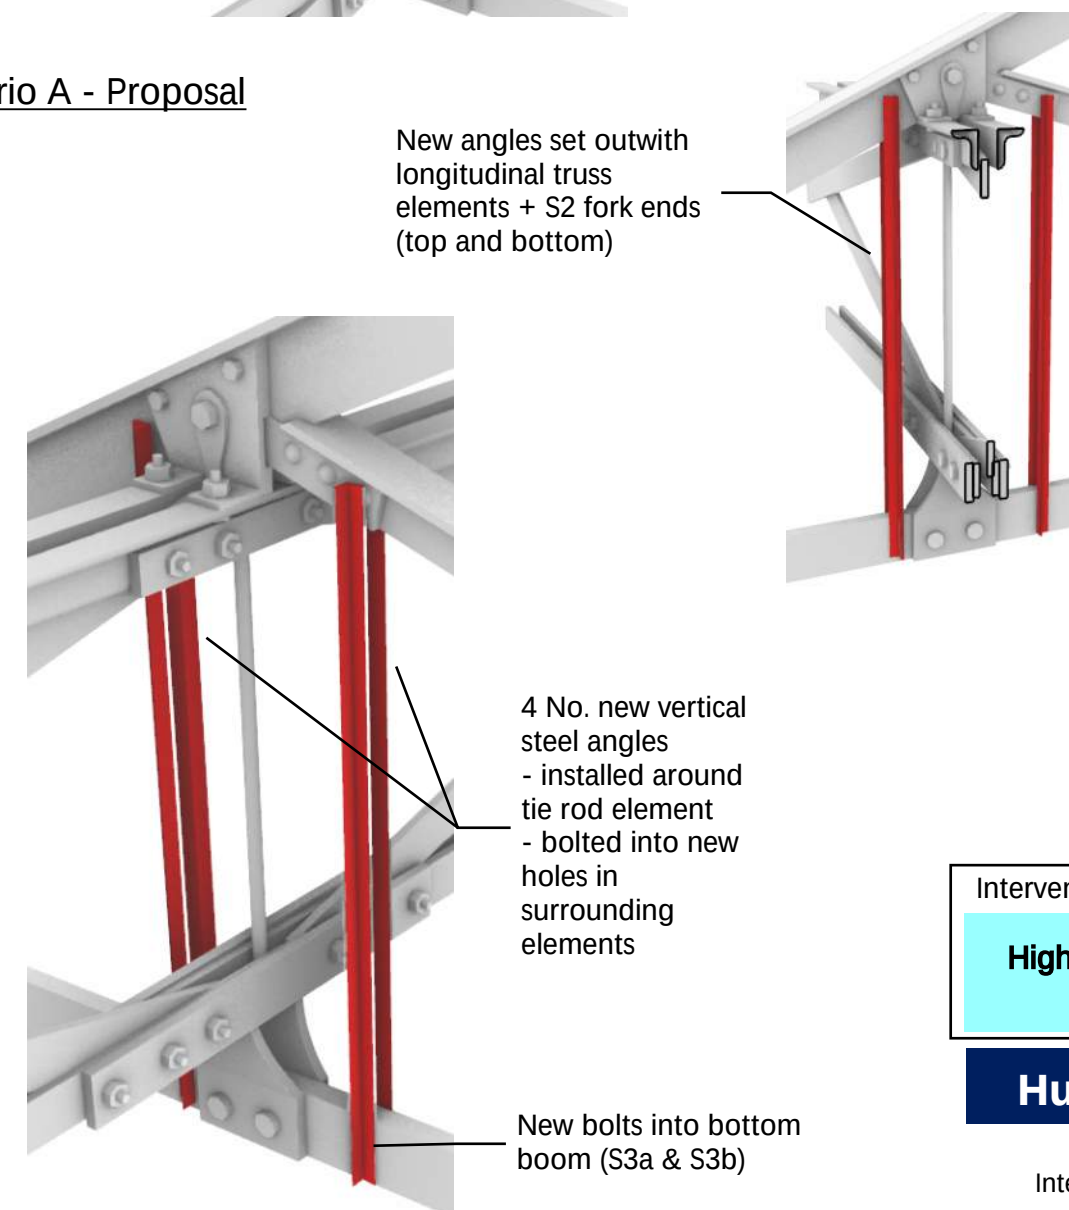
The elements are generally in good condition and the design forces sufficiently low that there is very minimal risk that section loss through corrosion will cause the elements to be under design capacity.

In the notional deterioration scenario of a cracked cross section with zero capacity, S2 is to be left in place and four angles bolted around the tie element through new and existing holes. The alternative strategy of replacing S2 like-for-like has been deemed impractical given the difficulties of removing the hanger fork ends from the existing connection assemblies at C2 and C3.

No temporary works are assumed to facilitate this remedial: the existing elements are being supplemented by additional structure and the temporary case does not make the condition weaker than existing.

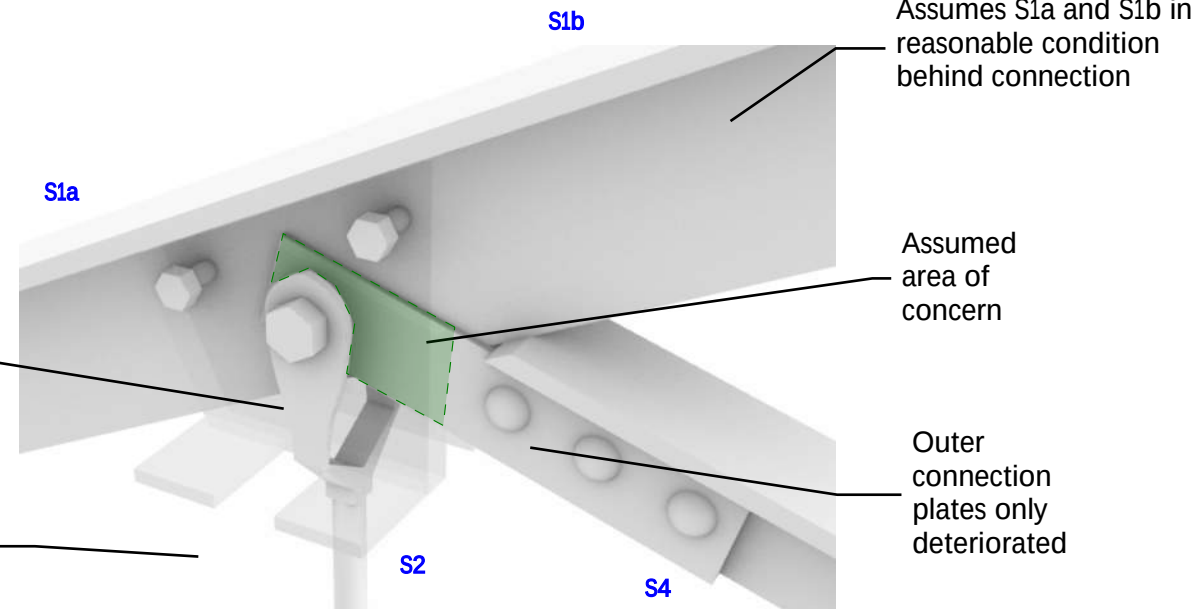
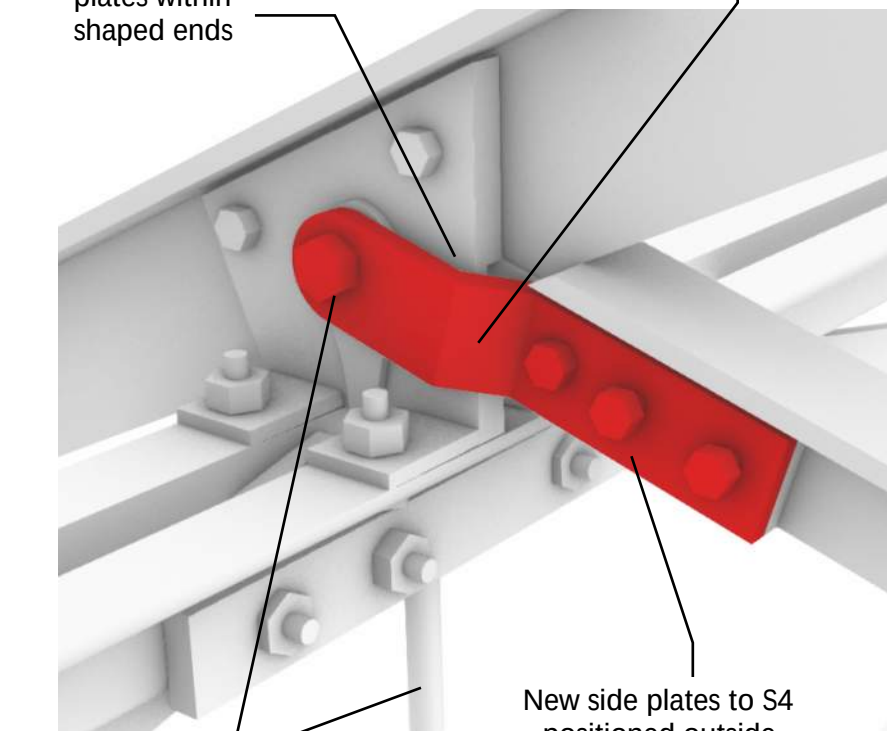
An assumed deterioration scenario is similar to C4 however the area of concern (S4 connection plates) are now positioned within the longitudinal truss brackets and replacement of these plates is not possible without removal of not just the S2 hanger but also the longitudinal truss elements.

Assumes S2 and associated end connection is in reasonable condition

A different strategy is required which aims to keep as many existing elements in place and to install supplementary side plates outside the existing assembly. This is facilitated by temporary works to hold elements in place while the single through pin is replaced and made longer.

Packing plates within shaped ends

Shaped ends to side plates extend to outside S2 fork ends (top chord omitted for clarity)

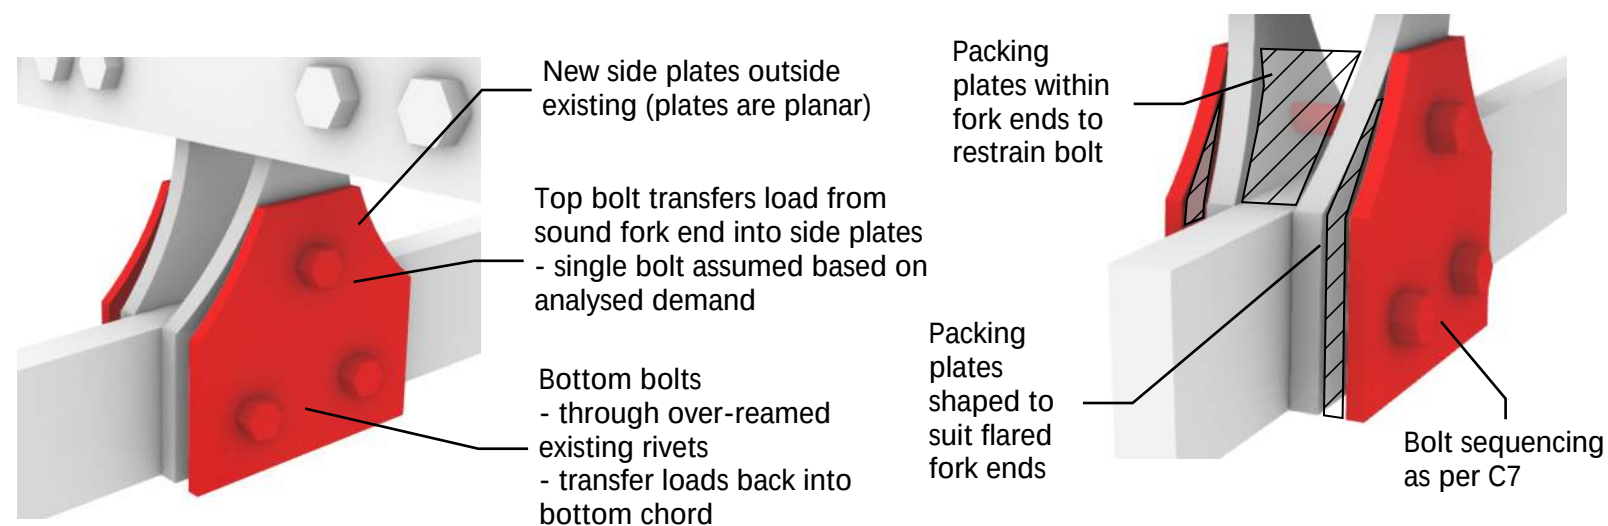
## Scenario A - Proposal

## Scenario A: Outer connection plates deteriorated

Outer connection plates only deteriorated

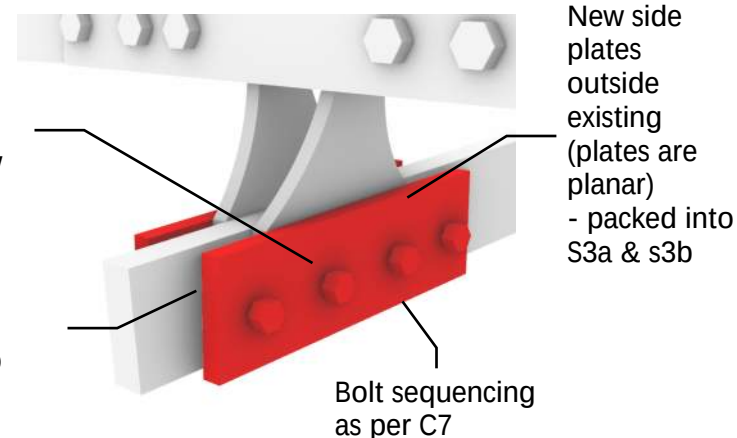
## Scenario B: Inner connection plates deteriorated

Assumed area of concern

Internal bolts - through over-reamed existing rivets - transfer S2 loads into new side plates

External bolts - transfers S2 loads into sound bottom chord - transfers S3a loads into S3b via side plates

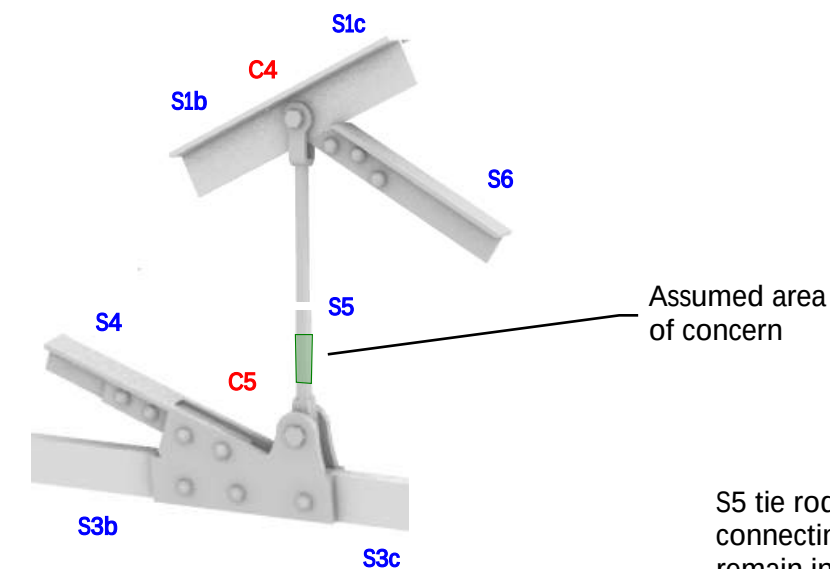
## Scenario A

In the notional deterioration scenario of a cracked cross section with zero capacity, two proposals are suggested:

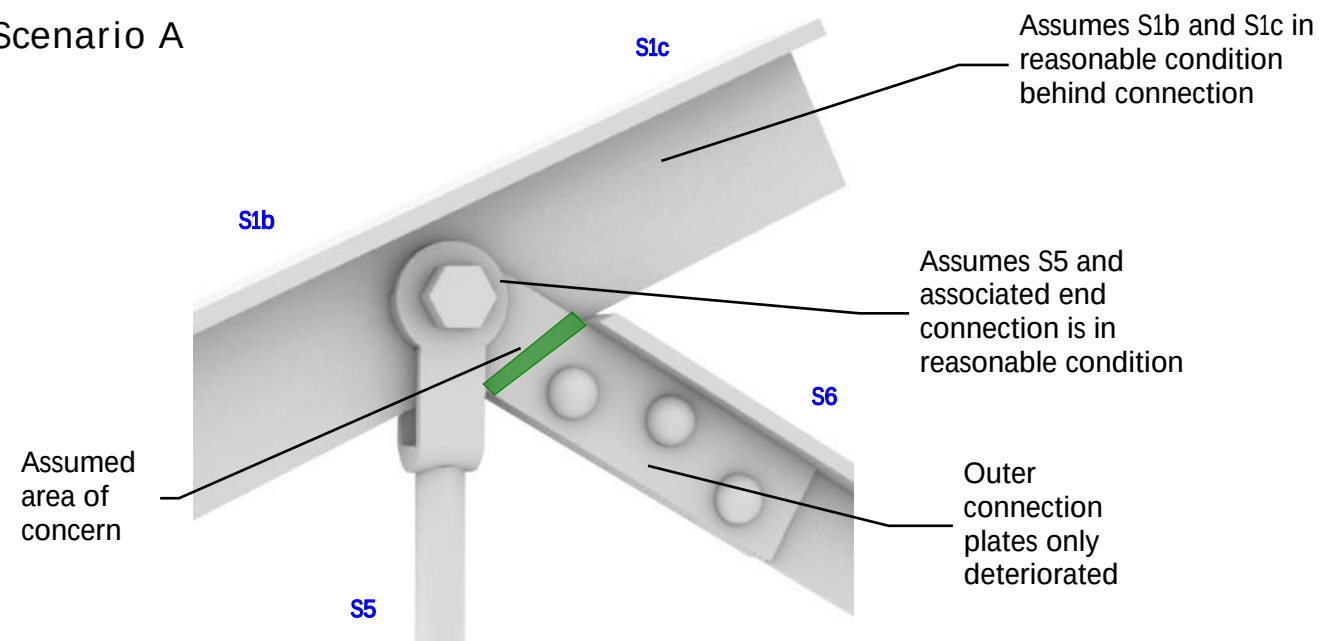
## Scenario A

The notional deterioration scenario presumes damage to the internal plates from S6 - to reiterate no evidence of deterioration has been identified at this position but this is the assumption to allow potential options to be considered.

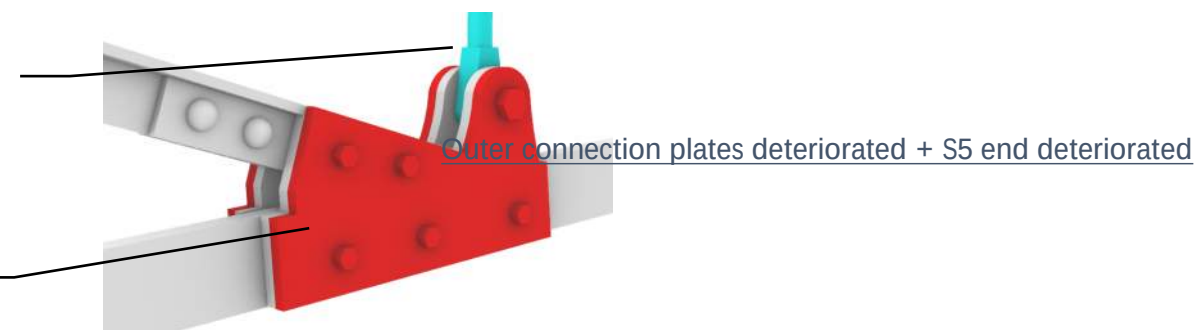
## Scenario B: Outer connection plates deteriorated + S5 end deteriorated

- **Proposal B** - if the end of S5 has deteriorated then replacement structure rather supplementary structure is recommended, since the assumed new bridging plates would imply temporary works are already in place to bypass S5. the replacement S5 could be an equivalent salvaged element from the dismantled end trusses.

Assume replacement S5 tie rod with new pin

As Proposal A UNO

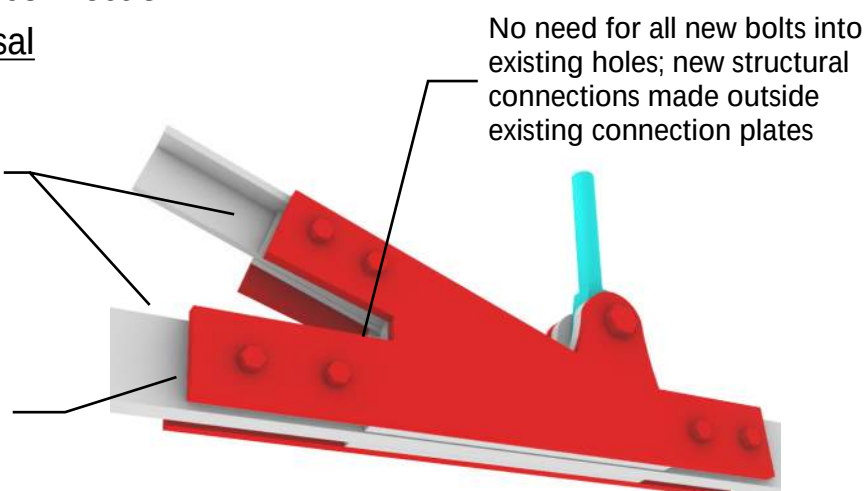
## Scenario C - Proposal

## Scenario C: Outer connection plates deteriorated + S5 end deteriorated + S3b & S3c deteriorated within connection

Packing plates between new connection and existing bottom chords / diagonal angle.

Bridging plate extended past existing connection with additional bolts through new holes into sound existing elements

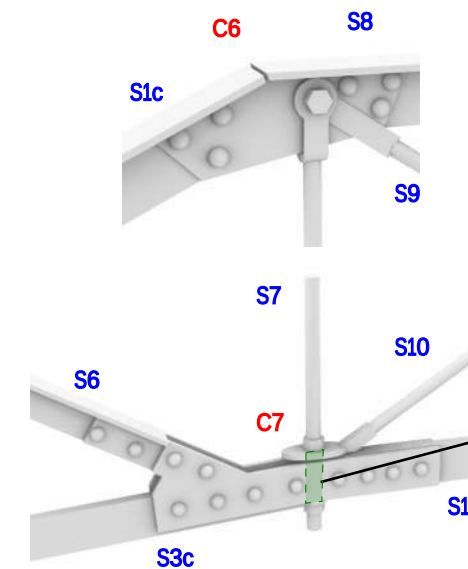
## Scenario A

Assumed area of concern  
- positioned within area inaccessible to other remedial approaches

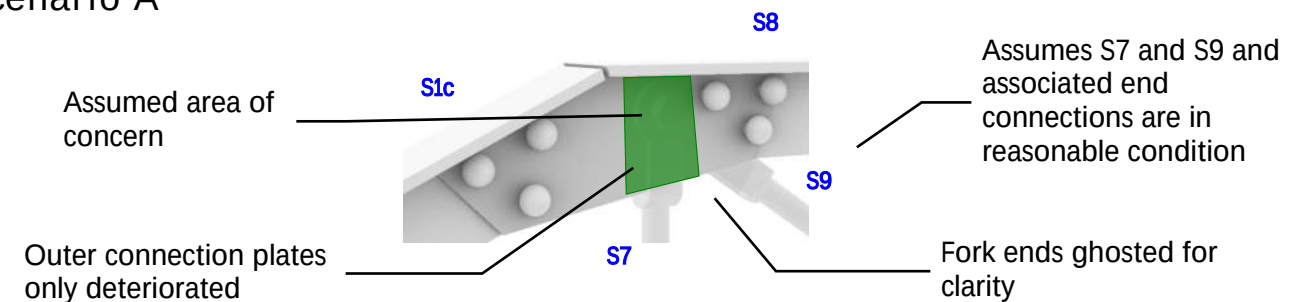
## Scenario A

C6 is largely understood to be in reasonable condition and strengthening works through rivet replacement with new bolts is already proposed as part of the main works package. A notional deterioration scenario assumes damage to the outer plates at the connection of incoming ties.

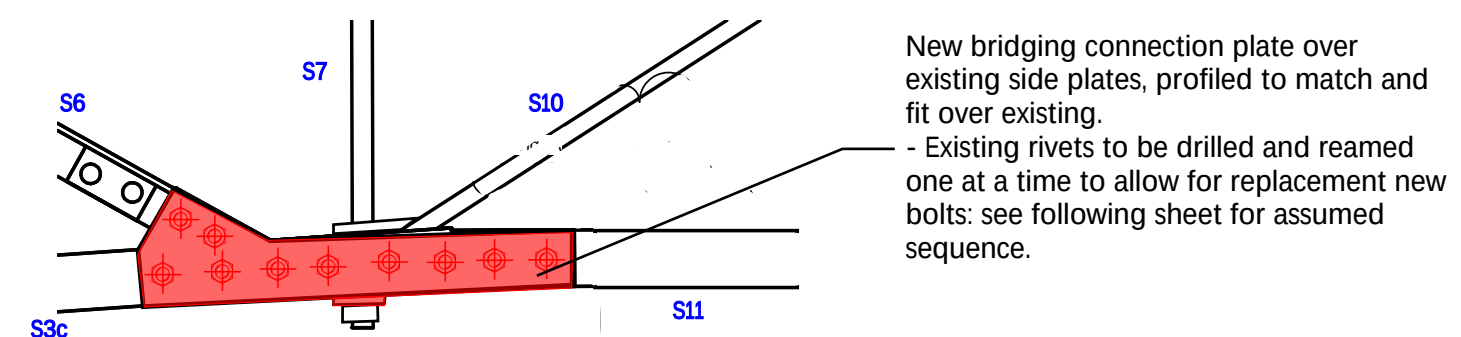
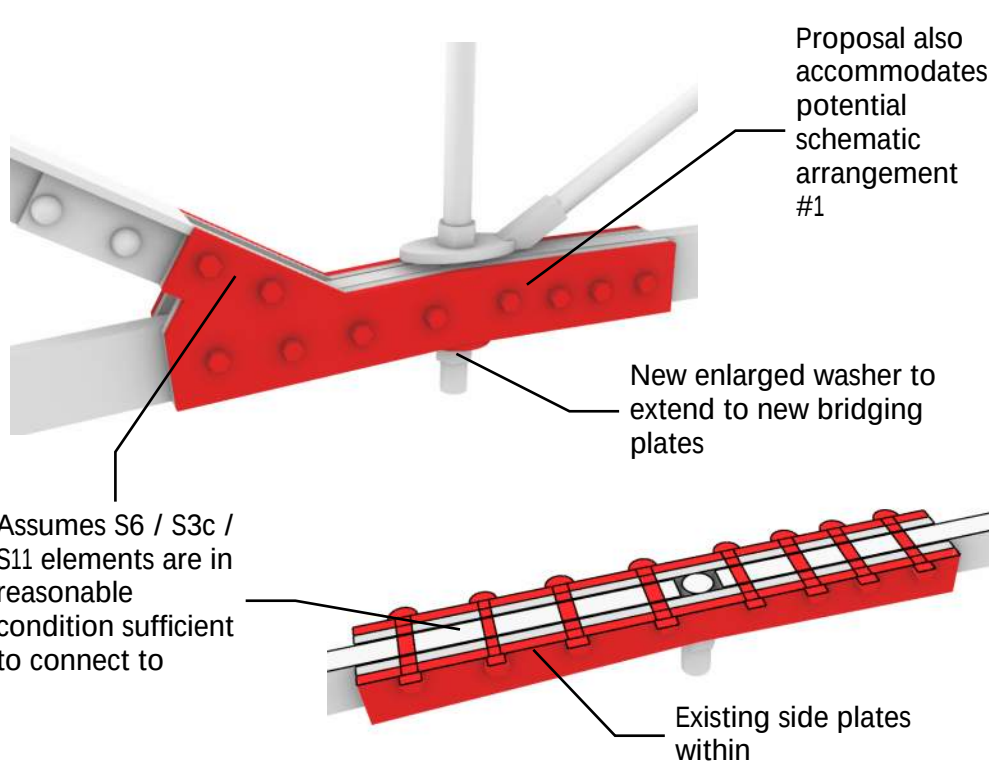
Scenario A - Proposal

C7 has been identified as having corrosion present which appears to have progressed between the initial survey in 2019 and the latest in 2023. The corrosion appears most significant in the bolts and connection plates around the base of the diagonal members and particularly on the central side of the truss (towards member S11). It unclear from the photos to what extent the corrosion and water ingress has penetrated to the inner plates of the connection and what condition they may be in. The vertical tie rod S7 and associated washers and bolts appear generally to be in good condition as do the incoming diagonal angle S6 and its associated bolts.

Any intervention will need to be considerate of the part of the connection which is identified as deteriorated. Given the current condition, the most likely elements to be identified as understrength is the central section of the outer connection plates and the associated inner plates of the corresponding connecting elements. Scenarios are presented to account for increasing deterioration.

Precedent for the rivet replacement with bolts has been set in the proposed intervention drawing 151667-TSA-30-MVL3-DRG-S-ST-180022 as already agreed.

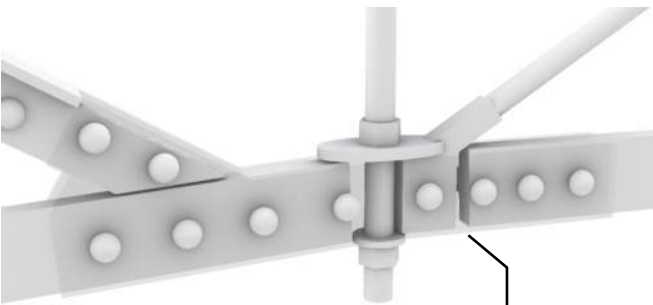
Schematic arrangement #1

S10 has fork end within and behind side plates - less likely

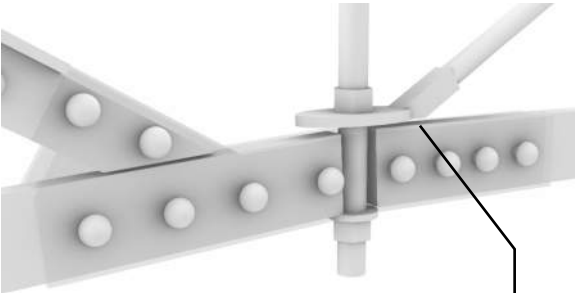
Schematic arrangement #2

S10 terminates only with bracket connecting into S7 - more likely; proposals assume this arrangement

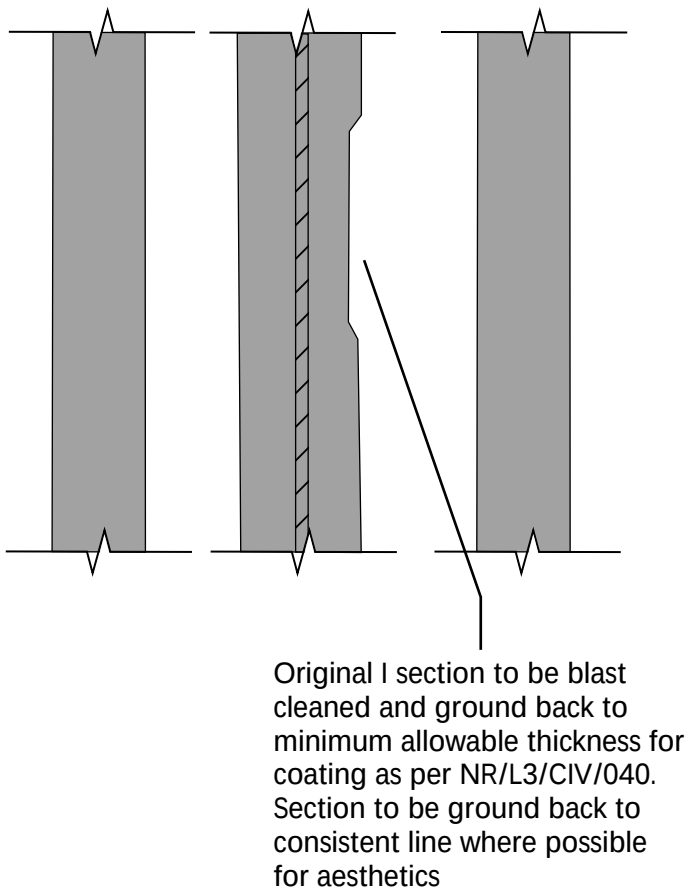
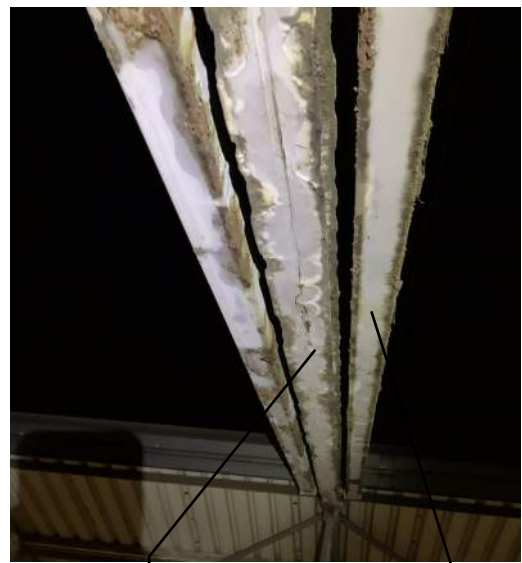
Scenario A - Proposal

The remedial opposite assumes a known deterioration scenario where the edges of the I section are ragged and frayed due to corrosion. The flanges are to be ground back to a minimum thickness in line with Network Rail Guidance NR/L3/CIV/040 (Specification for the Use of Protective Coating Systems) and should be ground back to a consistent line where possible to reduce the visual impact of the section loss when viewed from platform level.

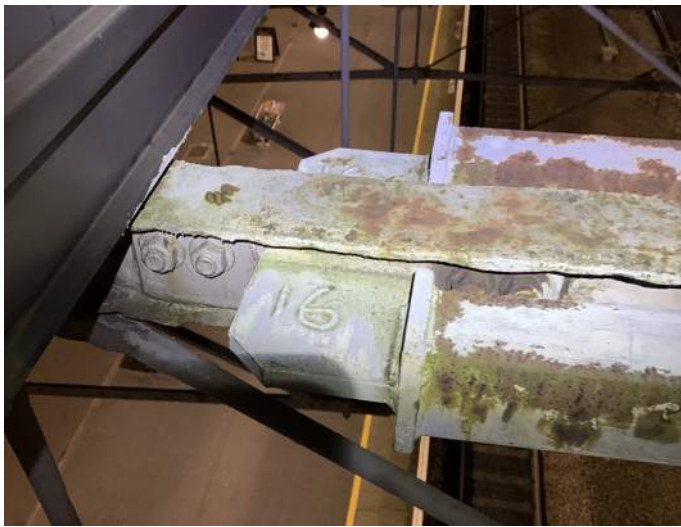
Original I section of S8

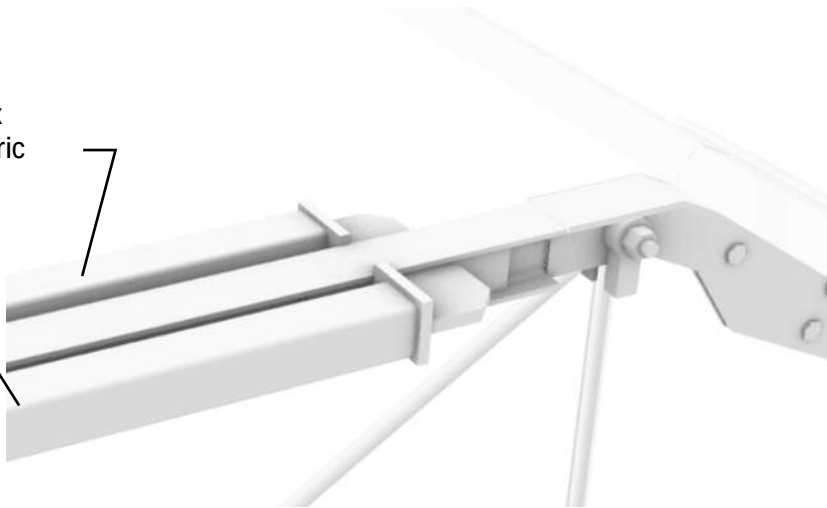
Supplementary box sections from historic strengthening

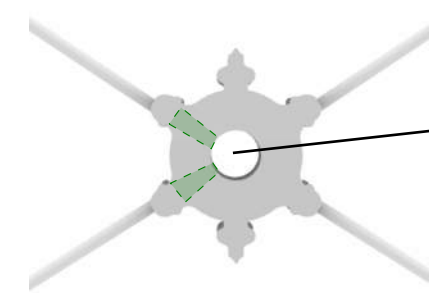
## Scenario A

As a conservative consideration, the notional deterioration considers a serious structural failure within the inaccessible area within C8. A pair of failed incoming rods are considered.

Assumed area of concern  
- positioned within area inaccessible to other remedial approaches

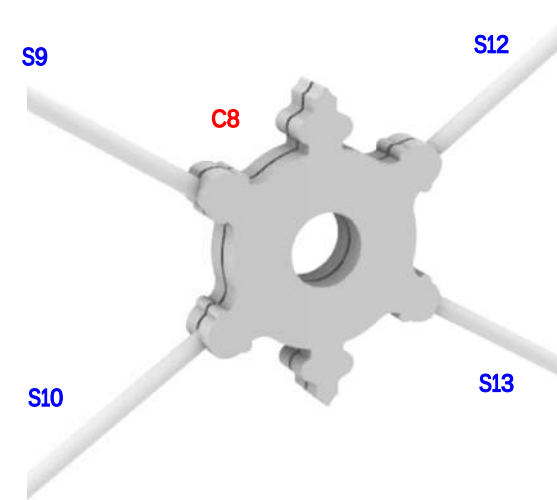
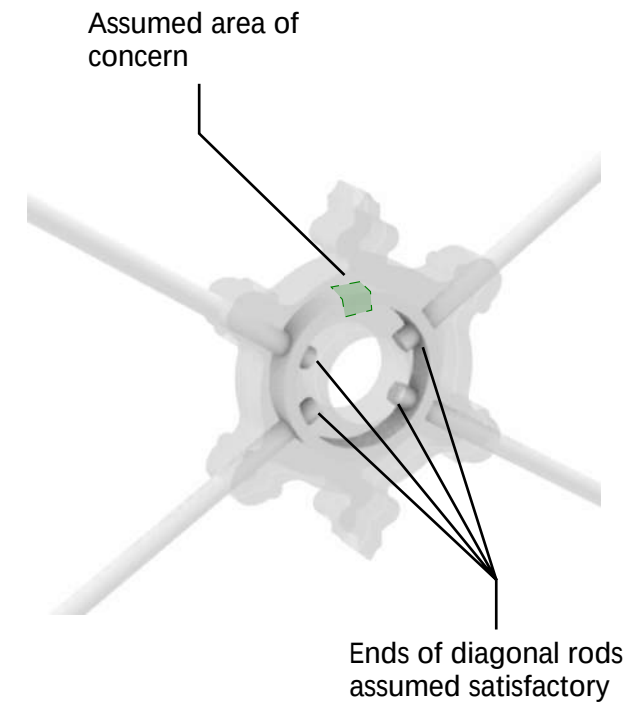
## Scenario A

The condition of the inner structural ring is currently unknown, given its inaccessibility within the suspected non-structural fascias. As a positive there aren't any indications of excessive corrosion to the fascia plates, which could otherwise be interpreted as a sign of hidden ongoing deterioration. However it could equally be the case that corrosion of the ring is simply hidden behind the fascias and has not reached the position where the fascias are affected. Given the position of the rose directly under the open roof, and the potential for trapped water within the connection, the risk of corrosion cannot be ruled out.

For the purposes of this assessment, a notional deterioration scenario considers full failure of a part of the structural ring. The remedial proposal is constrained by the architectural sensitivity of the rose, its central aspect on the truss, and the difficulty of using supplementary steelwork when it would have to interface with the non-structural fascias. For this reason a simple new replacement structural ring is proposed, like-for-like, which can again be concealed within the fascias. The significant temporary works to facilitate this proposal - temporarily replacing the action of the cross bracing- should be recognised.
