## GOMERSAL ST MARYS PRIMARY SCHOOL

### Sustainable Drainage Strategy

Hexa ref: SRP1134-HEX-XX-XX-T-C-0001

Revision: P02

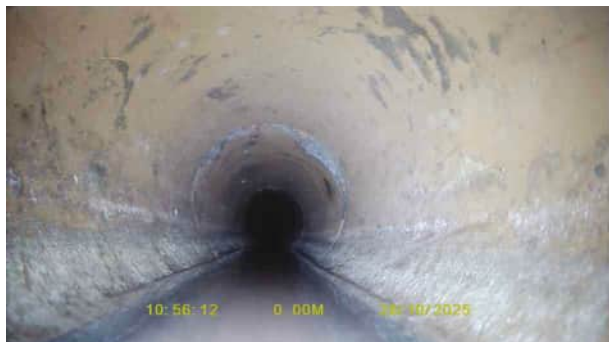
FW3X\_f96d133b-4b66-4a8e-bb0a-ab71a3787eff\_20251105\_131826\_068.jpg, 00:00:00, 0.00 m  
Start node, inspection chamber, reference: FW1

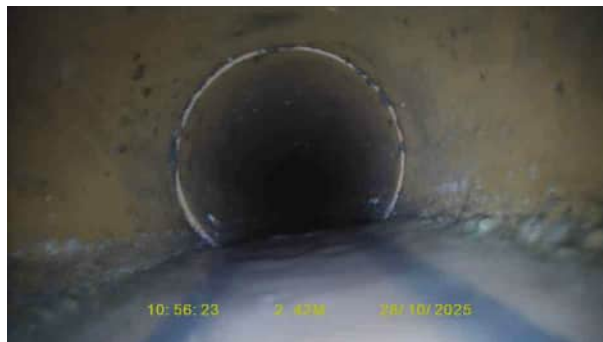
FW3X\_a445b793-2a80-4e35-8496-ca9087429080\_20251105\_132059\_614.jpg, 00:00:10, 2.50 m  
Joint displaced, medium

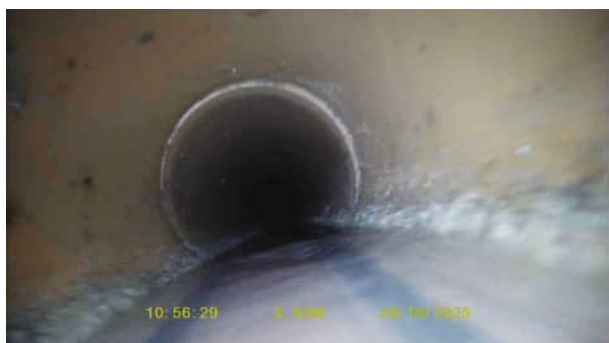
FW3X\_e738eed4-f1b5-4782-b250-e9f5282f7fa0\_20251105\_132143\_702.jpg, 00:00:16, 4.00 m  
Joint displaced, medium

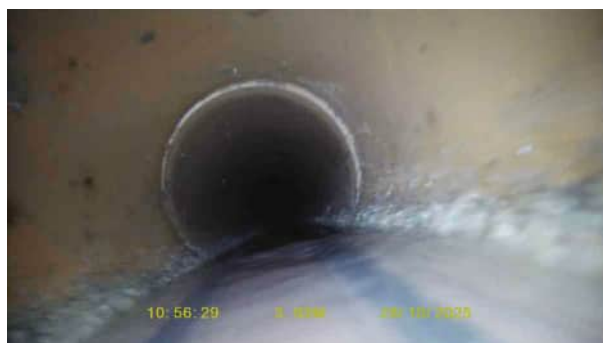
FW3X\_9551a688-1181-4b2f-90e4-8d48369dc648\_20251105\_132245\_394.jpg, 00:00:16, 5.90 m  
Joint displaced, medium

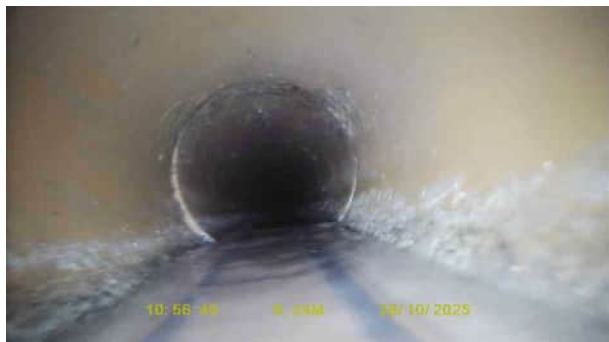
FW3X\_e09411e4-4c7b-4c1b-85fa-4bc1ed0eae81\_20251105\_132408\_611.jpg, 00:00:36, 9.30 m  
Joint displaced, medium

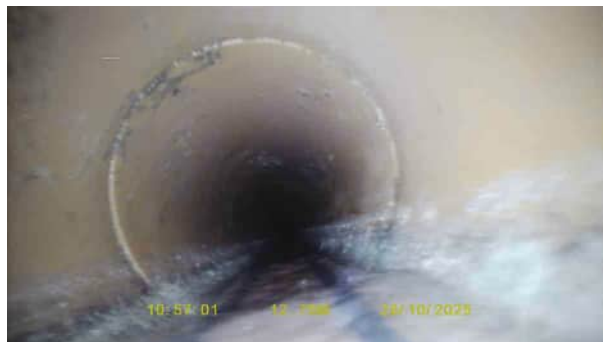
FW3X\_242d2110-7232-4526-a57d-6bedde13ea2d\_20251105\_132508\_165.jpg, 00:00:48, 12.80 m  
Joint displaced, medium

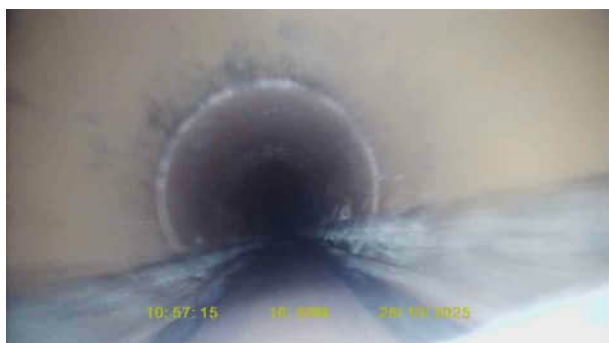
FW3X\_d7ff3a7-2b1a-47aa-9810-a03255046e8f\_20251105\_132620\_238.jpg, 00:01:02, 16.20 m  
Joint displaced, medium

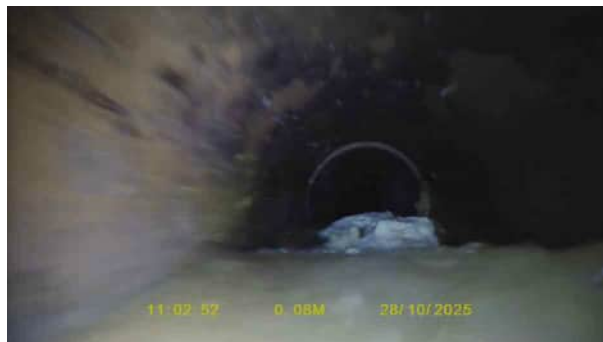
F1X\_4c7e71f5-719c-4dc9-94a1-7f3bba4236da\_20251105\_135027\_113.jpg, 00:00:02, 0.10 m  
Other obstacles from 4 o'clock to 7 o'clock, 30% cross-sectional area loss, Toilet Roll

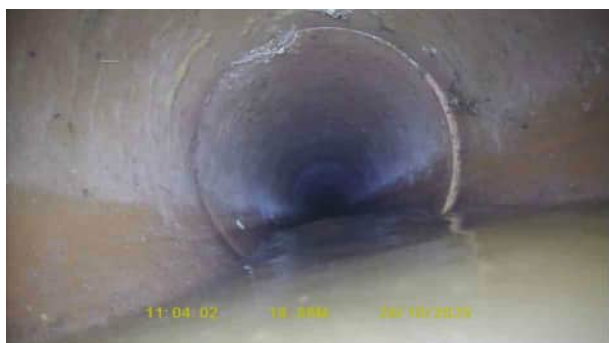
F1X\_c6f60755-7b2a-4aaa-9ca6-c47bde1e8880\_20251105\_140504\_454.jpg, 00:01:12, 19.00 m  
Joint displaced, medium

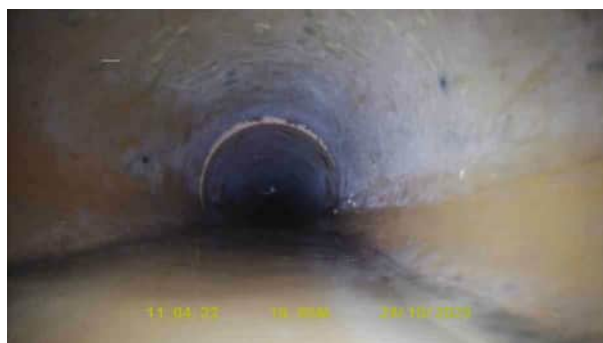
F1X\_9a8f4df7-5336-4bc7-b7d3-fb74378dffa\_20251105\_140809\_548.jpg, 00:01:31, 20.20 m  
Joint displaced, medium

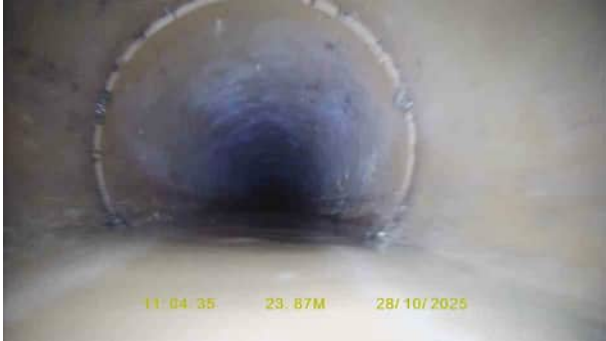
F1X\_7ef61e4e-ab48-4070-99f4-73e215dc79c3\_20251105\_141016\_166.jpg, 00:01:45, 23.75 m  
Joint displaced, medium

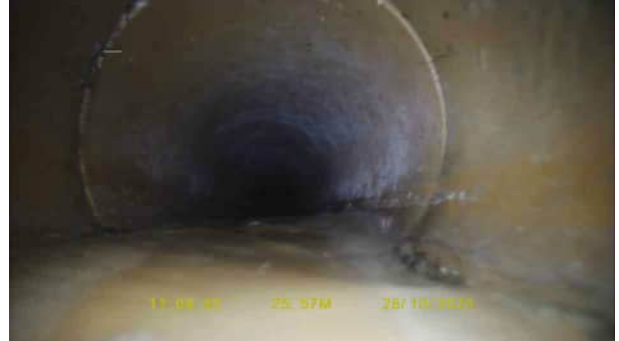
F1X\_14970dac-c4da-4082-b7ad-68042f41e63c\_20251105\_141203\_411.jpg, 00:01:51, 25.40 m  
Joint displaced, medium

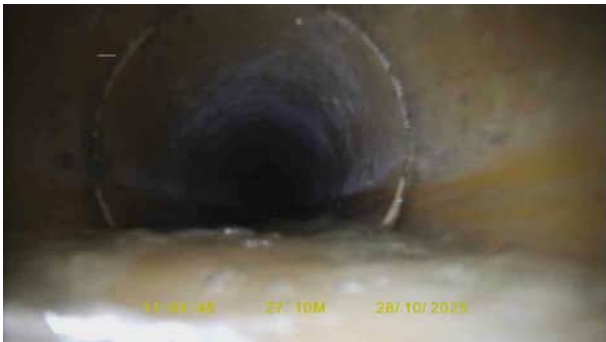
F1X\_2a07ccbe-25cb-454d-a96b-777802066aa4\_20251105\_141332\_621.jpg, 00:01:58, 27.20 m  
Joint displaced, medium

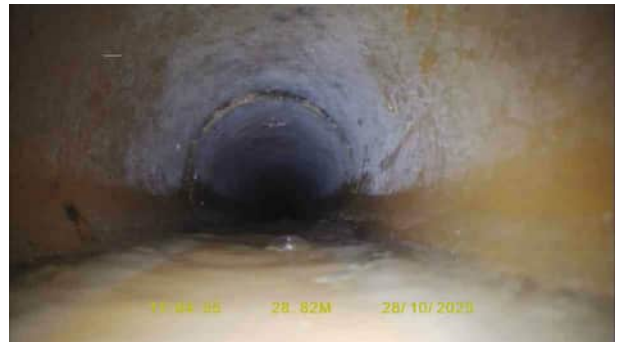
F1X\_18dca5ae-c488-4489-8fb3-59bc18f92f6b\_20251105\_141543\_239.jpg, 00:02:05, 29.00 m  
Joint displaced, medium

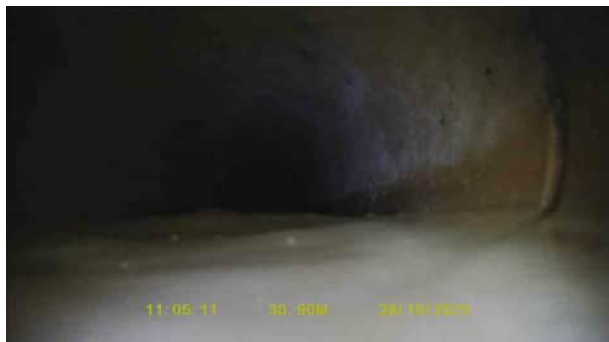
F1X\_d18718f8-3ad9-41a6-966c-4f6e2f15b3b4\_20251105\_14  
1719\_174.jpg, 00:02:21, 31.00 m  
Joint displaced, medium

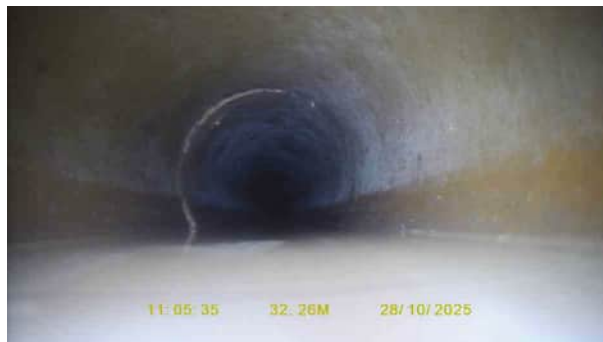
F1X\_d374c5be-b6c6-4f32-a187-84de2f0924b3\_20251105\_14  
1840\_879.jpg, 00:02:45, 32.50 m  
Joint displaced, medium

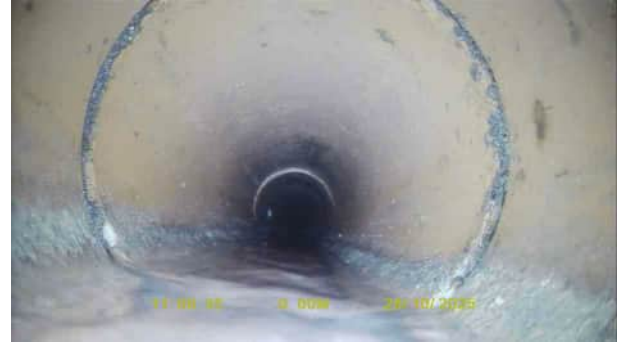
FW1X\_bb6485bd-548d-4be5-91c5-705dffaed8c2\_20251105\_142555\_498.jpg, 00:00:00, 0.10 m  
Joint displaced, medium

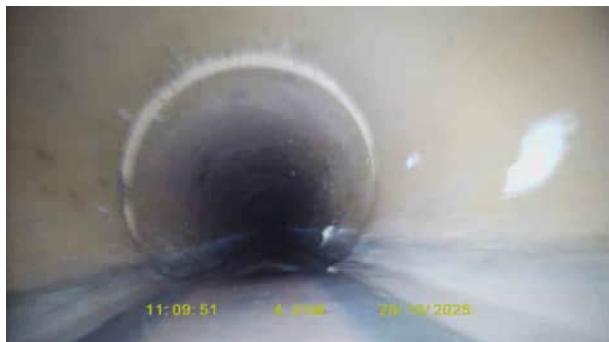
FW1X\_5b273742-cf5f-47da-959e-2f2496b86c59\_20251105\_142910\_140.jpg, 00:00:14, 4.10 m  
Joint displaced, medium

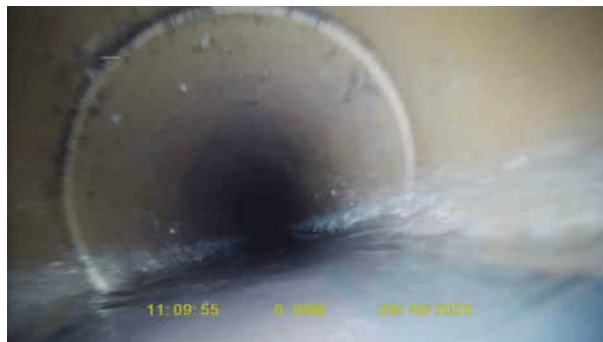
FW1X\_d7d02a65-f620-4ce9-b720-8c0dc29dab83\_20251105\_142949\_117.jpg, 00:00:19, 6.10 m  
Joint displaced, medium

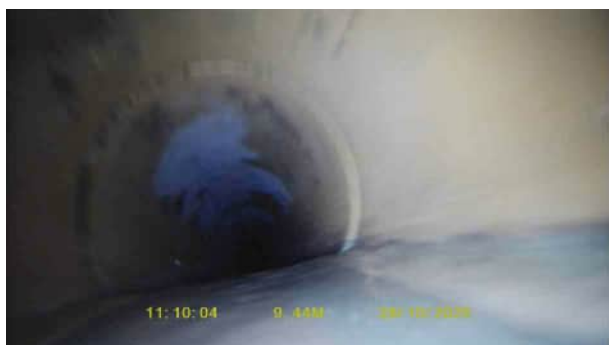
FW1X\_e22c0d4d-da6a-44d6-b8d2-c4ba35c96a92\_20251119\_122751\_755.jpg, 00:00:29, 9.40 m  
Joint displaced, medium

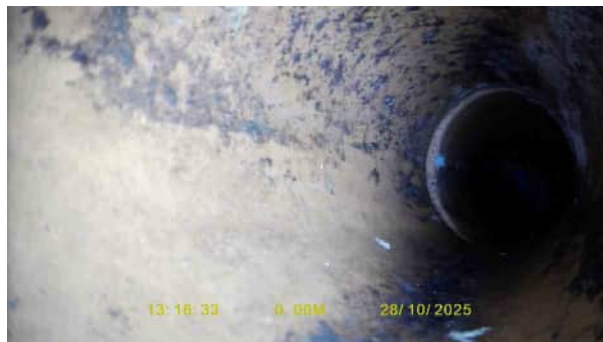
FW4X\_b0ed26bb-f7b6-410a-bfa3-1cb3b7f78ce0\_20251111\_143723\_272.jpg, 00:00:01, 0.30 m  
Joint displaced, medium

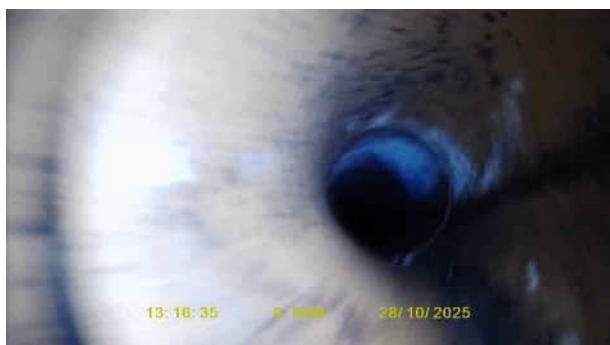
FW4X\_77facc1b-5bb4-4911-9460-b696df87e01f\_20251111\_144013\_094.jpg, 00:00:02, 0.50 m  
Joint displaced, medium

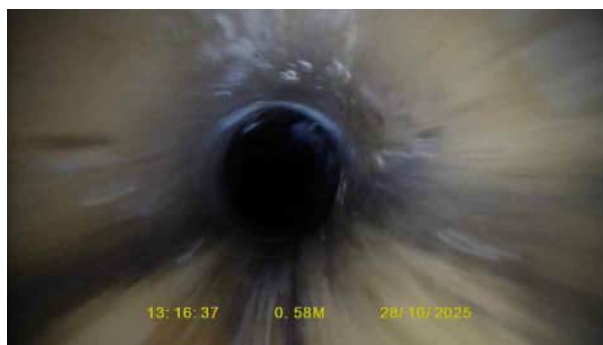
FW4X\_2ac60ace-1e68-4b42-82f6-1e6de404bb26\_20251111\_144129\_445.jpg, 00:00:04, 0.90 m  
Joint displaced, medium

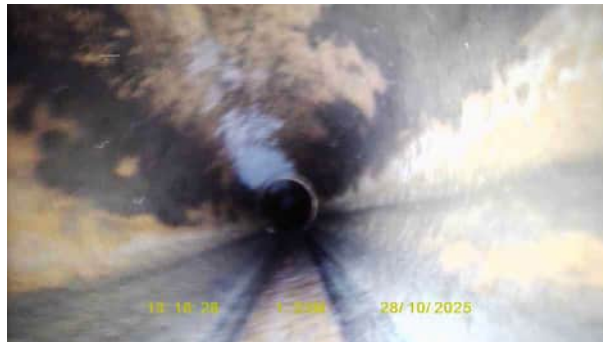
F5X\_20481a2c-edda-4770-8428-e4544c3a0b90\_20251111\_151230\_068.jpg, 00:00:07, 2.20 m  
Joint displaced, medium

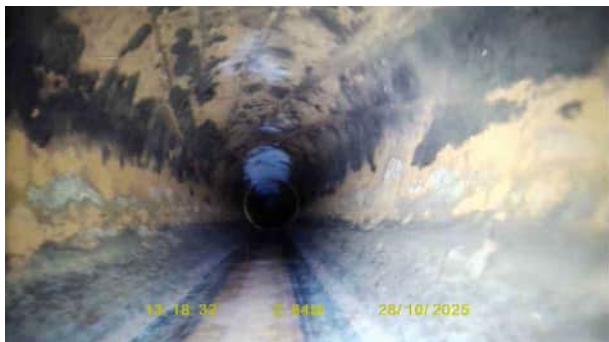
F5X\_1ea38ad1-2927-441f-9033-f555f4d9b313\_20251111\_151311\_267.jpg, 00:00:11, 3.80 m  
Joint displaced, medium

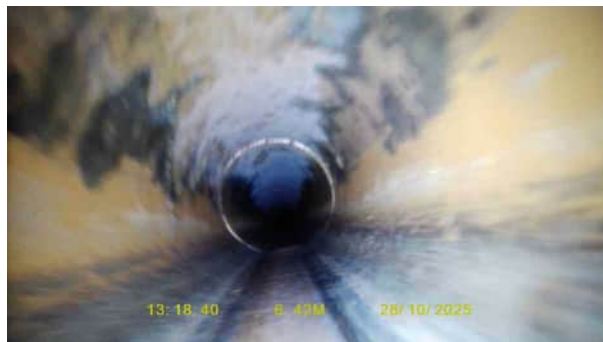
F5X\_7d85b6ee-c78c-444c-a187-0e71105c7bbc\_20251111\_151402\_932.jpg, 00:00:18, 7.00 m  
Joint displaced, medium

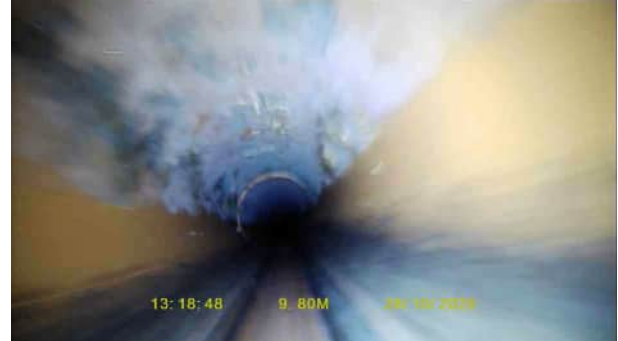
F5X\_f2ad8170-38f7-4875-990a-c4721f5776df\_20251111\_151  
502\_630.jpg, 00:00:27, 10.20 m  
Joint displaced, medium

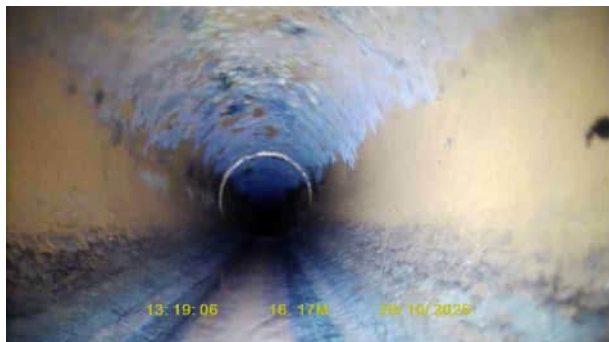
F5X\_186ab68e-9783-46da-b64a-9a03585a2133\_20251111\_151757\_964.jpg, 00:00:45, 16.80 m  
Joint displaced, medium

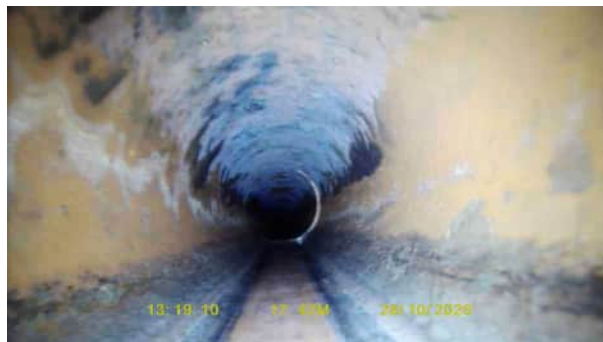
F5X\_b261c99f-01b4-4737-b120-e29244078c5d\_20251111\_151905\_154.jpg, 00:00:49, 18.40 m  
Joint displaced, medium

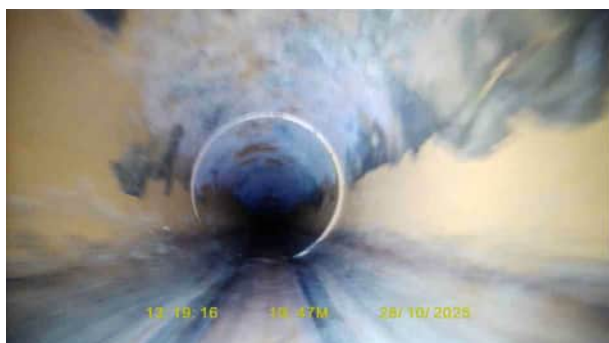
F5X\_1dff66bd-032e-4a8e-bacd-66fb24f26518\_20251111\_152044\_033.jpg, 00:00:54, 19.70 m  
Joint displaced, medium

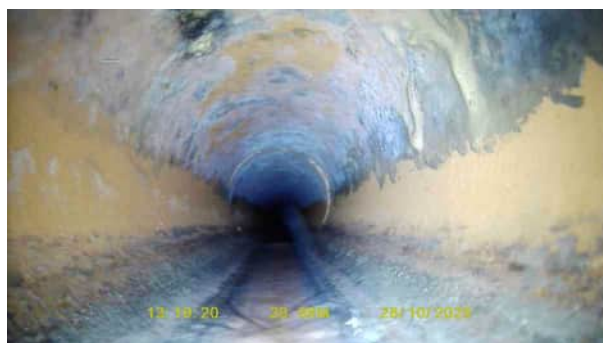
F5X\_d6a7aa87-dce6-45ac-9724-88720cfde97b\_20251111\_152206\_594.jpg, 00:00:58, 21.30 m  
Joint displaced, medium

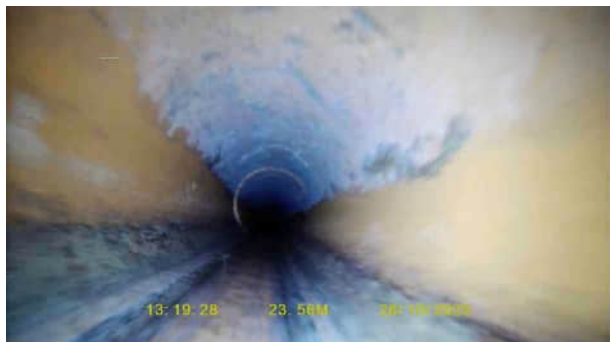
F5X\_51817b73-068f-4963-a431-87c08025ca0e\_20251111\_15  
2352\_977.jpg, 00:01:07, 24.50 m  
Joint displaced, medium

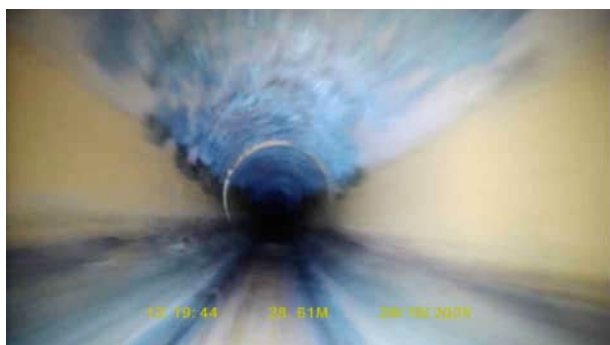
F5X\_a9c42148-3f50-4634-a154-bce27f79a3a9\_20251111\_15  
3305\_087.jpg, 00:01:22, 29.00 m  
Joint displaced, medium

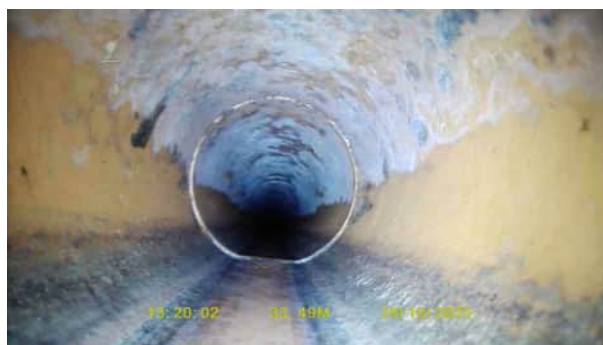
F5X\_0f6711bb-da22-4f6b-844e-7ba240578ac5\_20251111\_15  
4255\_973.jpg, 00:01:40, 34.00 m  
Joint displaced, medium

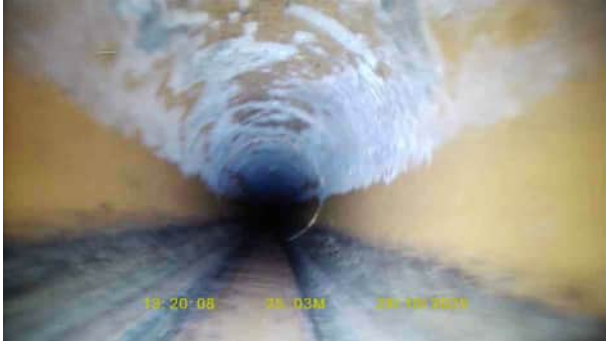
F5X\_8bb544a3-cf0a-48fa-a29e-19c2b8d823d8\_20251111\_15  
4407\_360.jpg, 00:01:47, 35.30 m  
Joint displaced, medium

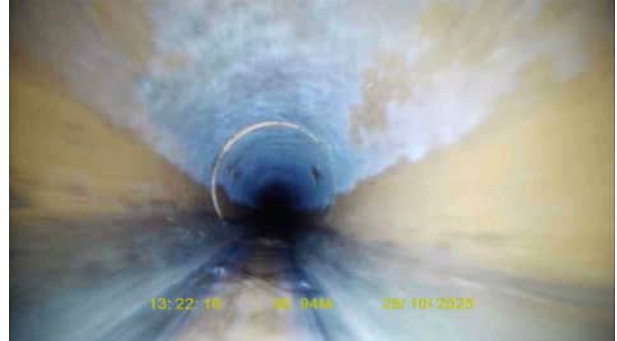
F5X\_4f78a5c3-e6c6-4d3a-b391-cc41a5f31005\_20251111\_15  
5138\_101.jpg, 00:03:54, 37.00 m  
Joint displaced, medium

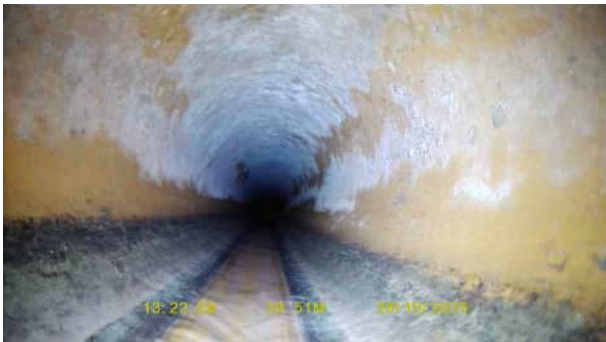
F5X\_bf9c670c-df98-4406-b0ae-73b764d32fc0\_20251112\_090  
243\_777.jpg, 00:04:07, 39.42 m  
Survey abandoned, Traction

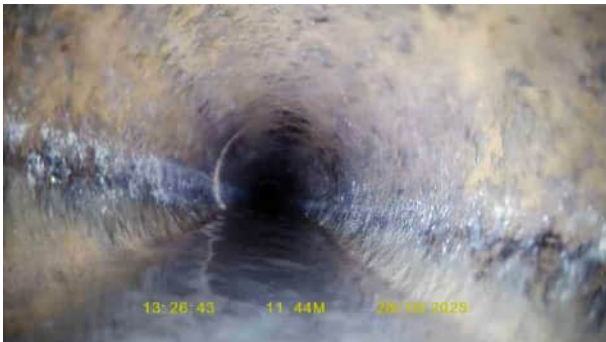
FW10X\_db7cfa2-fd05-44a5-9589-2edd2dbbb439\_20251112\_095209\_492.jpg, 00:00:47, 11.50 m  
Joint displaced, medium

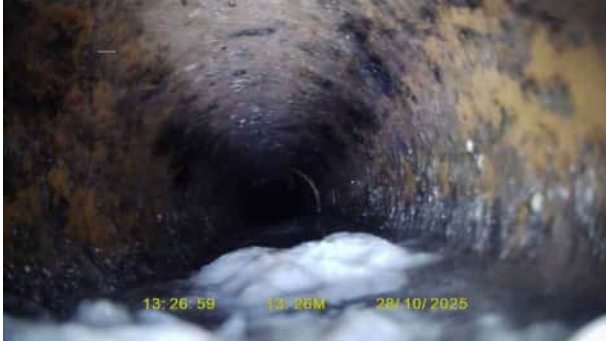
FW10X\_895e0a00-141f-4287-92d8-25938a8ac141\_20251112\_100631\_338.jpg, 00:01:03, 14.00 m  
Joint displaced, medium

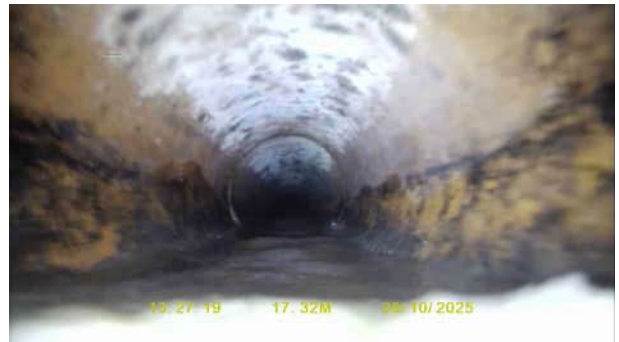
FW10X\_81088a87-189d-4eeb-b334-c13ca4e55463\_20251112\_101705\_448.jpg, 00:01:23, 17.60 m  
Joint displaced, medium

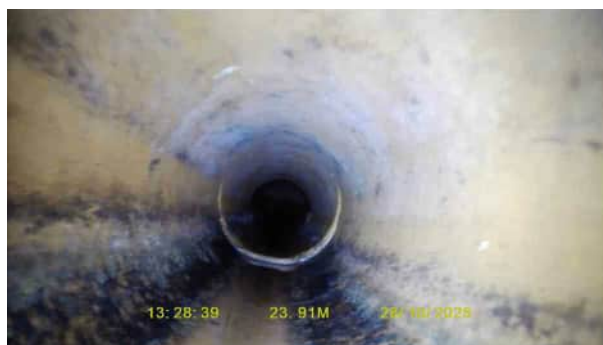
FW10X\_2adfbab0-1aa4-4164-9016-1c85cfea51b3\_20251112\_103340\_900.jpg, 00:02:43, 24.10 m  
Joint displaced, medium

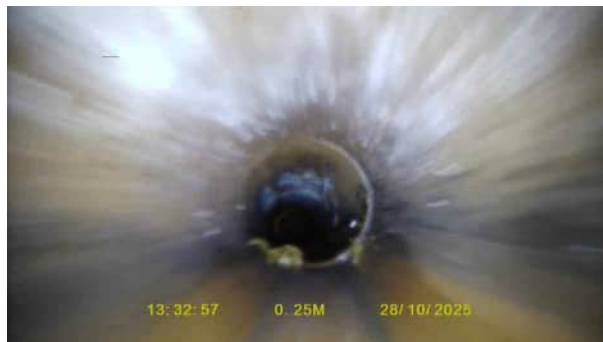
FW5X\_26907e93-da37-43a8-b343-da660b5443da\_20251112\_104058\_307.jpg, 00:00:02, 0.50 m  
Joint displaced, medium

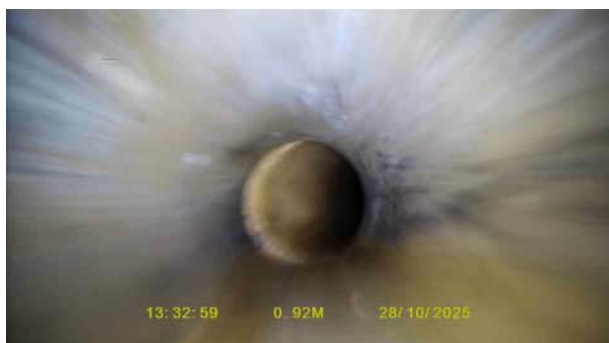
FW5X\_c14c5f38-df04-489c-bb58-9c5b14575b02\_20251112\_104120\_606.jpg, 00:00:04, 1.00 m  
Joint displaced, large

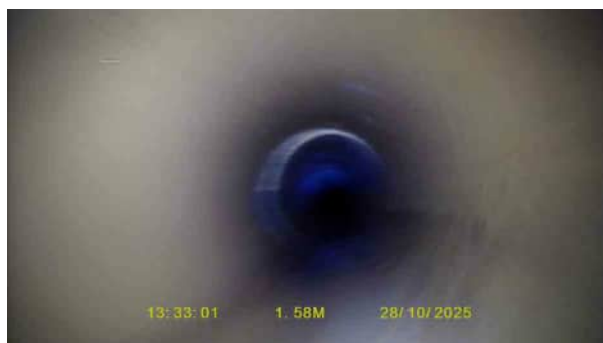
FW5X\_d3886a20-5566-4197-b158-1086b139d2d7\_20251112\_104200\_300.jpg, 00:00:06, 1.90 m  
Joint displaced, medium

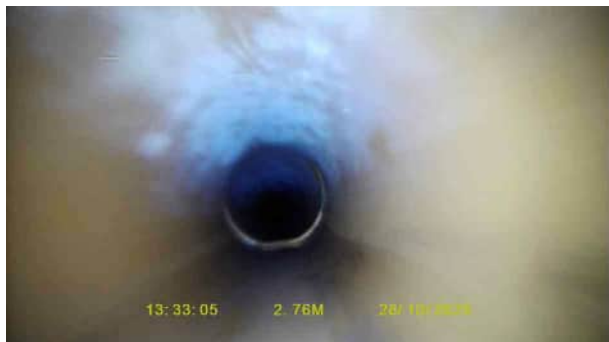
FW5X\_9053817d-fad6-48c5-b896-a1d56bd0ecf9\_20251112\_104229\_971.jpg, 00:00:10, 3.20 m  
Joint displaced, medium

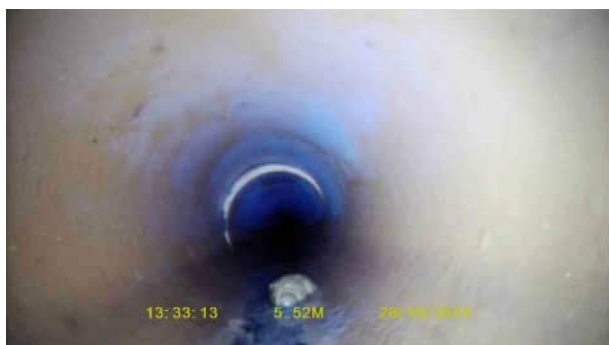
FW5X\_1629d8bf-9f25-4cea-9d51-af0238f9ded7\_20251112\_104334\_417.jpg, 00:00:18, 5.80 m  
Joint displaced, large

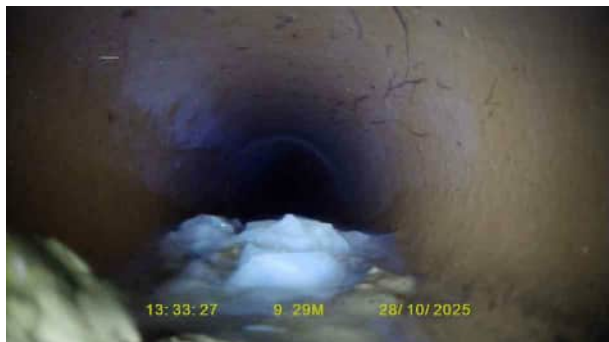
FW5X\_e68be286-3fb0-4a62-9ec8-9cdf7f42df51\_20251112\_104940\_946.jpg, 00:00:32, 9.50 m  
Joint displaced, medium

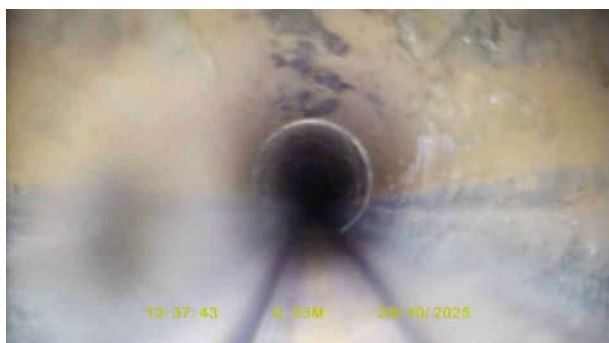
FW3X\_d94fc0fa-2b98-4d40-8bcb-c1e5c83bc869\_20251112\_113714\_025.jpg, 00:00:04, 0.80 m  
Joint displaced, medium

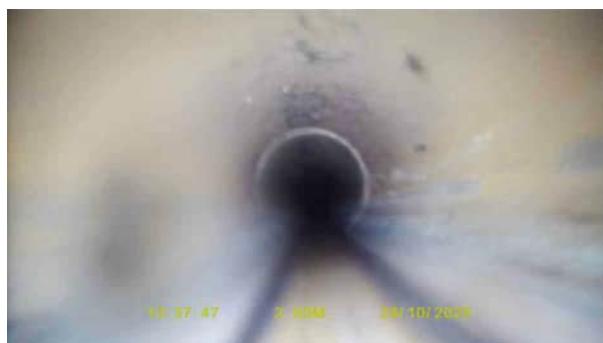
FW3X\_e6bc3317-0dc7-4658-ab6d-99b905ed7266\_20251112\_113822\_607.jpg, 00:00:08, 2.60 m  
Settled deposits, fine, 5% cross-sectional area loss, finish

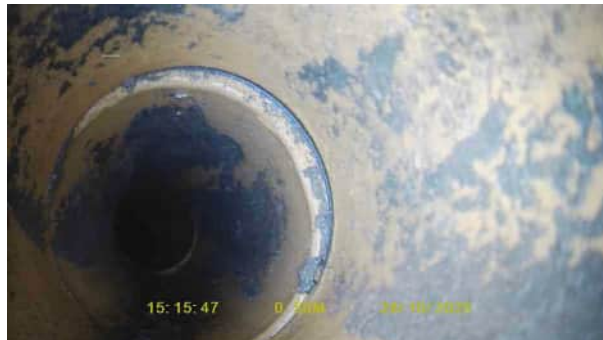
F12X\_1414158c-9cc2-454c-81ca-7f4db72234b7\_20251120\_084949\_077.jpg, 00:00:10, 0.60 m  
Joint displaced, large

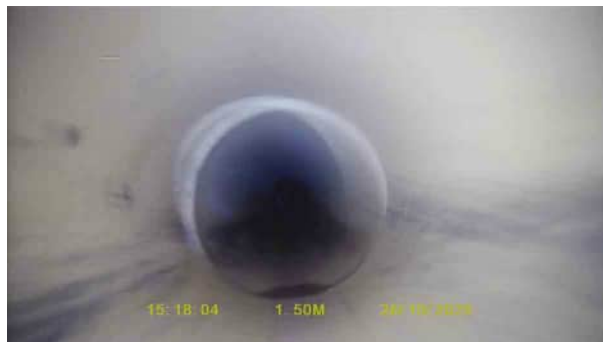
F17X\_e672bf31-b12a-43ec-853c-c1446073dc43\_20251120\_085721\_547.jpg, 00:00:58, 1.80 m  
Joint displaced, medium

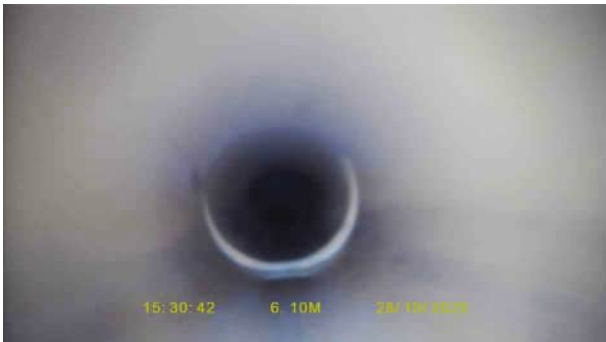
FW8X\_678862db-929b-46e8-b434-01713861fd8f\_20251120\_091429\_518.jpg, 00:00:20, 6.35 m  
Joint displaced, medium

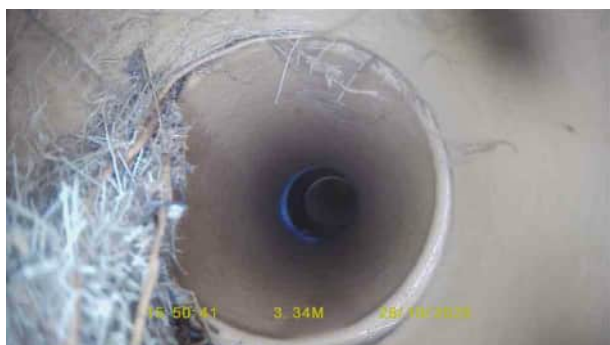
F16X\_ca098908-7440-4f91-bfb8-af5343603fbc\_20251120\_094917\_659.jpg, 00:00:17, 3.35 m  
Roots, mass at joint, 15% cross-sectional area loss

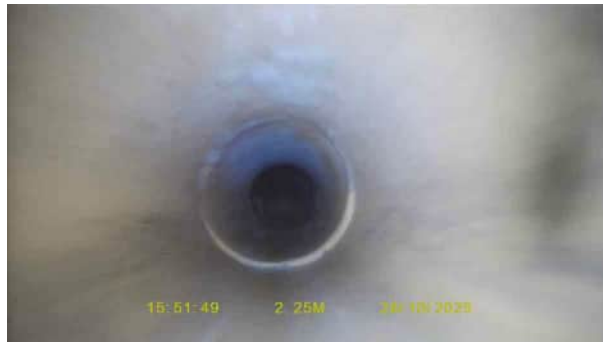
FW9X\_99a7e607-1d8d-4e43-a25e-42f48c057b03\_20251120\_095504\_821.jpg, 00:00:11, 2.50 m  
Joint displaced, medium

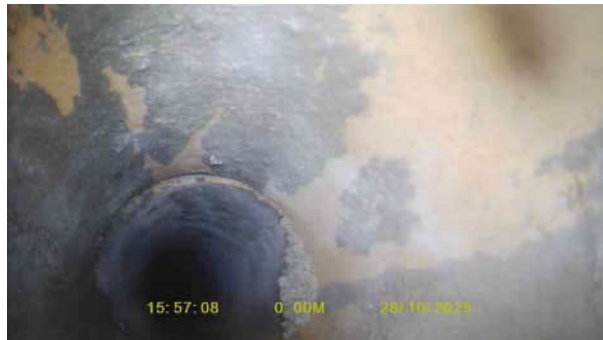
F18X\_71e8331f-eacb-4d38-967e-dfb9aac1f9a7\_20251120\_095755\_996.jpg, 00:00:00, 0.15 m  
Joint displaced, medium

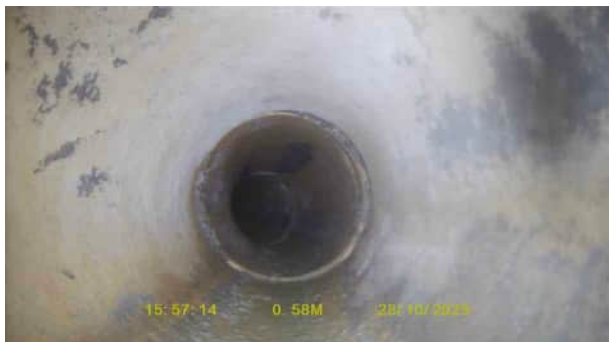
F18X\_c7e4496d-2752-4866-8a41-ee8af329f7dc\_20251120\_095819\_872.jpg, 00:00:06, 1.30 m  
Joint displaced, medium

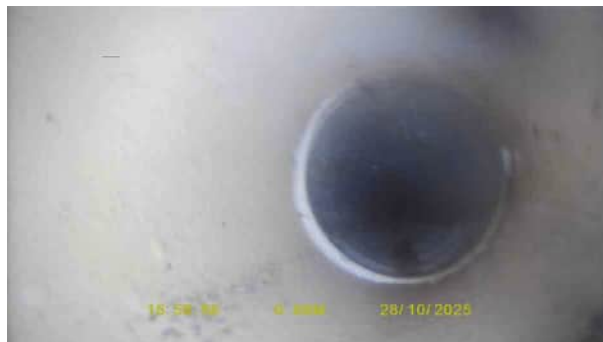
F19X\_6afdfd43-a8e3-4970-9bdb-038c5f50a752\_20251120\_101332\_001.jpg, 00:00:04, 0.40 m  
Joint displaced, medium

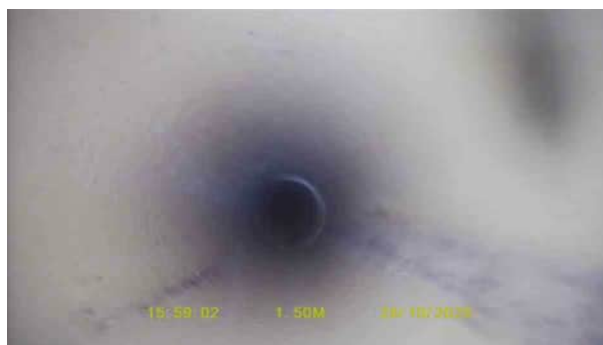
F19X\_350fa825-05e1-4b2b-bbbd-cd063b224118\_20251120\_101422\_908.jpg, 00:00:08, 2.20 m  
Joint displaced, medium

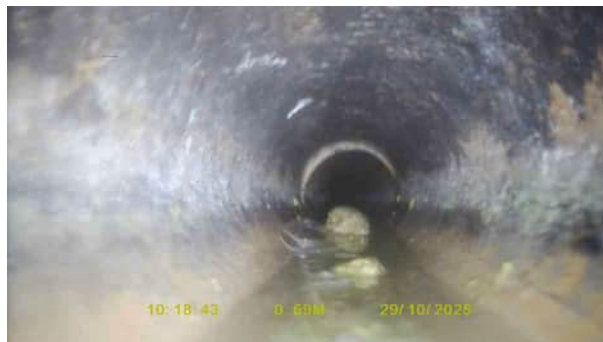
FW11X\_233712f4-b549-4f77-92a5-c976eede4891\_20251120\_113830\_811.jpg, 00:00:05, 1.16 m  
Joint displaced, medium

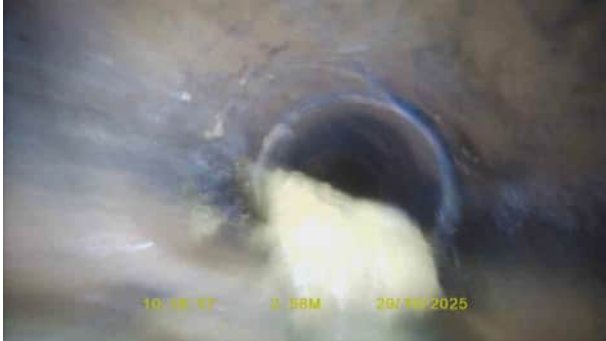
FW11X\_26d85041-8c72-4dde-a82d-4ce203946c4a\_20251120\_114026\_559.jpg, 00:00:18, 2.60 m  
Joint displaced, large

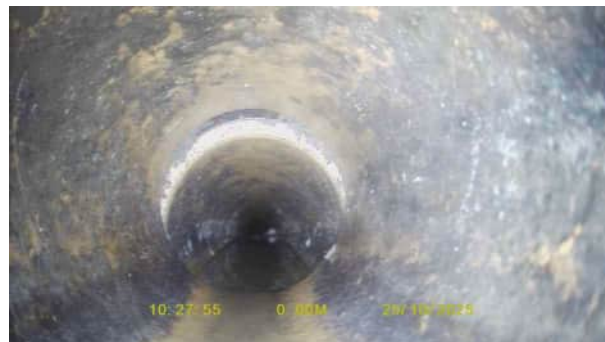
FW13X\_ab5e0ca1-c957-4deb-96ab-785ed34d6408\_20251120\_114927\_807.jpg, 00:00:00, 0.60 m  
Joint displaced, large

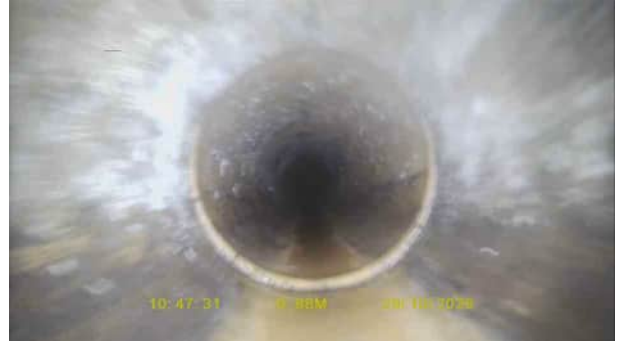
FW13X\_3edb8a71-4c39-4554-9429-70adf5819015\_20251120\_123654\_775.jpg, 00:00:04, 0.90 m  
Joint displaced, medium

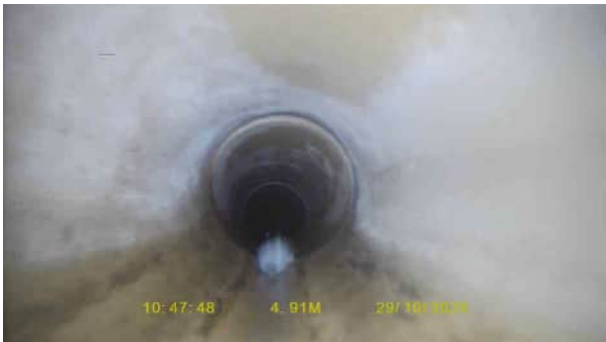
FW13X\_60e47147-1baf-41fa-8881-d245d2a19dcf\_20251120\_123723\_383.jpg, 00:00:21, 5.17 m  
Joint displaced, large

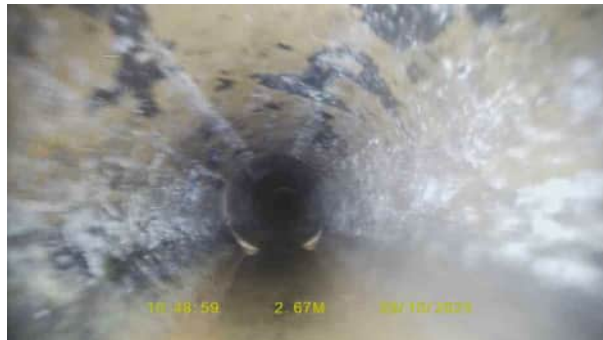
FW12AX\_4bd3fe5a-ad99-4f7d-aa8f-49db1b421f49\_20251120\_124011\_429.jpg, 00:00:14, 3.20 m  
Joint displaced, medium

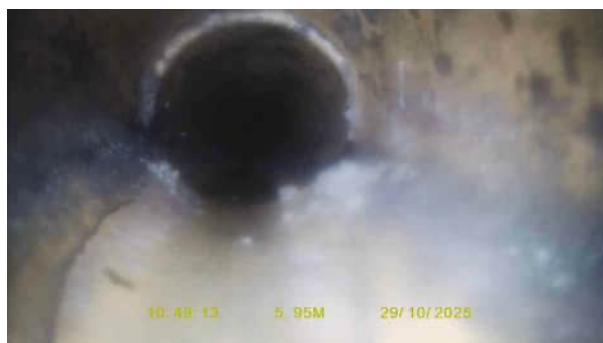
FW12AX\_38cf8bb1-48c1-46a1-8f4c-39dde8b70faf\_20251120\_124045\_174.jpg, 00:00:28, 6.20 m  
Joint displaced, medium

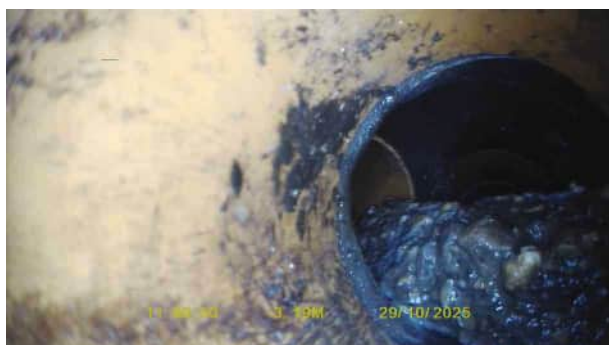
F26X\_96c58a51-cfb6-4bba-8549-2484045e34fa\_20251120\_132918\_009.jpg, 00:00:17, 3.20 m  
Survey abandoned, Silt

For removal of silt, I recommend using a jet vac tanker where access allows, this can be carried out by EDI via quote request.

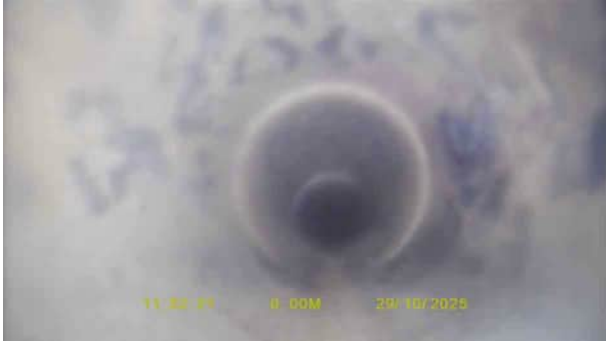
F28X\_bb191c79-a988-4738-b69f-8a408ab3b77d\_20251120\_133952\_183.jpg, 00:00:00, 0.00 m  
Start node, inspection chamber, reference: FW14

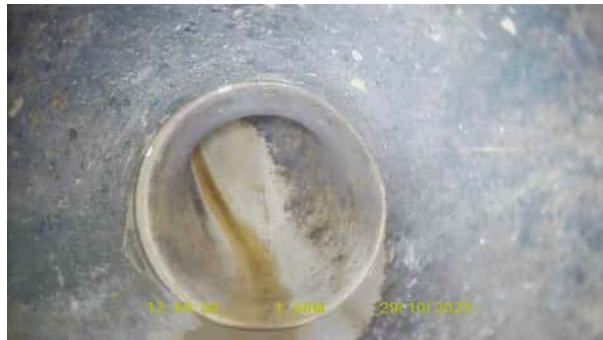
F29X\_c6789ac2-5bf9-43df-aa9f-c744bd57e938\_20251120\_14  
2254\_962.jpg, 00:00:14, 2.10 m  
Finish node, other special chamber, reference: F29, WP

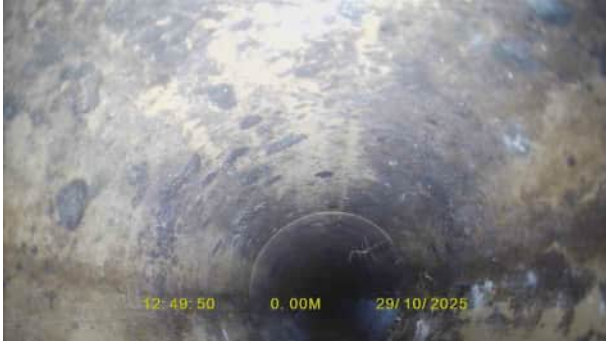
F30X\_2214ed51-15aa-4e46-aab5-35143f1f0843\_20251120\_142439\_476.jpg, 00:00:00, 0.00 m  
Start node, inspection chamber, reference: FW15

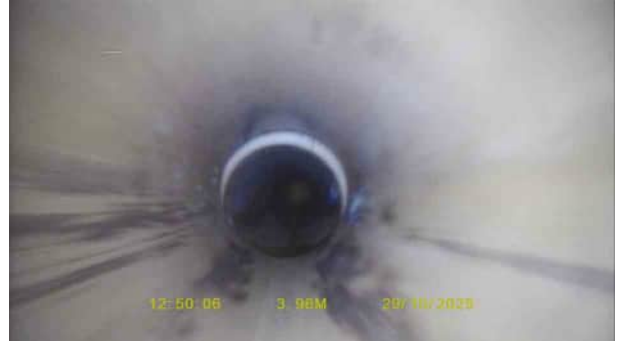
F30X\_25466a79-dbe6-4cfb-8afa-e0c51efdd0e6\_20251120\_142507\_728.jpg, 00:00:17, 4.40 m  
Joint displaced, large

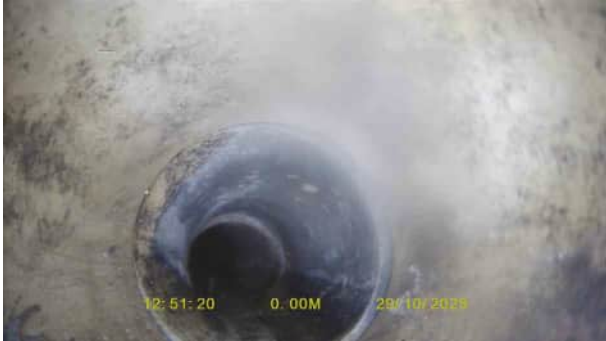
FW15X\_842db7ba-f857-4f86-9676-71779cf196c2\_20251120\_142648\_489.jpg, 00:00:00, 0.00 m  
Start node, inspection chamber, reference: FW15

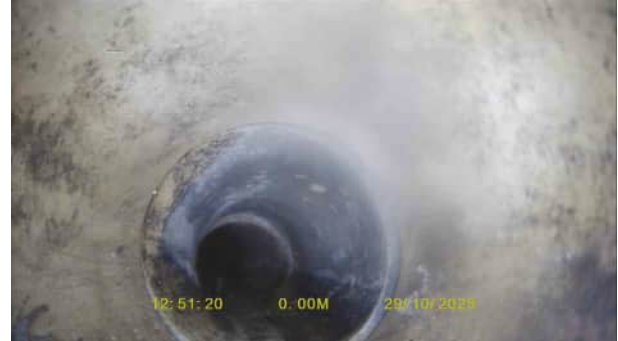
FW15X\_ec53d5a4-d240-470e-b5b4-b19574d2842b\_20251120\_142707\_026.jpg, 00:00:00, 0.10 m  
Joint displaced, medium

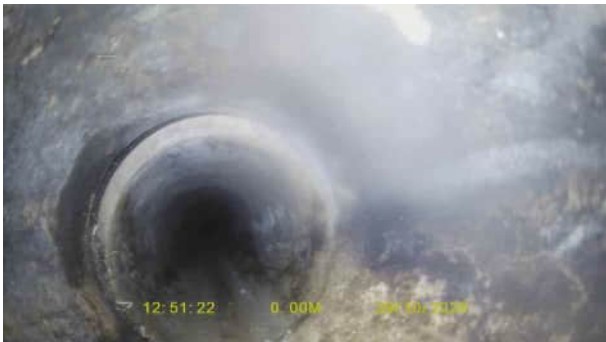
FW15X\_c47f3519-2aef-4f58-b566-75b58edba86\_20251120\_142717\_261.jpg, 00:00:02, 0.30 m  
Joint displaced, medium

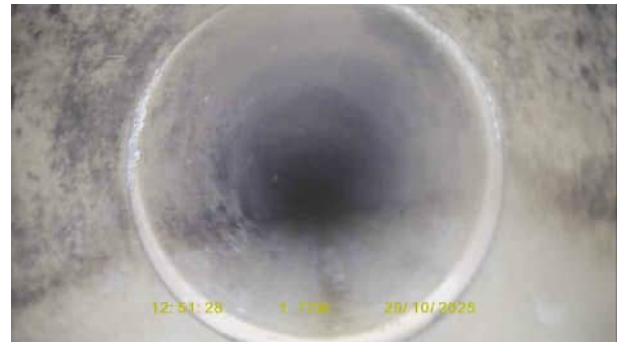
FW15X\_5751b8b2-d548-4040-93d6-f1d89f78612b\_20251120\_142745\_986.jpg, 00:00:08, 1.81 m  
Joint displaced, medium

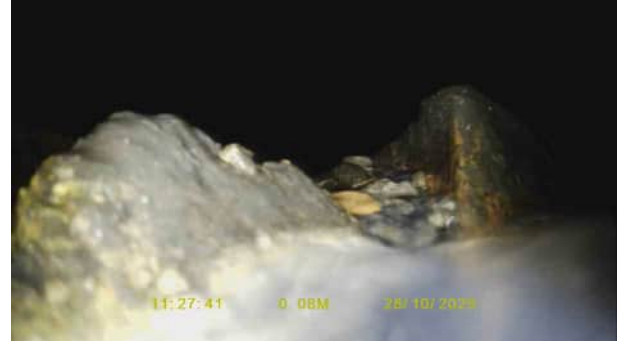
S1X\_f9988cf4-086b-4b6f-a43a-42ab54f98484\_20251105\_145615\_735.jpg, 00:00:03, 0.25 m  
Other obstacles, brick or masonry in invert from 5 o'clock to 7 o'clock, 30% cross-sectional area loss

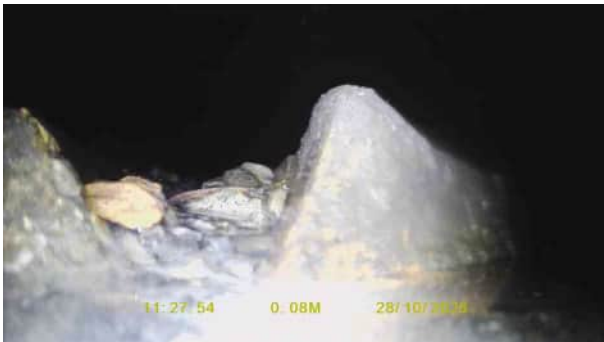
S1X\_ccb87a47-8972-4be7-bc84-d2fdd4963a08\_20251105\_145756\_969.jpg, 00:00:17, 0.25 m  
Survey abandoned, Debris

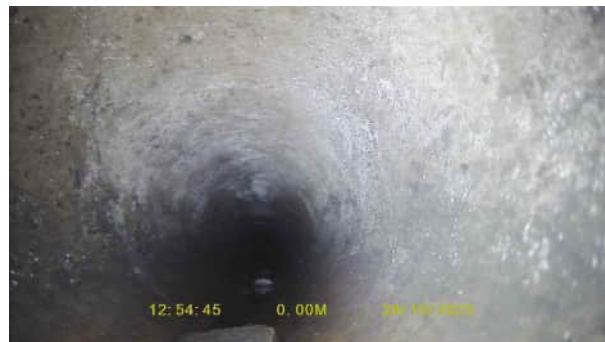
SW4X\_e6ad774e-b271-404a-9e09-c6d9f9d401b7\_20251105\_155337\_247.jpg, 00:00:01, 0.10 m  
Other obstacles, brick or masonry in invert at 6 o'clock, 5% cross-sectional area loss

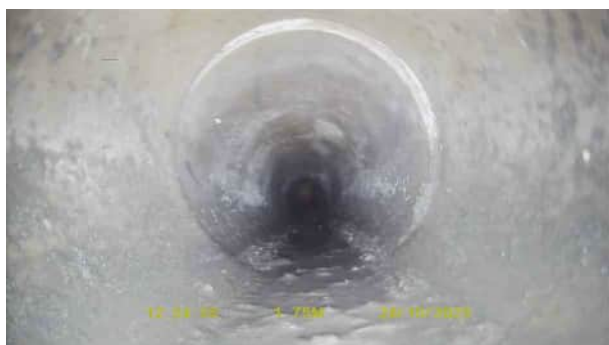
SW4X\_93ebfe04-d637-4380-8188-10eb1cf44634\_20251105\_155848\_749.jpg, 00:00:11, 1.80 m  
Joint displaced, medium

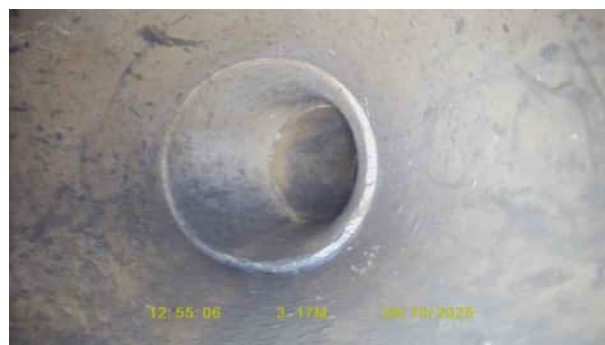
SW4X\_3e585ab9-7d0f-44ea-9d1d-10f6a8a65c99\_20251105\_160023\_596.jpg, 00:00:22, 3.30 m  
Joint displaced, medium

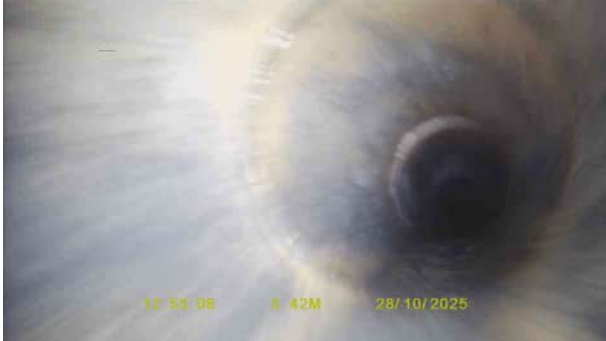
SW4X\_ac15fd9d-b3cb-408d-9338-c22110519835\_20251105\_160126\_610.jpg, 00:00:24, 3.40 m  
Joint displaced, medium

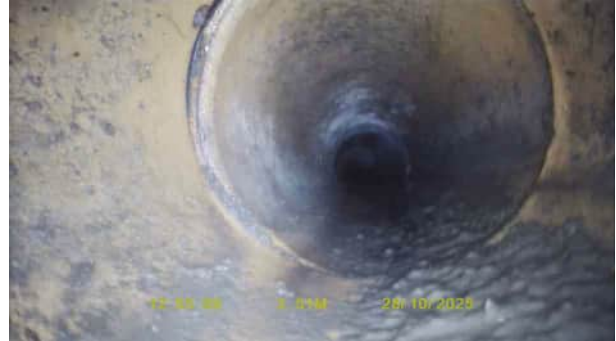
SW4X\_0bff2009-5ac1-4039-917c-d5662af05af0\_20251105\_160209\_044.jpg, 00:00:25, 3.80 m  
Joint displaced, large

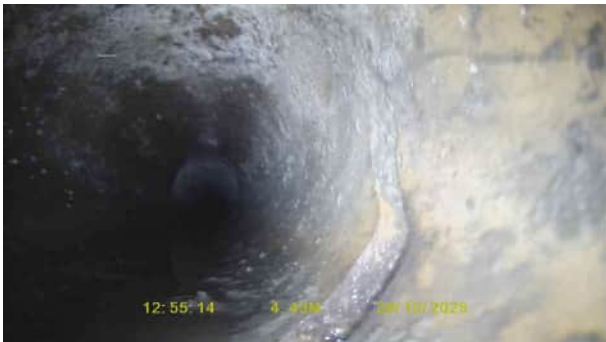
SW4X\_fac33b99-32e3-441c-af58-b6fa2db43352\_20251120\_075201\_800.jpg, 00:00:31, 4.45 m  
Joint displaced, large

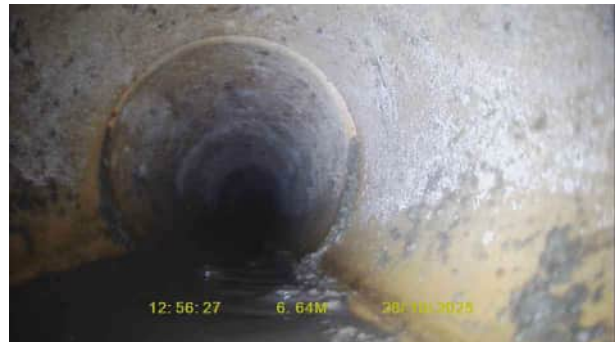
SW4X\_344ace52-f5a3-4b4e-a2e0-49438cc7dd4b\_20251105\_160948\_443.jpg, 00:01:43, 6.80 m  
Joint displaced, medium

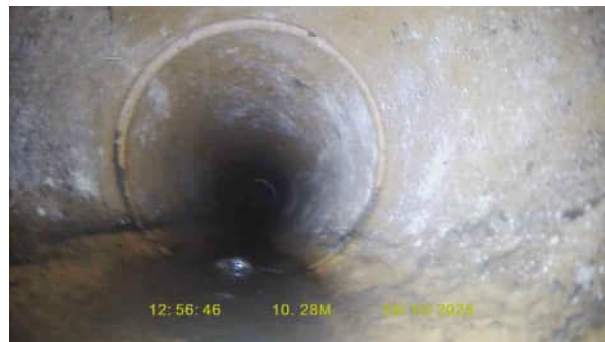
SW4X\_d7e1b6aa-48f1-4d97-9785-92e518df6c6a\_20251105\_161238\_563.jpg, 00:02:02, 10.20 m  
Joint displaced, medium

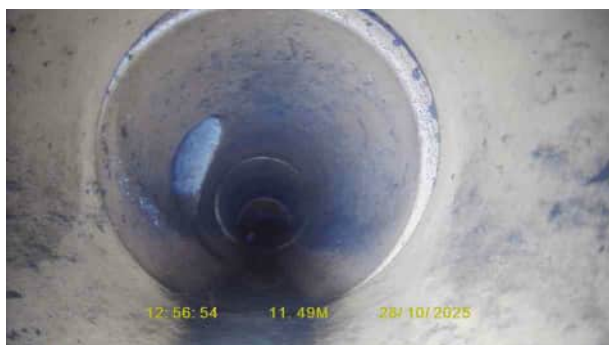
SW4X\_0384d613-8e0b-4560-8eaa-1ffee7734846\_20251105\_161316\_891.jpg, 00:02:10, 11.40 m  
Joint displaced, large

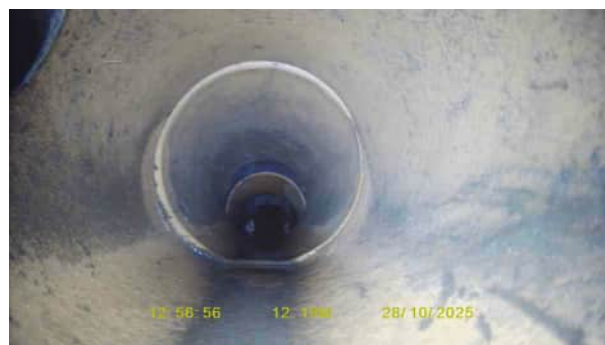
SW4X\_76ca052a-4878-4405-91c2-da6a748b62bf\_20251105\_161536\_485.jpg, 00:02:12, 12.30 m  
Joint displaced, medium

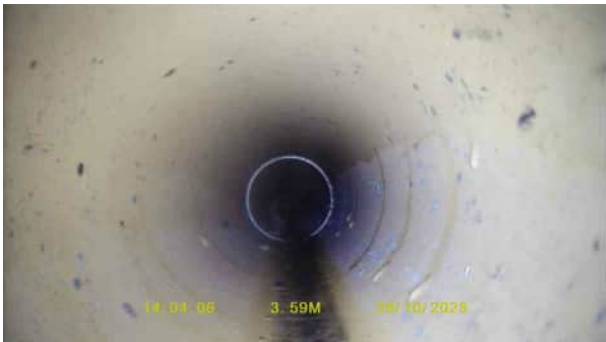
S4X\_9b052903-a3b1-4167-956a-5e1d06de5878\_20251112\_1  
21130\_284.jpg, 00:00:16, 4.00 m  
Joint displaced, medium

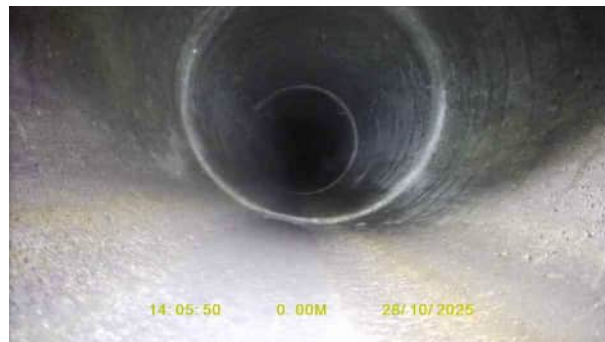
SW6X\_cf6c720b-8193-4c25-8249-174885ec6e19\_20251112\_125747\_867.jpg, 00:00:01, 0.20 m  
Joint displaced, medium

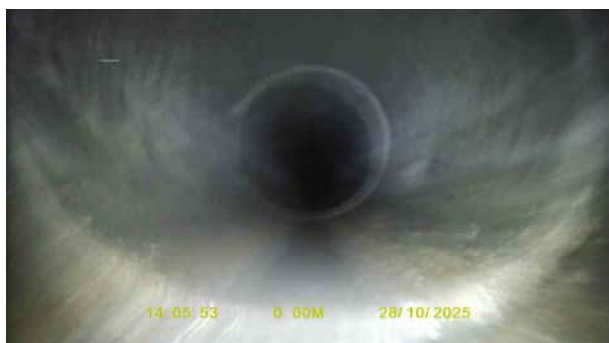
SW6X\_0dbe22f1-c6ad-4f60-8883-99275f9d9ee6\_20251112\_125843\_407.jpg, 00:00:03, 0.70 m  
Joint displaced, medium

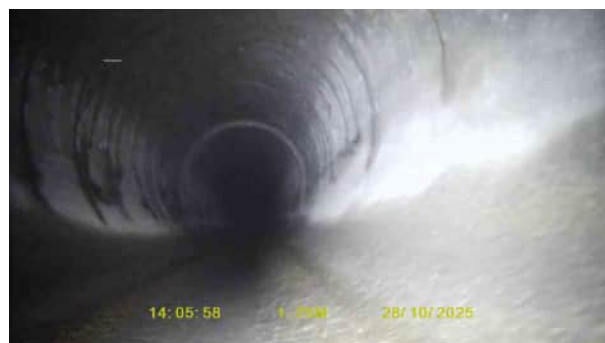
SW6X\_0364a2c1-1853-4d7a-90ea-fe45b66305ba\_20251112\_125949\_646.jpg, 00:00:08, 2.60 m  
Joint displaced, medium

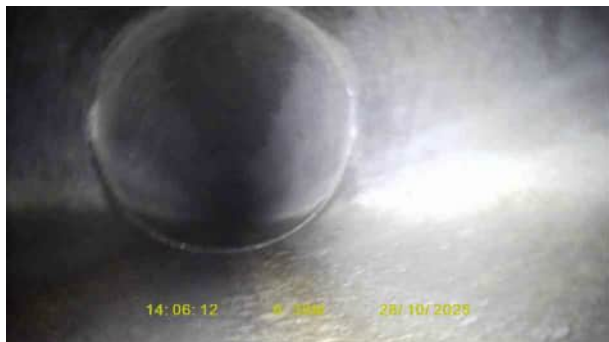
SW6X\_8156ae88-9333-4efd-bb9c-f8500dd038ac\_20251112\_130129\_689.jpg, 00:00:22, 6.70 m  
Joint displaced, medium

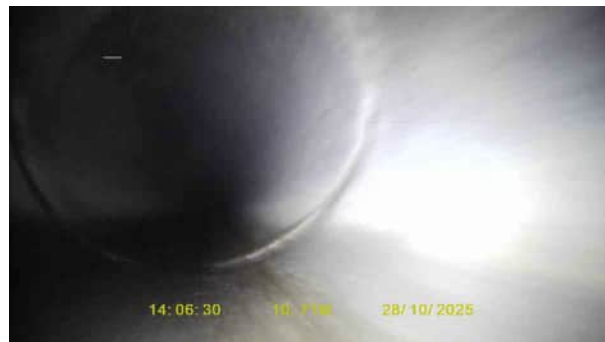
SW6X\_9809e080-7b3f-46eb-9453-336645aa06d1\_20251112\_130252\_993.jpg, 00:00:40, 11.00 m  
Joint displaced, medium

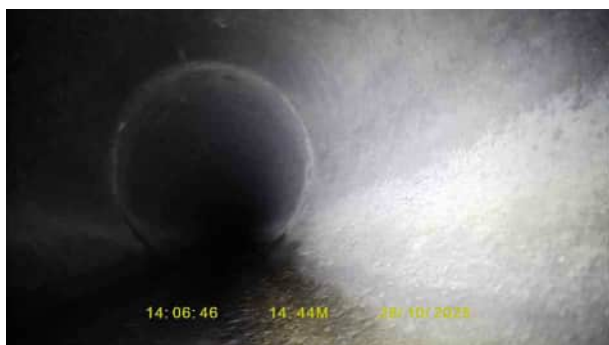
SW6X\_010c3b8e-ebd8-4f97-b7f4-cfd7704ee0b7\_20251112\_130710\_801.jpg, 00:00:57, 14.70 m  
Joint displaced, medium

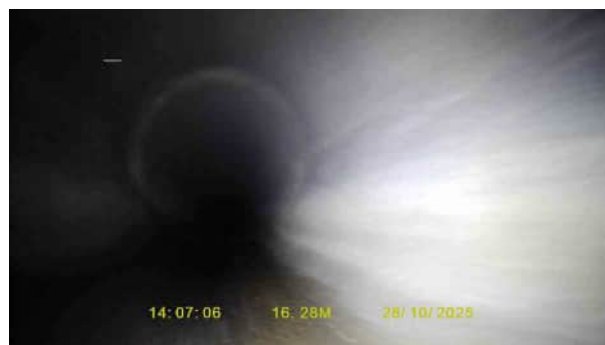
SW6X\_f108b99a-c7f9-4d56-80d3-ae6fcf5583d6\_20251112\_130822\_026.jpg, 00:01:17, 17.00 m  
Joint displaced, medium

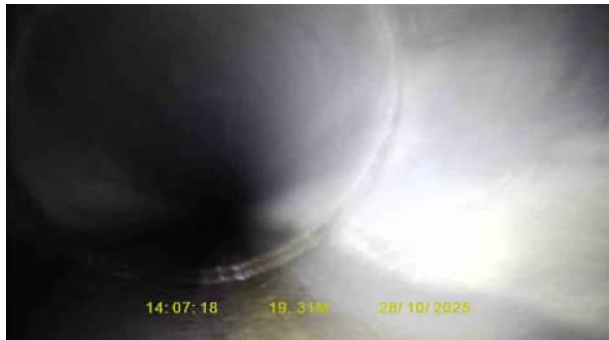
SW6X\_92c50ce9-9d5d-435c-8de1-50a8ed6cc66f\_20251112\_131701\_226.jpg, 00:01:28, 19.30 m  
Joint displaced, medium
