## GOMERSAL ST MARYS PRIMARY SCHOOL

### Sustainable Drainage Strategy

Hexa ref: SRP1134-HEX-XX-XX-T-C-0001

Revision: P02

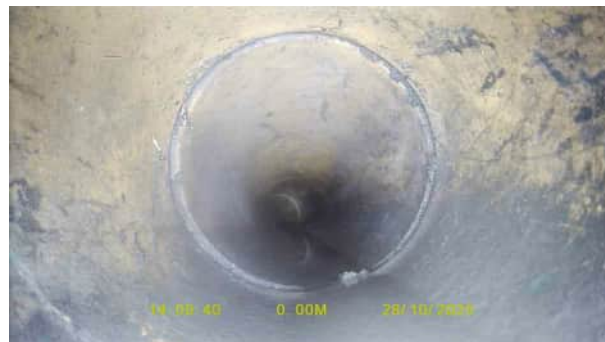
SW7X\_a791ce40-ffb1-4423-b40c-b3869c745efc\_20251112\_1  
32819\_891.jpg, 00:00:00, 0.20 m  
Joint displaced, medium

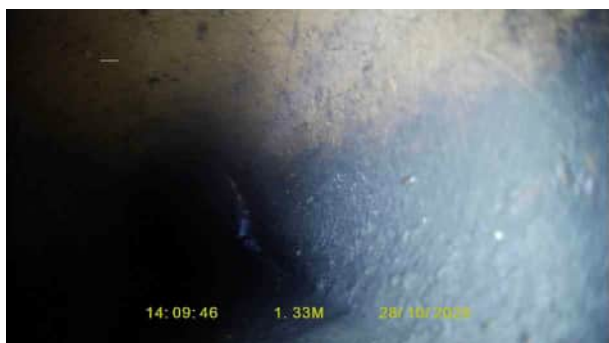
SW7X\_8cde98ef-dcf8-43ac-b0e6-0aa8b5c4d3ea\_20251112\_1  
144724\_058.jpg, 00:00:06, 1.80 m  
Joint displaced, large

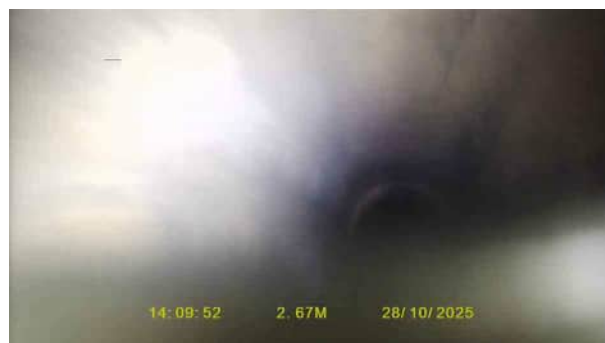
SW7X\_4fc16604-51e6-4740-b5f3-8dba510fab5d\_20251112\_1  
44910\_050.jpg, 00:00:13, 3.10 m  
Joint displaced, medium

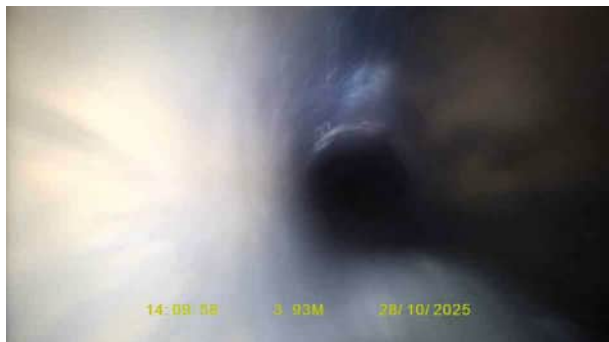
SW7X\_ddec846a-44d6-42c7-b6b0-1c121ad126d2\_20251112\_145057\_336.jpg, 00:00:18, 4.40 m  
Joint displaced, medium

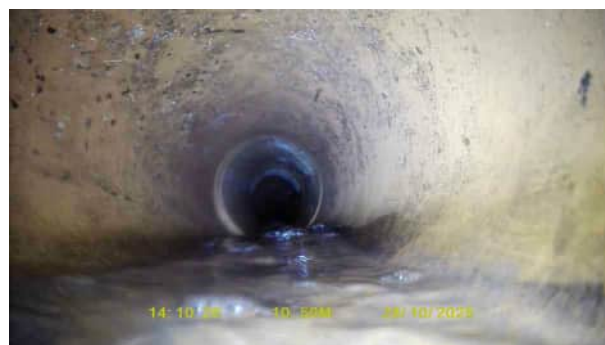
SW7X\_2c5e743a-e503-4b7b-9c62-5ce043e88d00\_20251112\_153020\_408.jpg, 00:00:47, 10.90 m  
Joint displaced, large

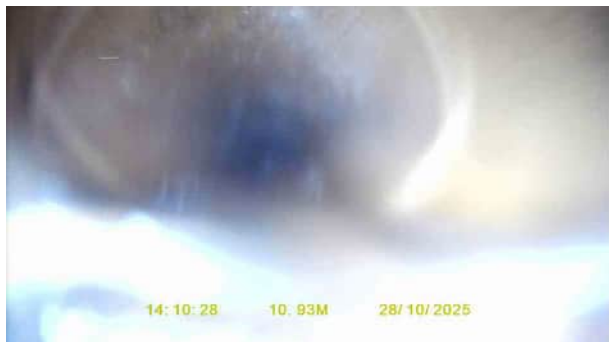
SW7X\_e8edcfe6-8ef0-4902-81ae-3bac1123c90b\_20251112\_153137\_115.jpg, 00:00:49, 11.50 m  
Joint displaced, medium

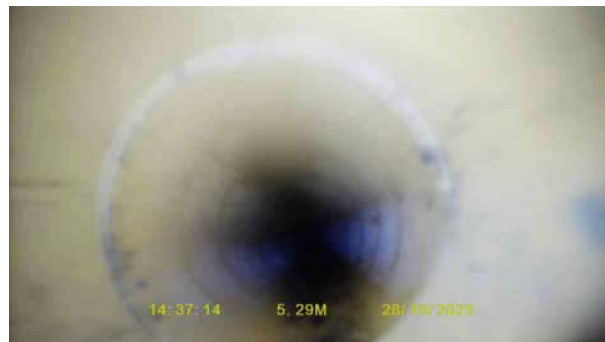
SW5X\_692a298b-7fe1-42d5-bdc9-f98913986d22\_20251113\_090120\_904.jpg, 00:00:54, 5.40 m  
Joint displaced, medium

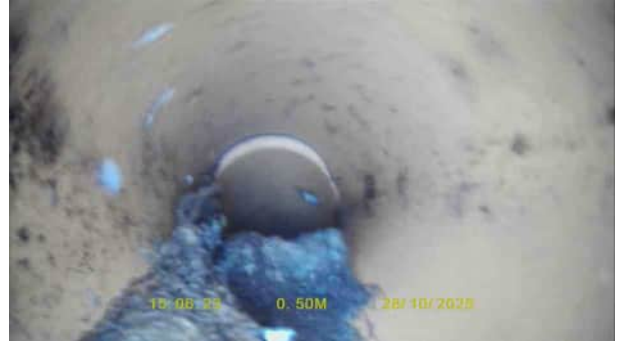
S9X\_51322b8a-ae6d-43bd-9632-2d49537fac94\_20251120\_082840\_553.jpg, 00:00:09, 0.60 m  
Joint displaced, medium

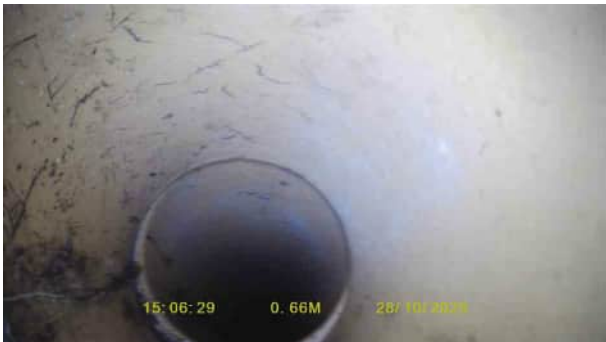
S9X\_cac218d6-5050-4ac9-95ae-9cfbb463f60c\_20251120\_082837\_710.jpg, 00:00:14, 0.80 m  
Joint displaced, medium

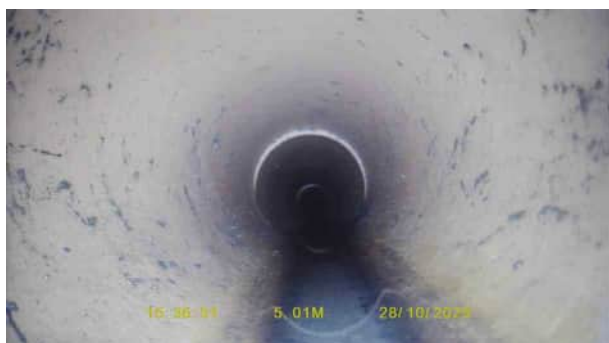
SW12X\_3930fb8c-112a-4c4a-978d-c214271d1fcf\_20251120\_092927\_788.jpg, 00:00:25, 5.25 m  
Joint displaced, medium

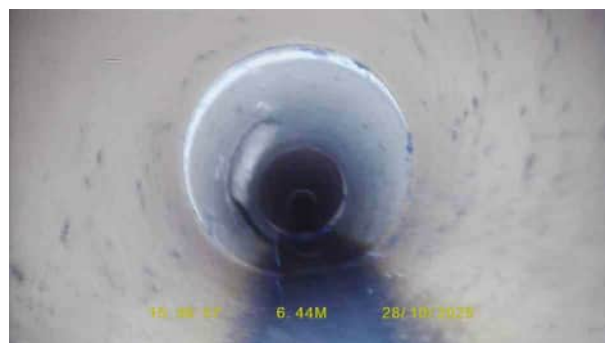
SW12X\_bd5a758e-b7a6-44c0-a9df-91213b054292\_20251120\_092950\_452.jpg, 00:00:31, 6.80 m  
Joint displaced, large

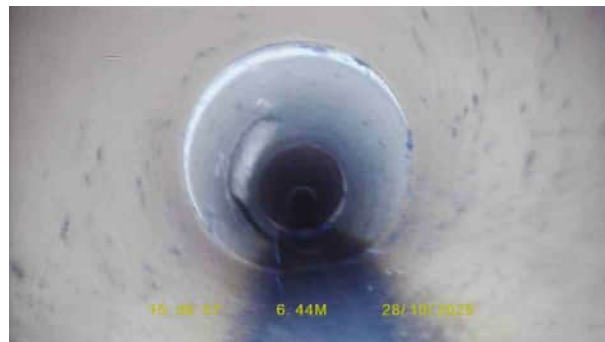
SW12X\_708f9320-0168-4373-bc60-1342c6975554\_20251120\_093025\_331.jpg, 00:00:31, 7.30 m  
Joint displaced, medium

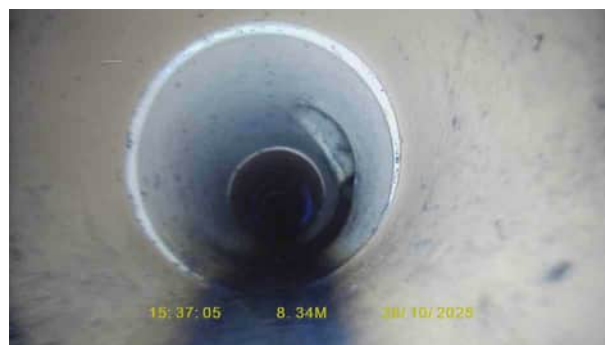
SW12X\_5227fff9-69f8-4cdc-843a-ac71f5b850f6\_20251120\_093106\_165.jpg, 00:00:38, 8.90 m  
Joint displaced, medium

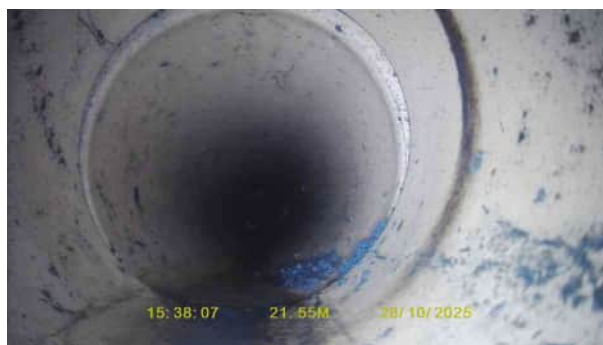
SW12X\_a758d0b9-8bcb-4146-9748-1725cf15742c\_20251120\_093303\_228.jpg, 00:01:41, 21.70 m  
Joint displaced, large

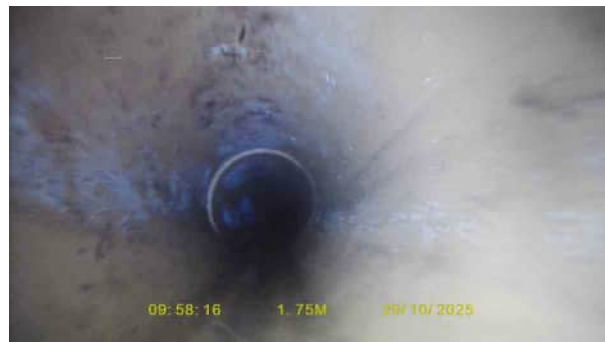
SW8X\_7c4436a6-c99b-4f92-9f0b-8304691609a5\_20251120\_110306\_556.jpg, 00:00:06, 2.40 m  
Joint displaced, medium

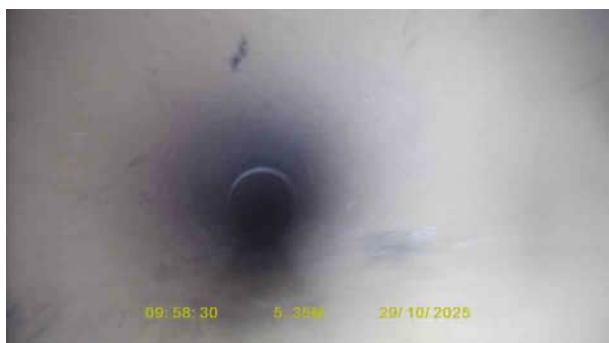
SW8X\_9f9d6bec-d13b-491e-9f74-bff07f54fa4e\_20251120\_110401\_438.jpg, 00:00:21, 6.10 m  
Joint displaced, medium

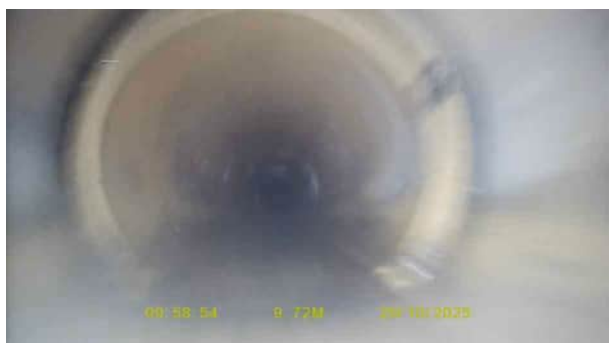
SW8X\_afbda8f2-88bc-4c1a-889e-648277c45fe1\_20251120\_110621\_345.jpg, 00:00:45, 10.15 m  
Joint displaced, medium

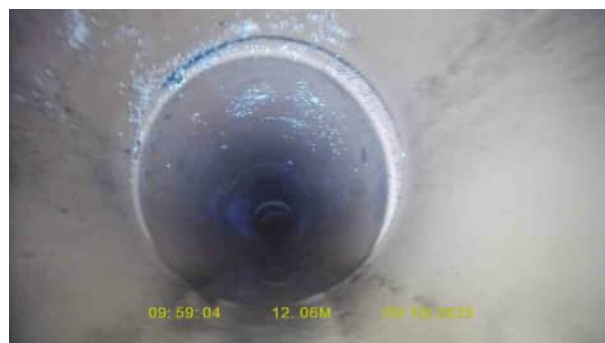
SW8X\_6b7aa3e6-624d-43c7-a01f-2c84c24d9417\_20251120\_111340\_944.jpg, 00:00:54, 12.40 m  
Joint displaced, medium

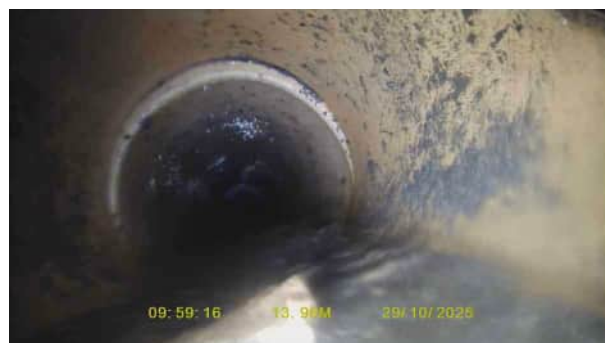
SW8X\_48ac1778-fd06-46a2-8c1f-0e6059bf6c79\_20251120\_12056\_486.jpg, 00:01:07, 14.25 m  
Joint displaced, medium

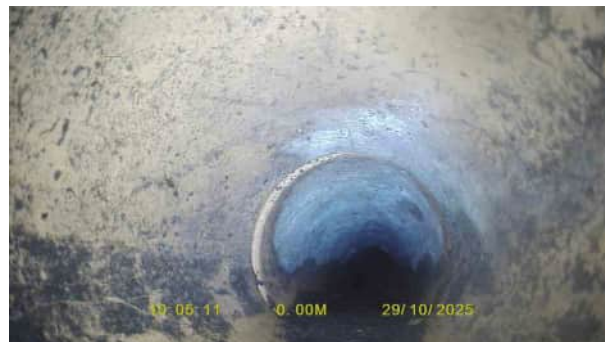
S15X\_3a5e1c1c-1ba4-4a48-b102-4824188774b1\_20251120\_1  
112808\_203.jpg, 00:00:00, 0.30 m  
Joint displaced, medium

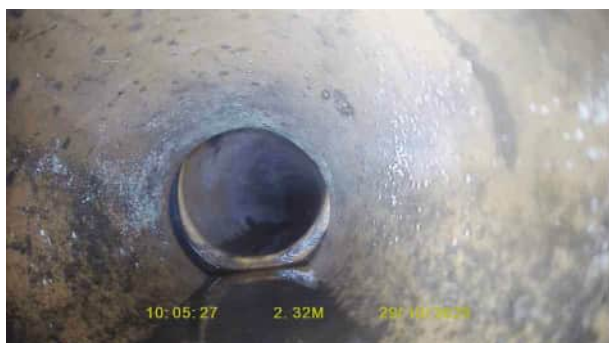
S15X\_55d7f610-1805-4625-aa96-faa487de34b9\_20251120\_1  
12929\_534.jpg, 00:00:17, 2.85 m  
Joint displaced, large

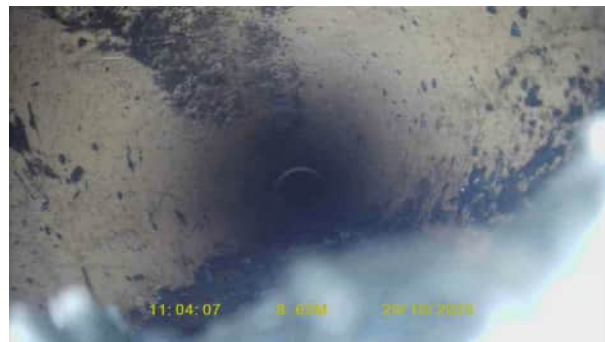
S17X\_334b8896-3de8-4452-9fb8-f5e9f4b0ef82\_20251120\_12  
5152\_380.jpg, 00:00:45, 8.65 m  
Survey abandoned, Silt

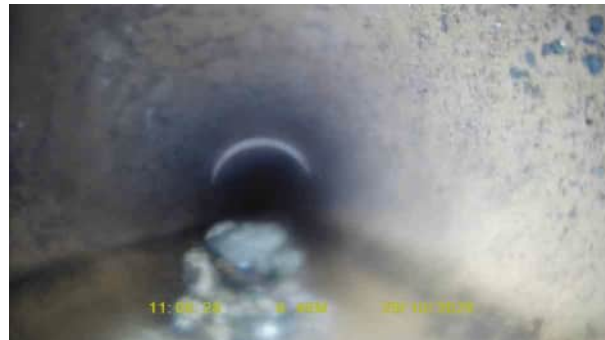
SW11X\_a4ce1147-b739-468c-8bb1-2dba0af452e1\_20251120\_130353\_190.jpg, 00:00:45, 7.20 m  
Joint displaced, large

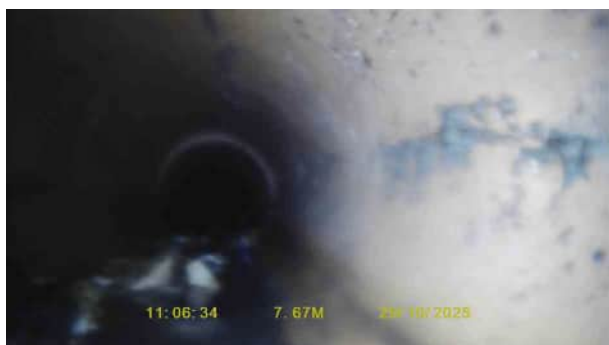
SW11X\_56da5348-cdd6-4006-96dd-fee3d40f985\_20251120\_130437\_224.jpg, 00:00:51, 8.35 m  
Joint displaced, medium

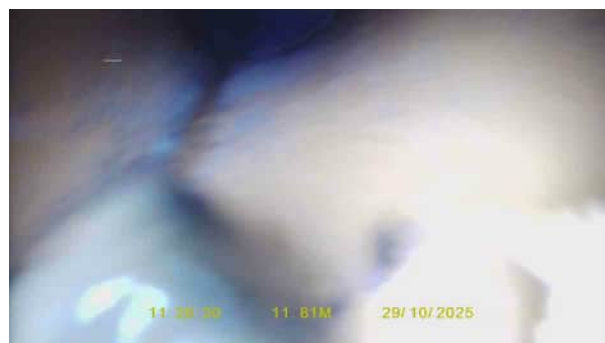
S22X\_b75231cb-4e39-4c12-ad52-8b74b5b91ed1\_20251120\_132257\_068.jpg, 00:00:55, 11.85 m  
Survey abandoned, Line rises unable to navigate
