# Site Investigation Report

## Overview

Auger were commissioned by Crawford & Co to undertake a site investigation and CCTV inspection of the underground drainage within the area of concern (AOC) at the property.

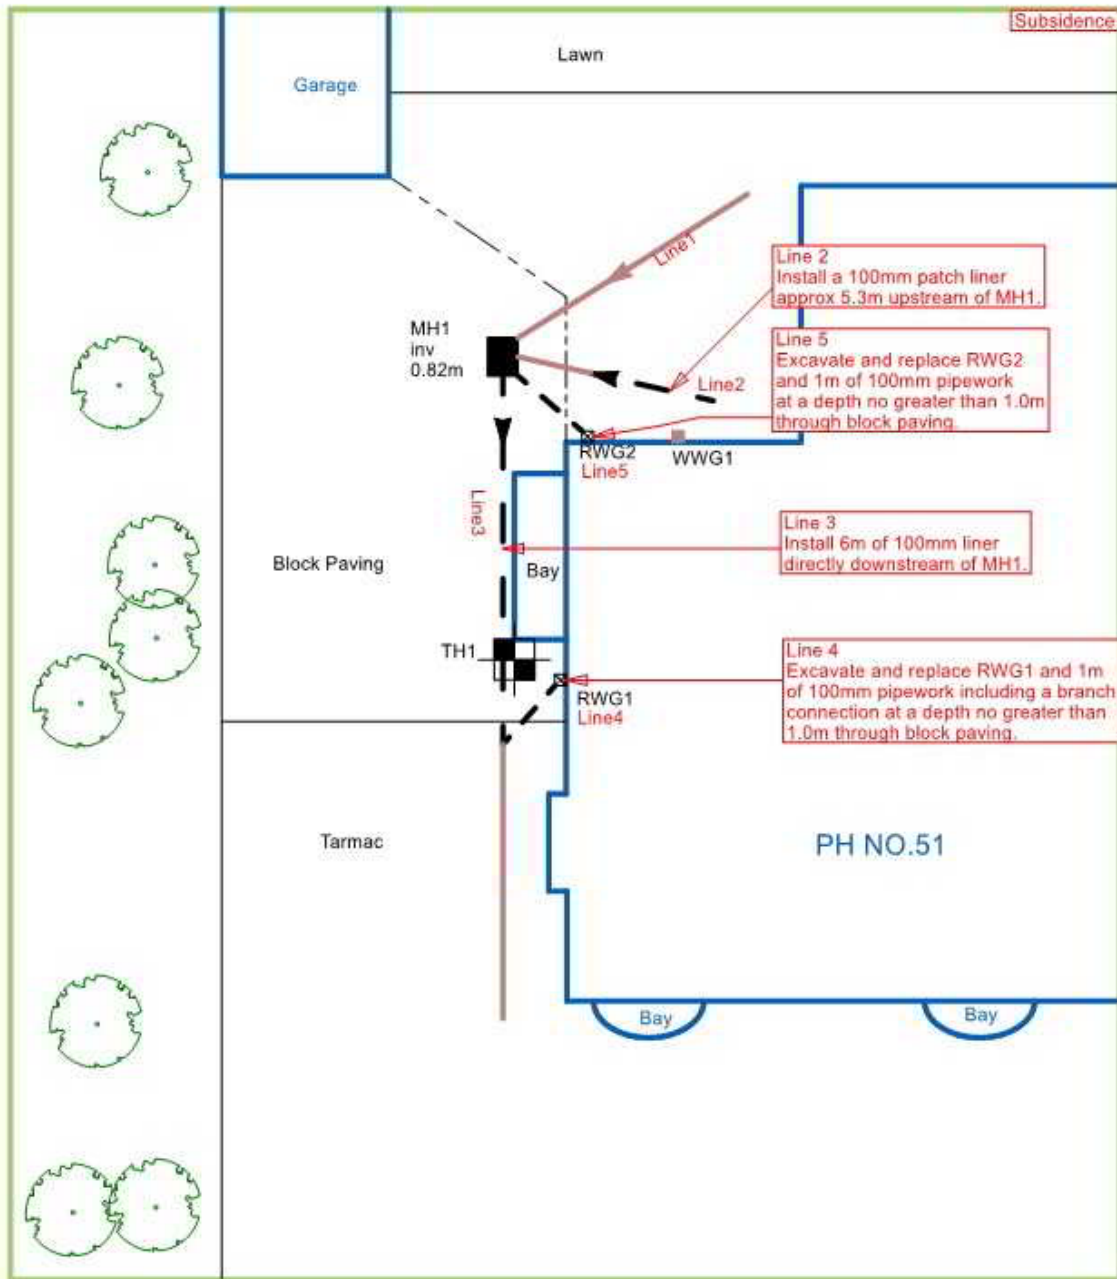
## FRONT OF PROPERTY

Our survey of line 2 revealed fractures.

Our survey of line 3 revealed root ingress, joint displacements and cracking.

Our survey of line 4 revealed joint displacements.

Our survey of line 5 revealed joint displacements.

Install a 100mm patch liner approximately 5.3m upstream of MH1.

Install 6m of 100mm liner directly downstream of MH1.

Excavate and replace RWG1 and 1m of 100mm pipework including a branch connection at a depth no greater than 1.0m through block paving.

Excavate and replace RWG2 and 1m of 100mm pipework at a depth no greater than 1.0m through block paving.
