## **STRUCTURAL CONDITION & DILAPIDATION REPORT**

**REF: MDL - 12499**

Retaining walls adjacent to highways that surround the property at:  
2 Elm Street, Skelmanthorpe, Huddersfield, HD8 9BH

To undertake a structural condition and dilapidation report of the existing retaining walls prior to construction works associated with the proposed alterations of the existing dwelling at 2 Elm Street, Skelmanthorpe, Huddersfield, HD8 9BH.

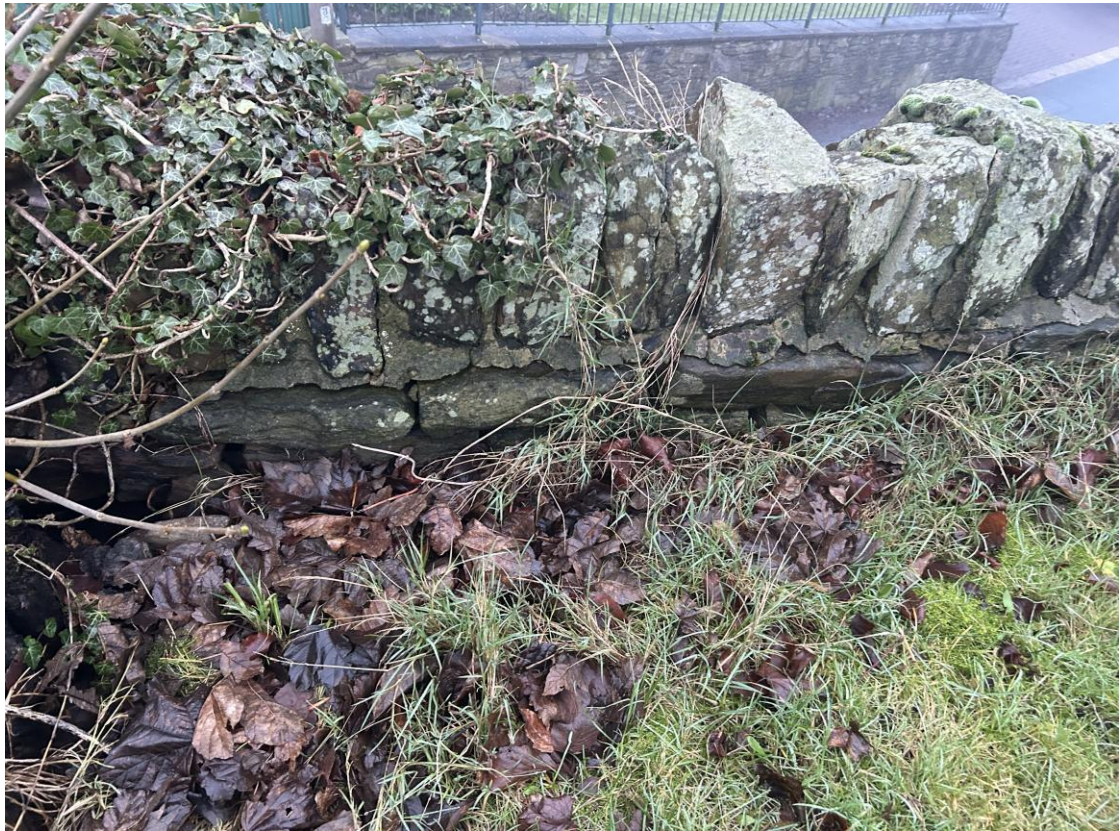
Photo B/R/1 – Wall B, Rear Face, ~CH 8.5m (Upper Parapet)

Inspection of the parapet wall adjacent to the public footpath appeared to be in a stable condition at the time of inspection, with no structural defects being observed.
