## Plot 23: Unresolved Waterproofing, Drainage and Lawfulness Issues

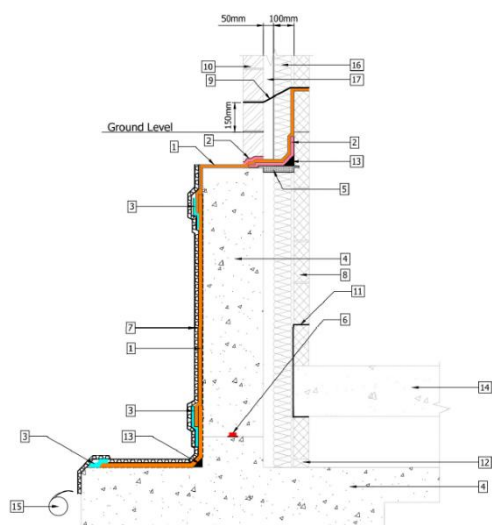
Documents disclosed by Kirklees under FOI reference 41699 include a detailed waterproofing arrangement incorporating a fully bonded waterproofing system on the external, earth-facing side of the concrete retaining wall.

Kirklees must establish whether this detail formed part of the approved planning documents, the Building Regulations submission or another technical specification applicable to Plot 23. The available photographic evidence nevertheless raises serious questions about whether the documented arrangement was followed.
