# LONG LANE, EARLSHEATON

## HIGHWAY CONDITION SURVEY REPORT

### WORDSWORTH PROPERTY DEVELOPMENTS LIMITED

Date: May 2026

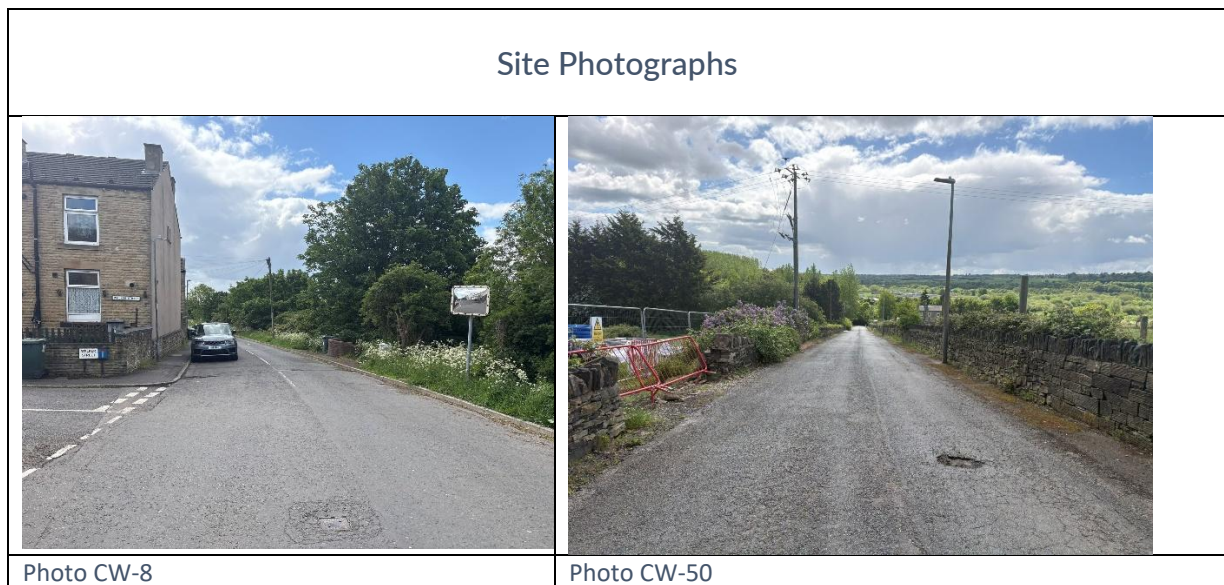
- 2.2.5 The drainage for Long Lane is in generally suitable condition in terms of blockages, however the carriageway in which surrounds it is often severely cracked and damaged.
