Post-Works Special Inspection Report

Storthes Hall Bridge

Structure No: K0150

June 2026

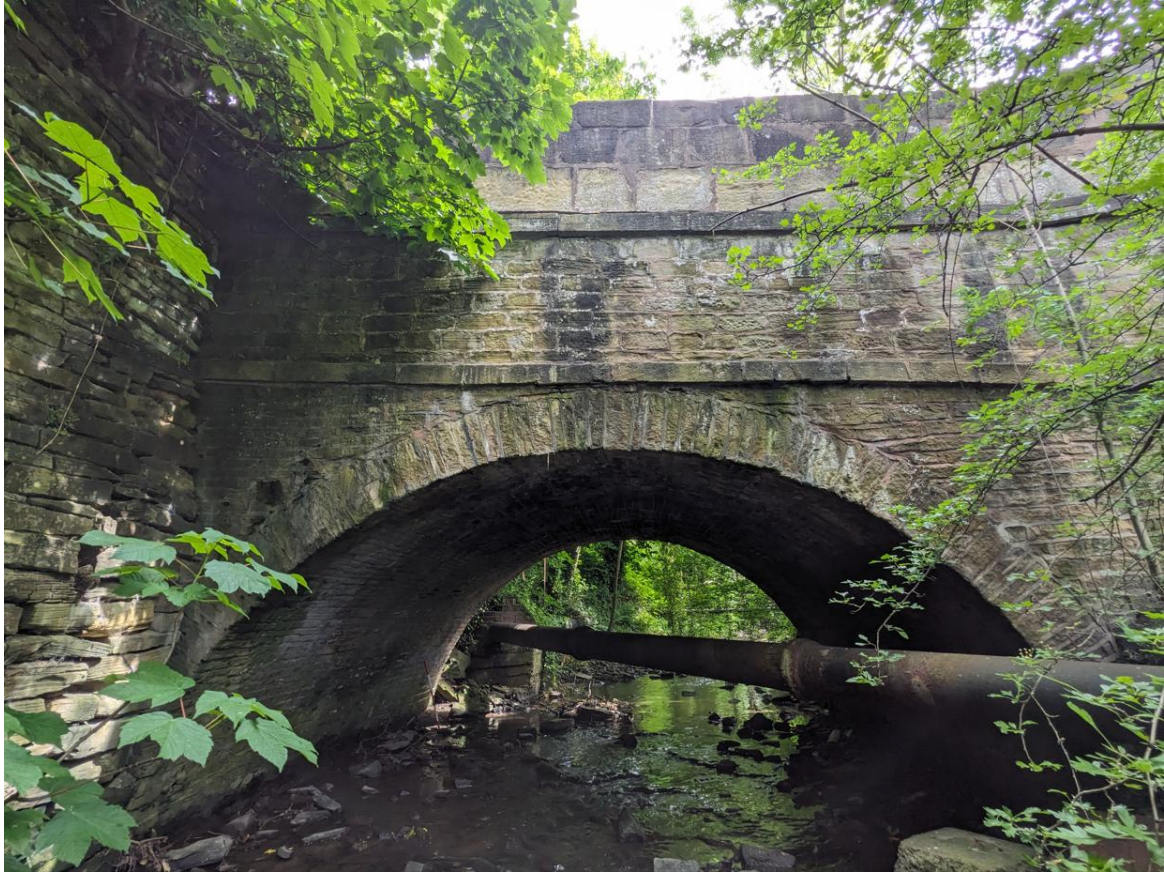
The spandrels for the structure were generally sound, with no notable deterioration exhibited.

Photograph 1 - General View of North (Downstream) Elevation

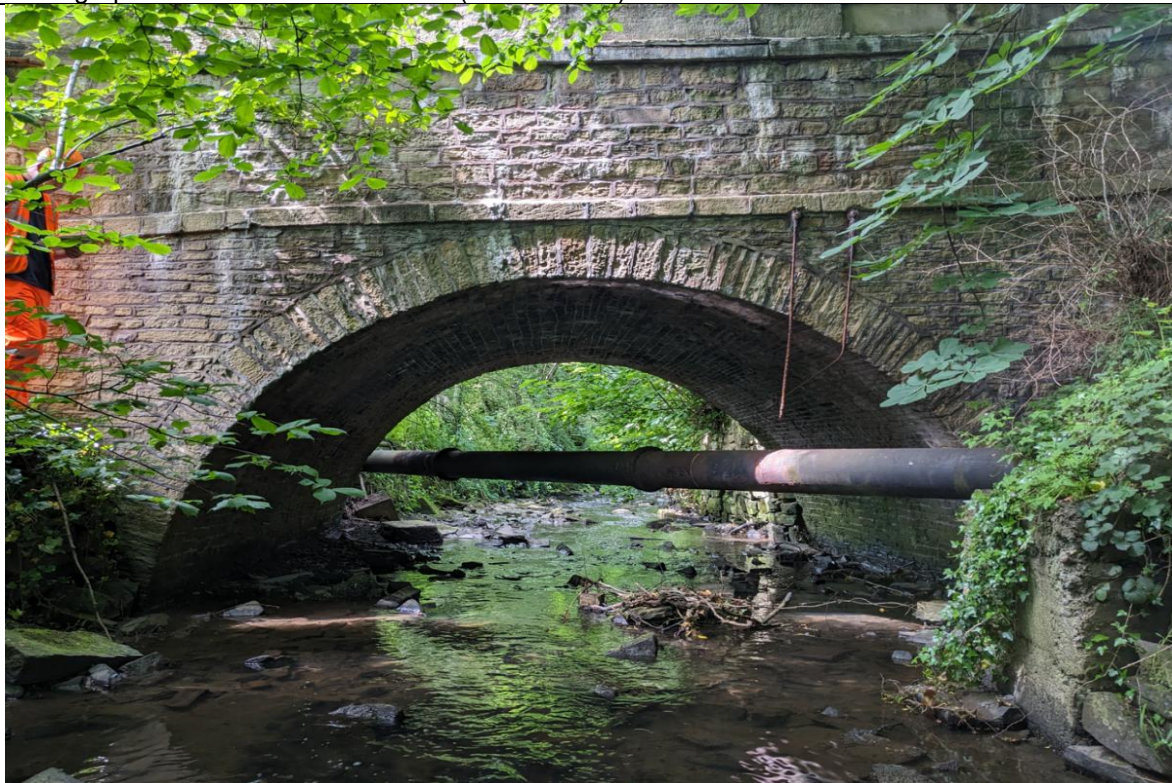
Photograph 2 - General View of South (Upstream) Elevation

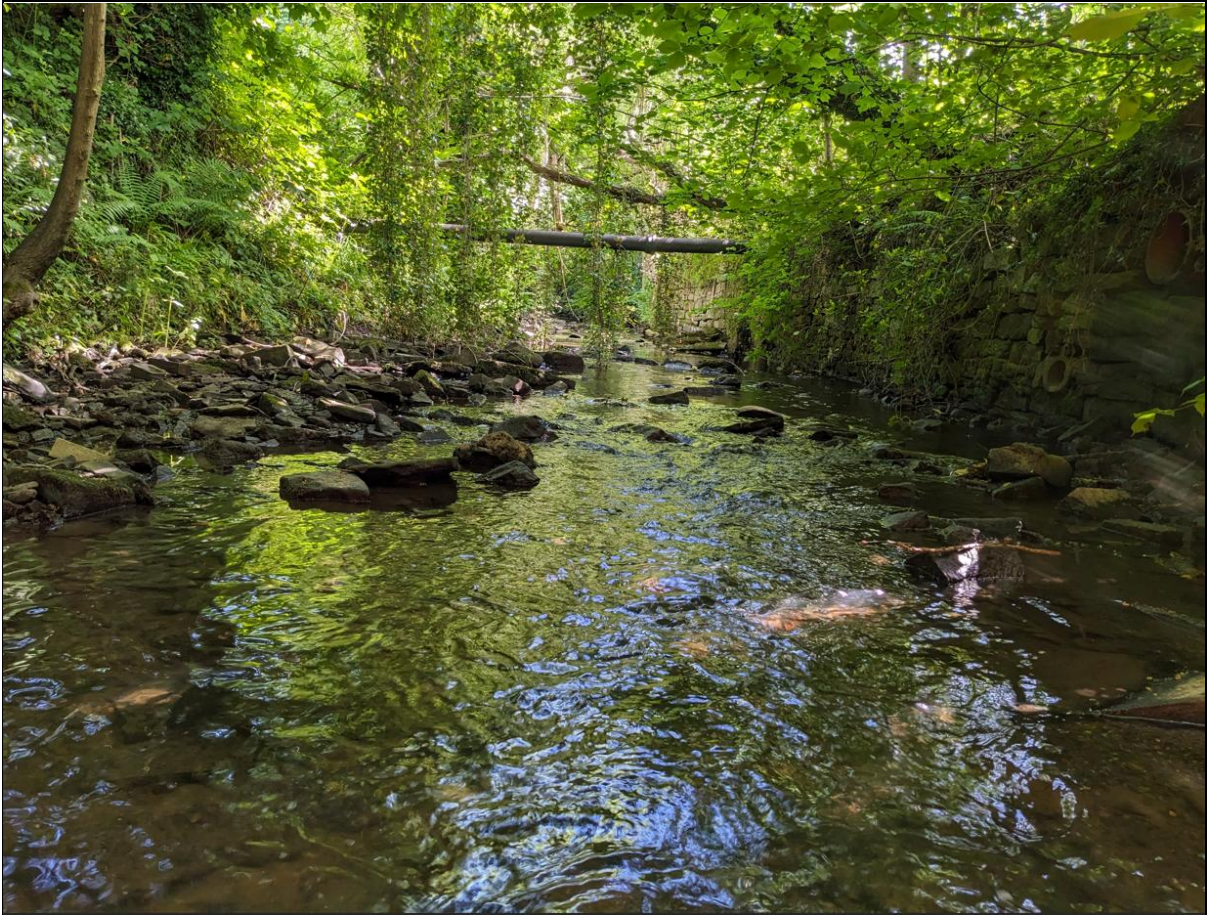
Photograph 5 - General View Upstream

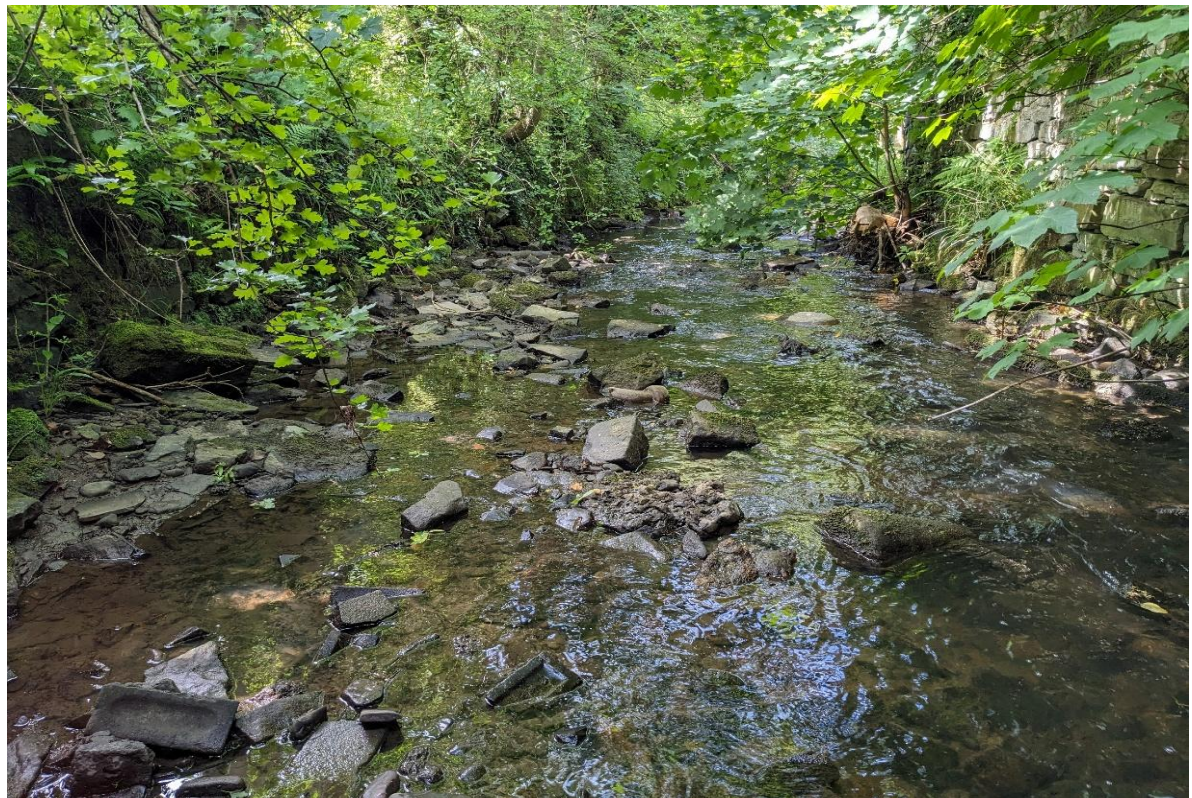
Photograph 6 - General View Downstream

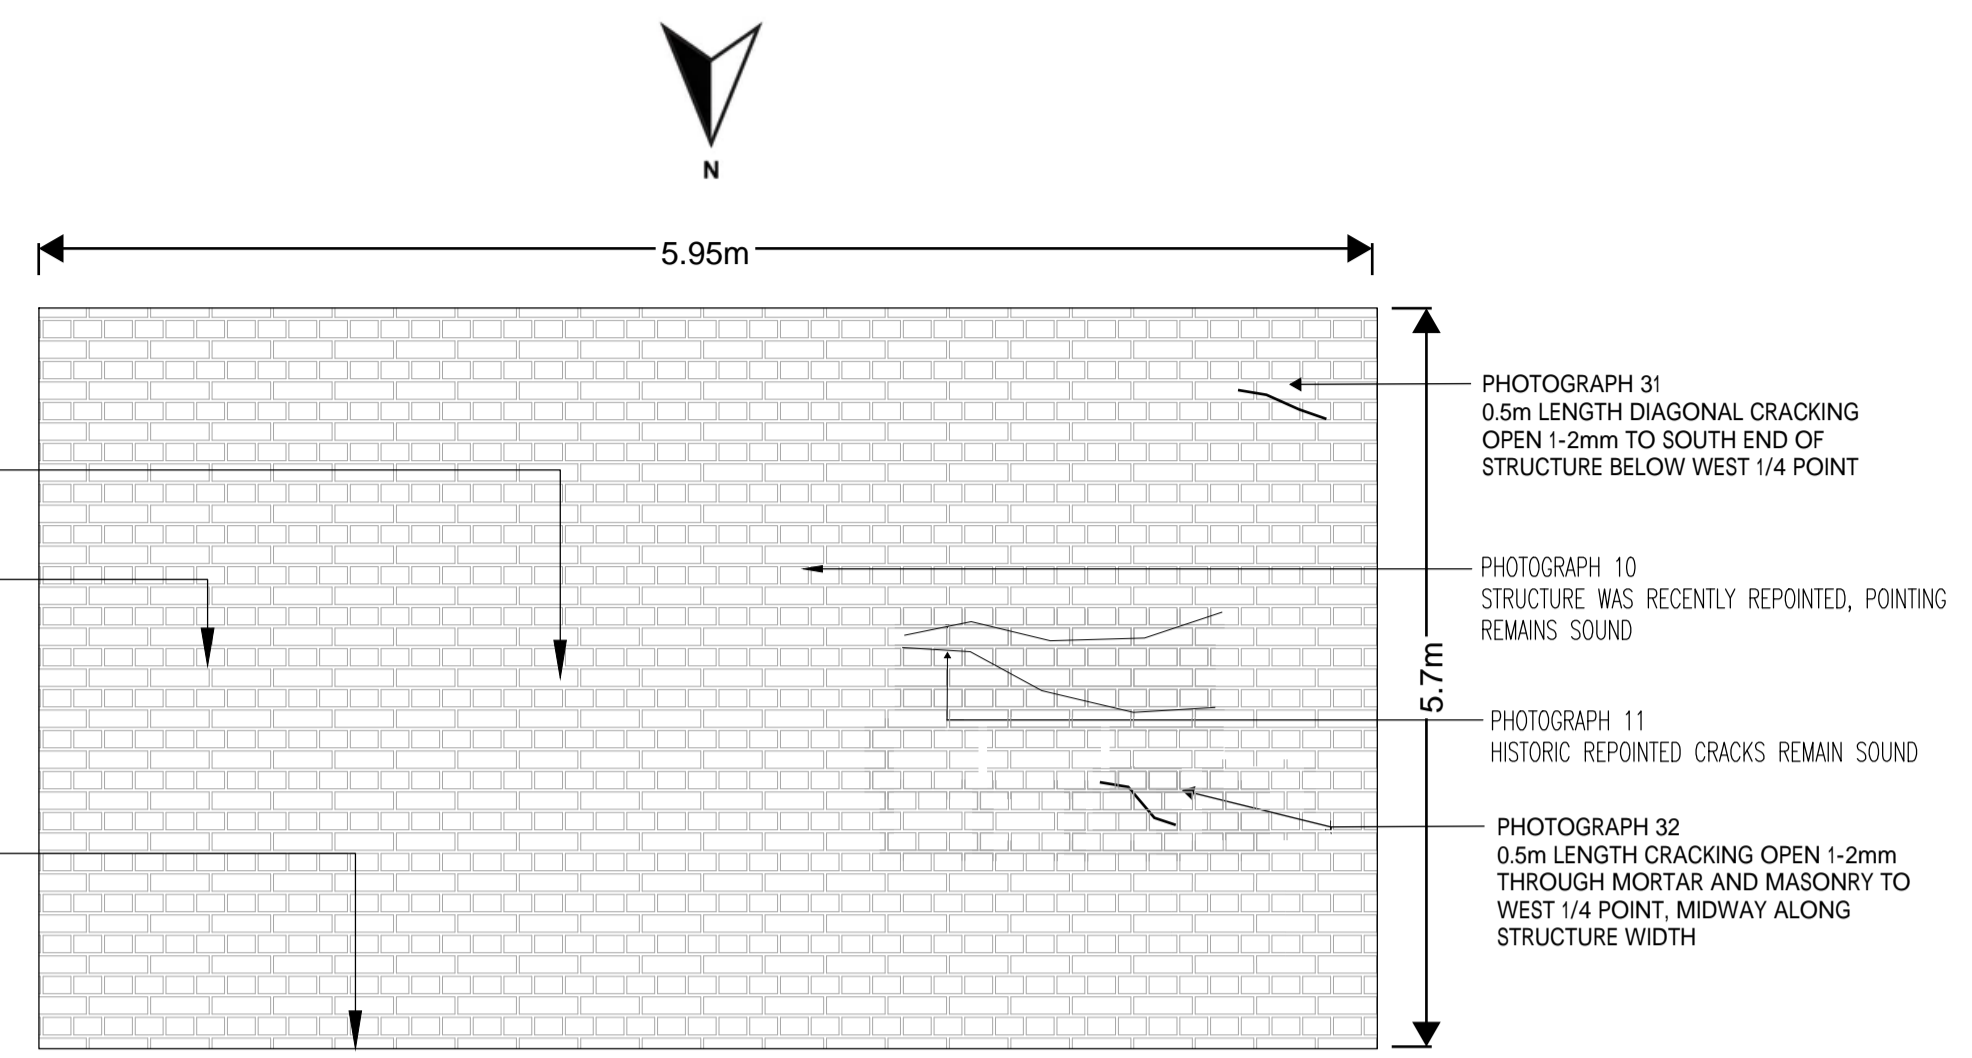
DEVELOPED VIEW OF ARCH BARREL
1:50

The arch barrel was recently repointed extensively, and remained dry, with the mortar sound. The joints were full, no distortion was visible to the arch profile, and no hollow sounding was found during the inspection.

2no. cracks were noted to below the west $\frac{1}{4}$ point, one at the south end and one at midway along the width of the structure. The cracking was measured at 1-2mm width and 0.5m length. It is recommended that the cracking is monitored for deterioration at subsequent inspections. These cracks were not identified during the 2025 Principal Inspection but were believed to be below the waterline.

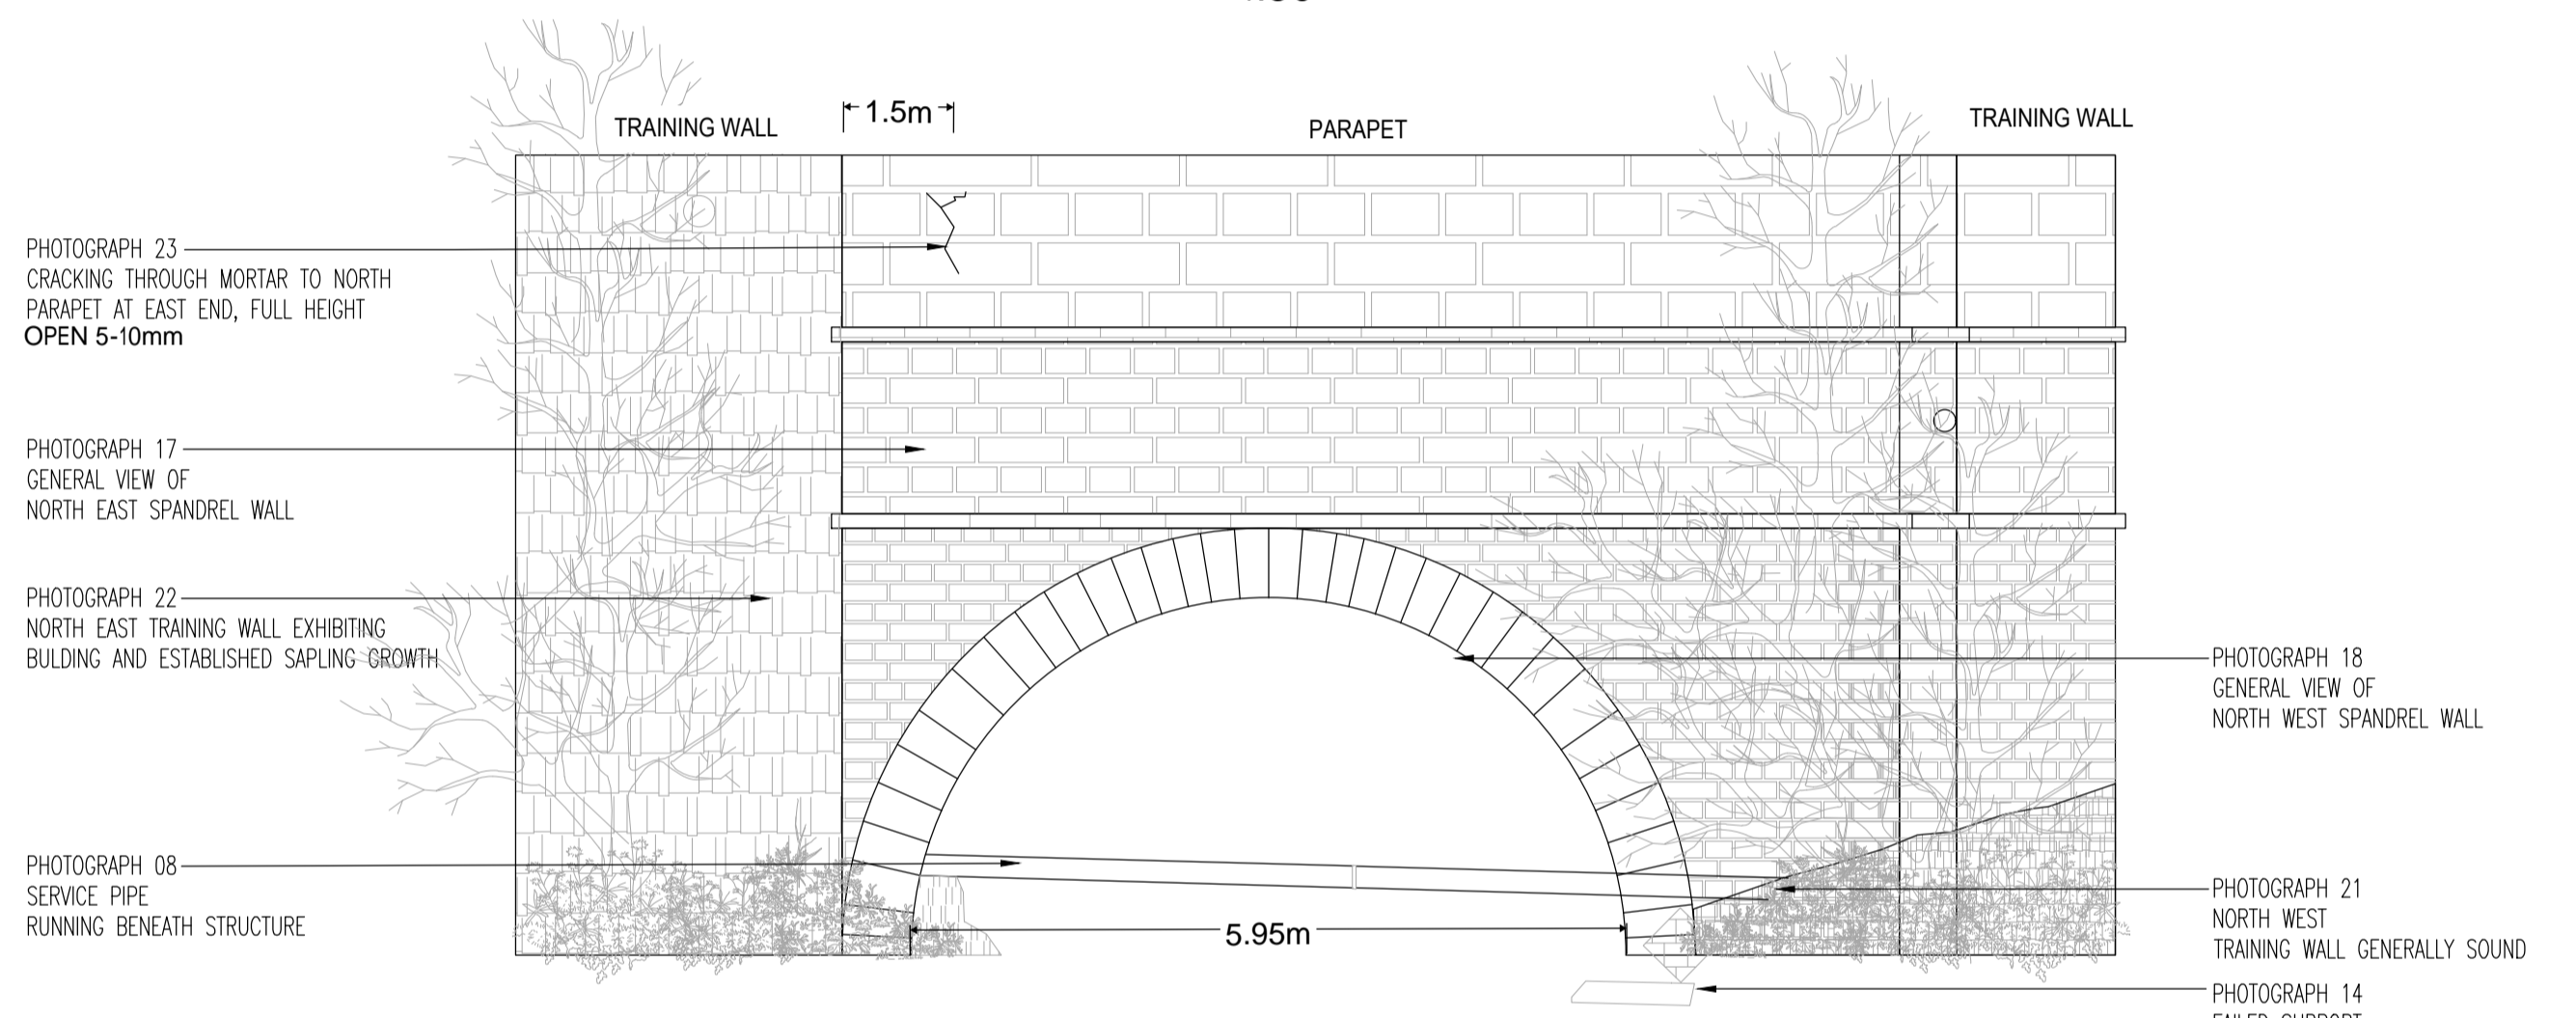
NORTH ELEVATION
1:50

The parapets were generally sound, however, there was cracking through mortar and masonry to the north parapet at the east end, full height, with associated spalled masonry. This crack should be repaired, and dated mortar tabs installed, to allow for monitoring at subsequent inspections.
