**Storthes Hall, Kirkburton
Highway Condition Survey 2**

June 2026 (Initial Issue)

Prepared on behalf of
Ubrique Investments Limited.

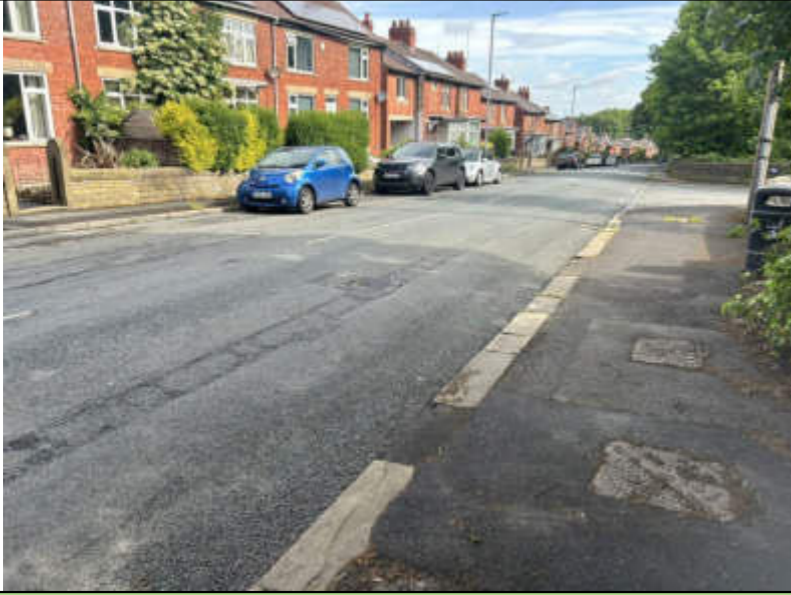
Table 2.4 Defect 1 (Image 1)

DEFECT	
Location	Facing northbound at Storthes Hall Lane/Southern Site Access junction.
Summary	Minor areas of fretting and cracking, slightly worn road markings and kerb damage.

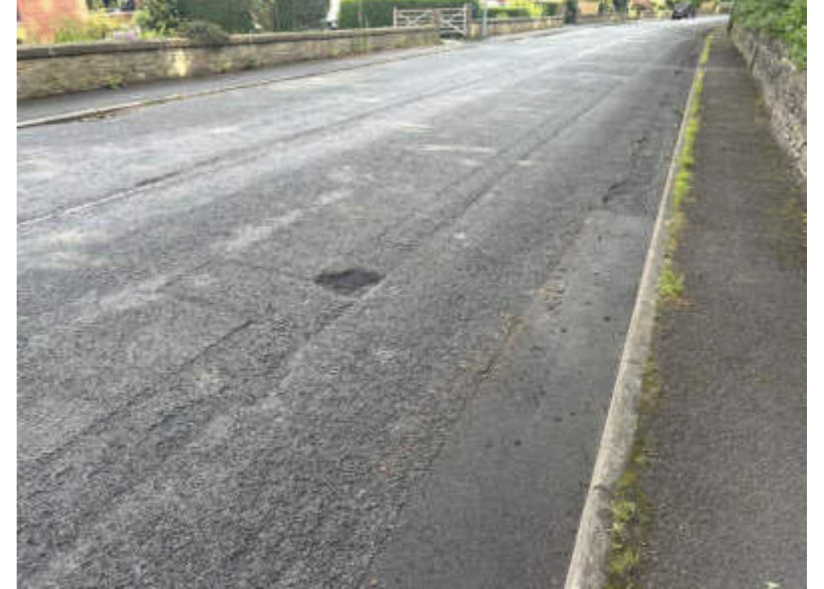
27

Table 2.1 Defect A (Image 27)

DEFECT	
Location	Facing northbound c. 125m north of the Southern Site Access.
Summary	<p>An area of patchwork surfacing has deteriorated further in the period between Survey 1 and 2, as shown in Image 14 within Appendix A of Survey 1.</p> <p>The additional defect is not considered to represent a highway safety concern and is generally comparable in nature and severity to existing defects already present along Storthes Hall Lane.</p> <p>The damage cannot be directly attributed to the construction activity.</p>

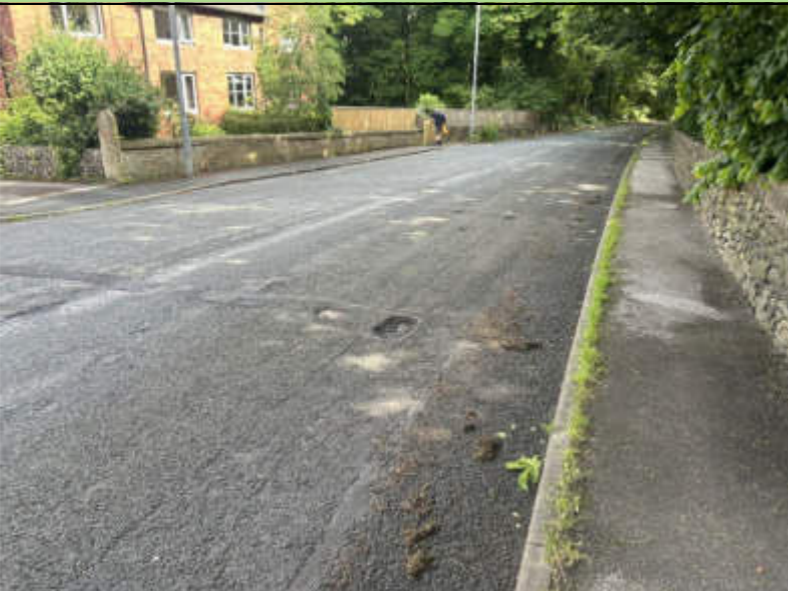
34

Table 2.2 Defect B (Image 34)

DEFECT	
Location	Facing northbound c. 200m north of the Southern Site Access.
Summary	<p>An area of patchwork surfacing has deteriorated further in the period between Survey 1 and 2, as shown in Image 14 within Appendix A of Survey 1.</p> <p>The additional defect is not considered to represent a highway safety concern and is generally comparable in nature and severity to existing defects already present along Storthes Hall Lane.</p> <p>The damage cannot be directly attributed to the construction activity.</p>

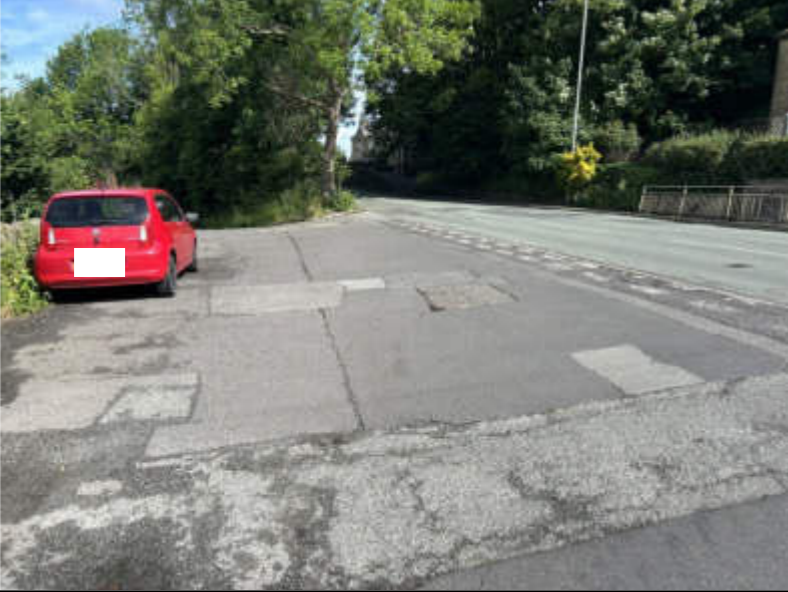
163

Table 2.17 Defect 13 (Image 163)

DEFECT	
Location	Facing northbound on Storthes Hall Lane at the A629 Penistone Road junction.
Summary	Patchwork along carriageway, cracking, worn road markings and damaged railings.

Survey 2 Comparison	No significant changes noted between Survey 1 and 2.

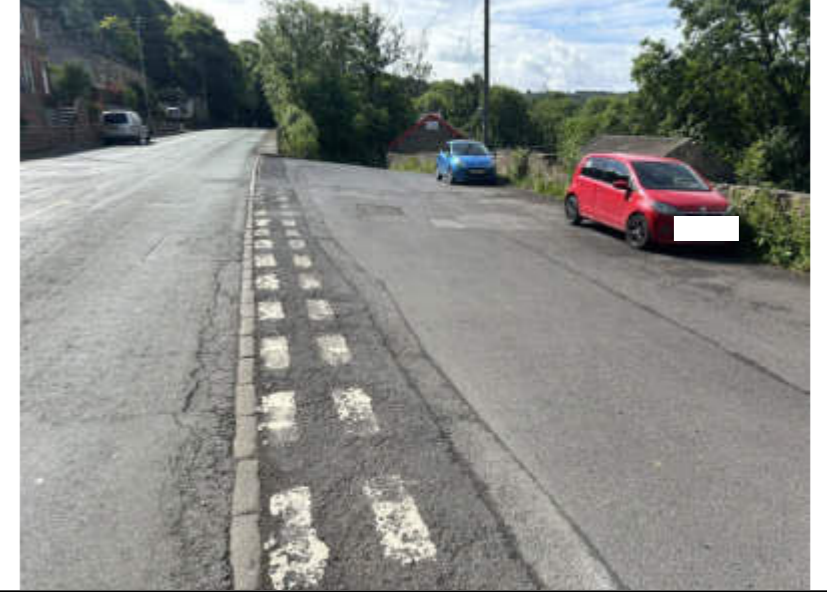
165

Table 2.18 Defect 14 (Image 165)

DEFECT	
Location	Facing southbound on Storthes Hall Lane at the A629 Penistone Road junction.
Summary	Patchwork along carriageway and cracking along give-way line.

A photograph showing a road junction. The road surface is asphalt and shows significant wear, including patchwork and cracking along the give-way line. A red car is parked on the right side of the road, and a blue car is parked further down the road. The background shows trees and a building.	
Survey 2 Comparison	No significant changes noted between Survey 1 and 2.
