# Tree Risk Assessment Report

Millbridge Playing Field  
Vernon Rd, Liversedge WF15 6HU

**Date of Survey:** 14<sup>th</sup> April 2026

Leonie Kapadia

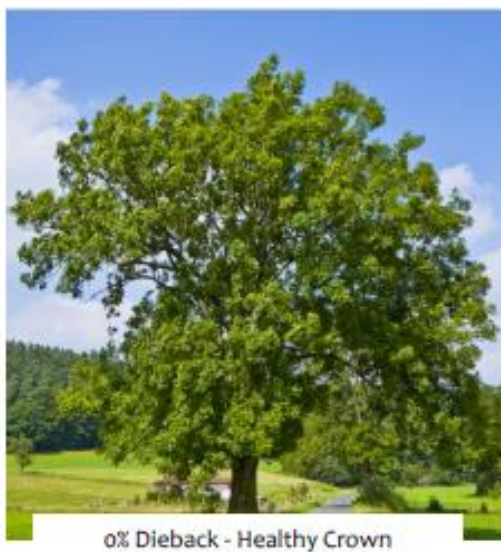
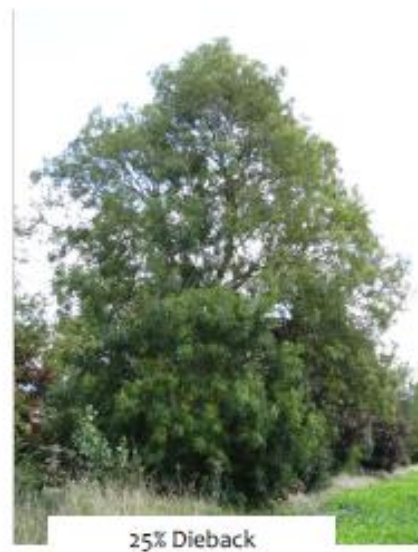
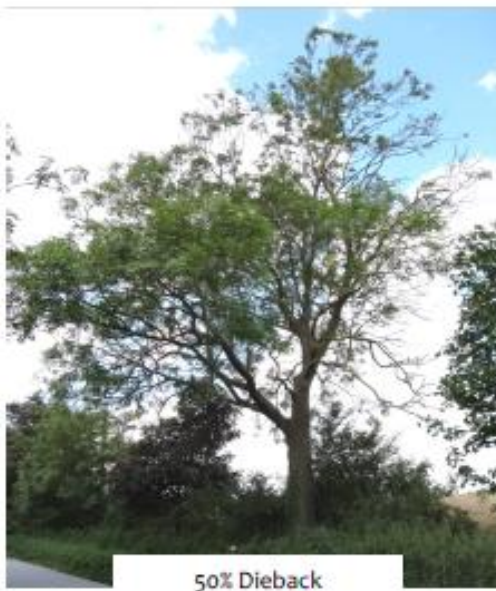
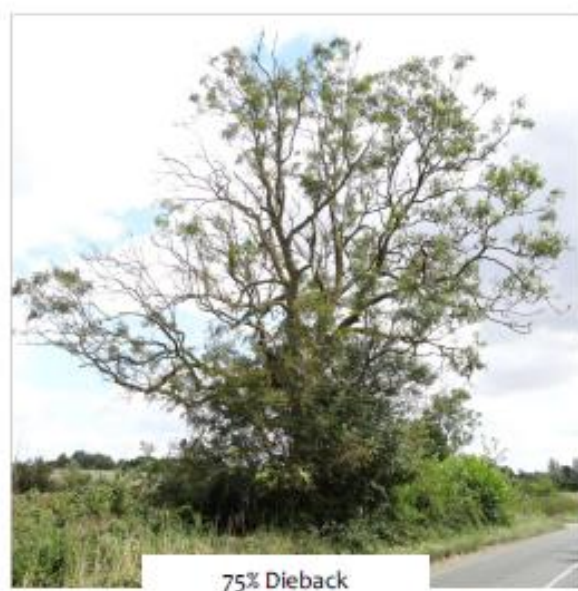
Figure 1: Photos of Dieback of ash trees

Ash Health Class 4 – 25% - 0% Canopy (Vitality Class 3)

likely to worsen it is recommended that trees are removed once canopies reach 50% usual density.
