## Supporting Statement – Proposed Replacement of Existing Windows and Doors

3 Bankfoot lane  
Armitage Bridge  
HD4 7NW

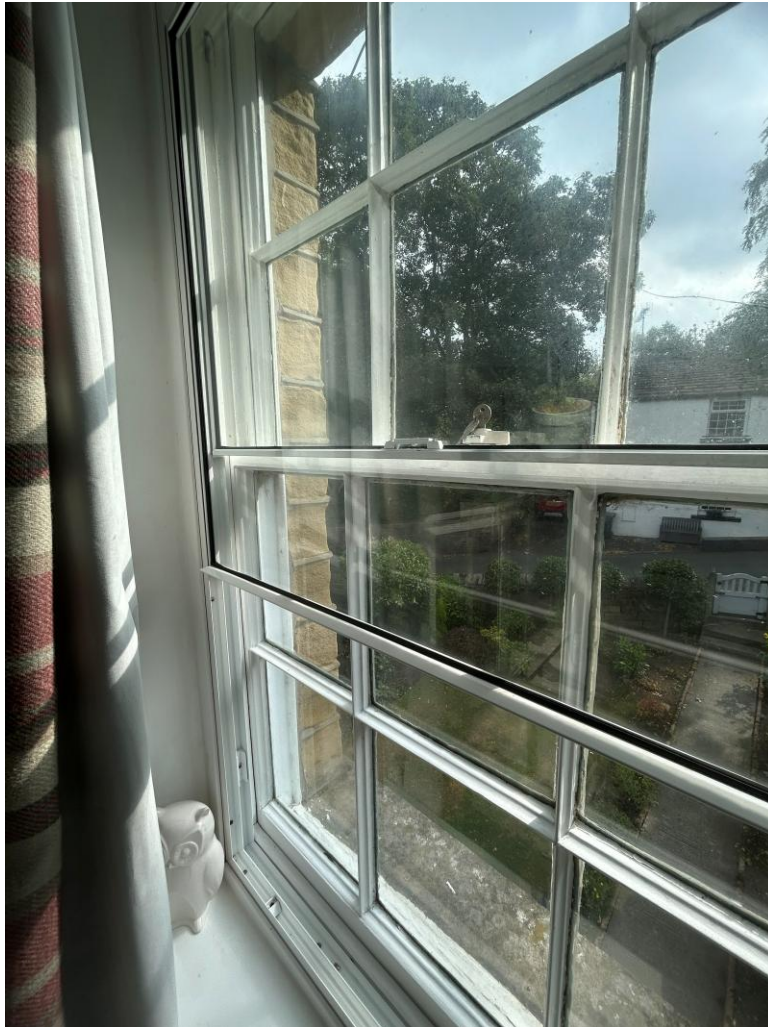
Alan and Julia have therefore already made a significant attempt to retain the existing windows and improve their performance without replacement. In practice, that intervention has failed to resolve the underlying problems and has introduced further difficulties.
