# Structural Dilapidation Report for the Retaining Wall

Woodman Inn, Thunder Bridge Lane, Kirkburton, Huddersfield  
HD8 0PX

## **Survey Report**

MDL - 11682

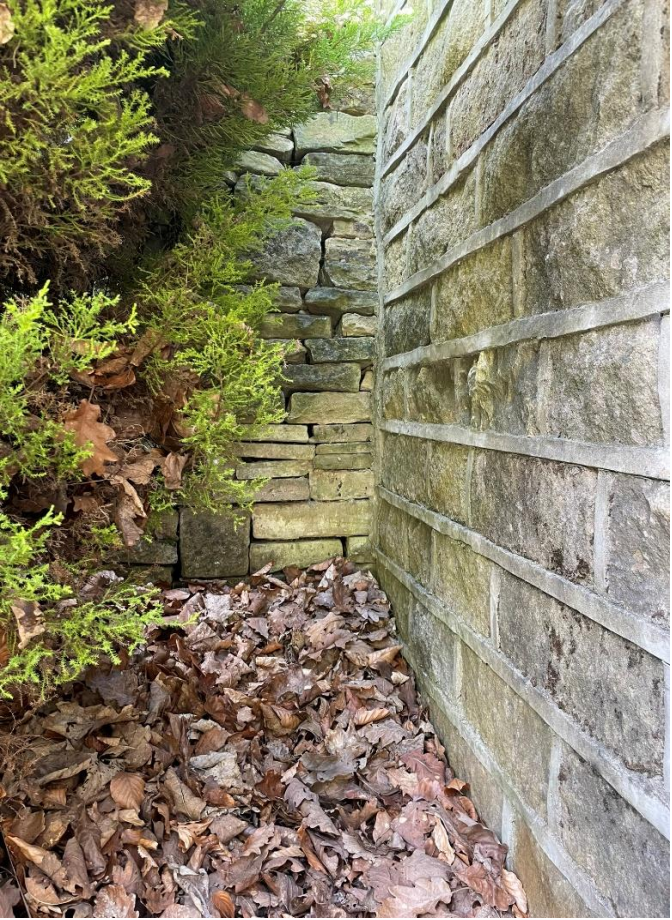
8

There is an additional lower retaining wall positioned 2.50m to the front to accommodate the raised bed. Approximate length of 6.50m @ 800mm high x 350mm wide. There are no signs of cracking and movement noted. Performing as intended. **Pic Ref: 8-11**

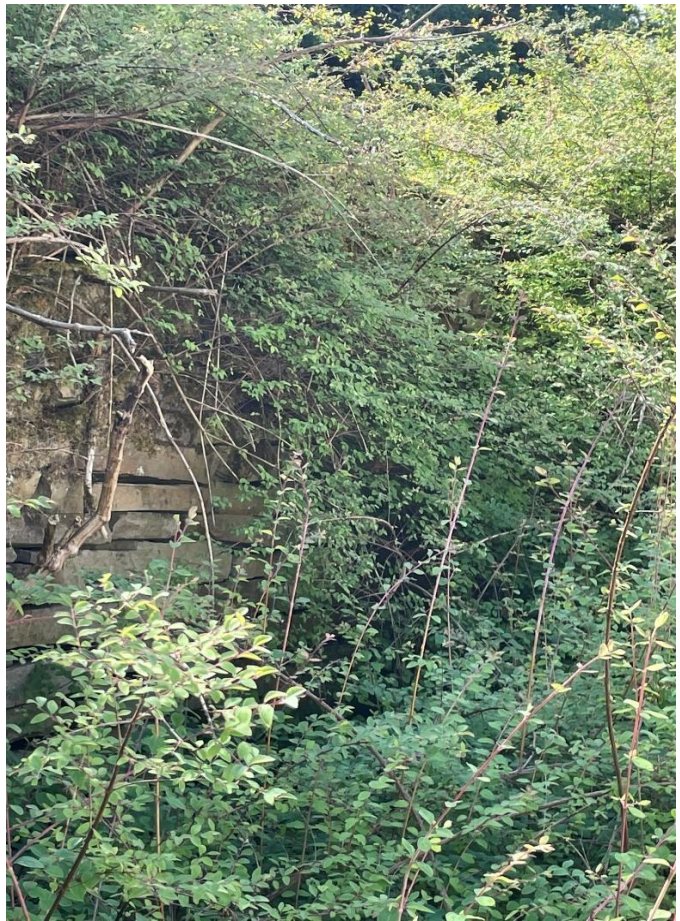
19

No movement and cracking noted to the additional brick pillar to the front of the dry-stone wall situated within the raised planter areas. **Pic Ref: 19**

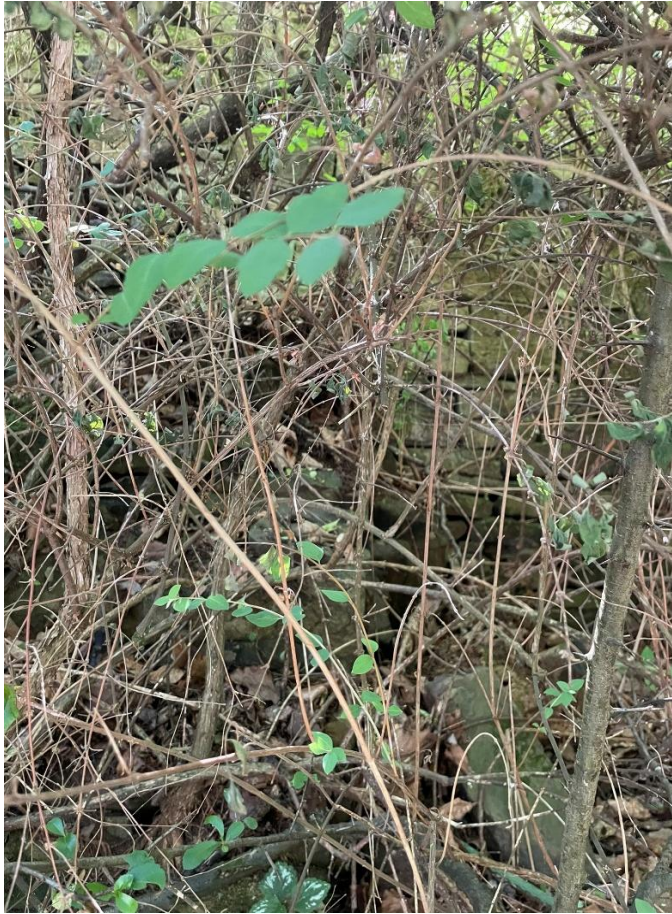
24

Further raised planter constructed in sleeper timbers positioned 1.50m to the front. Approximate length of 23.50m @ 800mm high. Slight lateral movement noted. Performing as intended. **Pic Ref: 24**
