### Demolition Asbestos Survey

### Ground Floor, Holme Park Court, Berry Brow, Huddersfield, HD4 7NH

Issue number:	2
Survey number:	7923.HPC. Ground
Survey date:	Jan 2026
Client:	Metropolitan Demolition
Survey carried out by:	Phil Cox & Graham Brown
Survey compiled by:	Phil Cox & Graham Brown
Survey checked by:	Phil Cox & Graham Brown
Survey Issued	05/02/2026

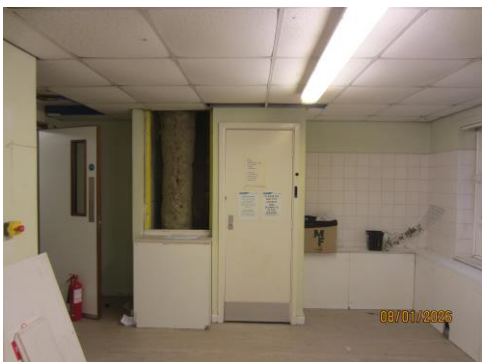
<b>Level of ID:</b>	Sampled	<b>Ref:</b>	S10
	<b>Building / Floor:</b> HPC / Ground <b>Area:</b> R31 Laundry room <b>Location:</b> Ceiling <b>Description:</b> Suspended grid below Artex <b>Asbestos Type:</b> Chrysotile <b>Amount:</b> 24m2			
<b>Recommendations:</b>				
Remove in accordance with the Control of Asbestos Regulations 2012 and dispose of as hazardous waste.

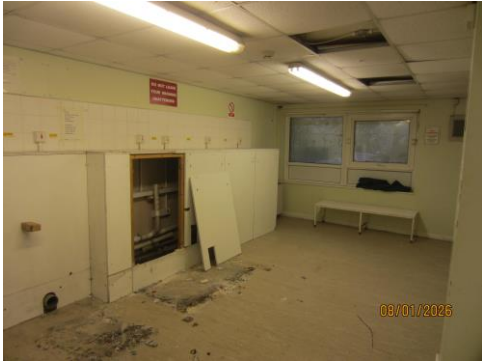
<b>Level of ID:</b>	Visually inspected	<b>Ref:</b>	S11
	<b>Building / Floor:</b> HPC / Ground <b>Area:</b> R31 Laundry room <b>Location:</b> Floor <b>Description:</b> Bitumen residue to slab below floor. <b>Asbestos Type:</b> Chrysotile <b>Amount:</b> 24m2

Remove in accordance with the Control of Asbestos Regulations 2012 and dispose of as hazardous waste.

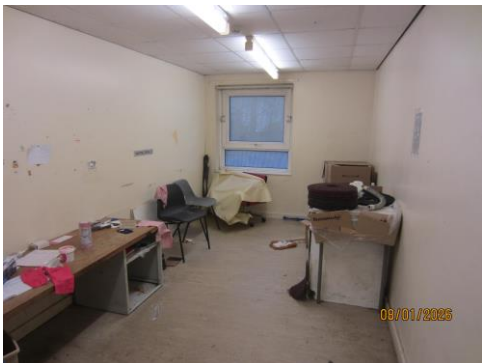
<b>Level of ID:</b>	Visually inspected	<b>Ref:</b>	As S10
	<b>Building / Floor:</b> HPC / Ground <b>Area:</b> R32 Office 6 <b>Location:</b> Ceiling <b>Description:</b> Suspended grid below Artex <b>Asbestos Type:</b> Chrysotile <b>Amount:</b> 12m2

Remove in accordance with the Control of Asbestos Regulations 2012 and dispose of as hazardous waste.

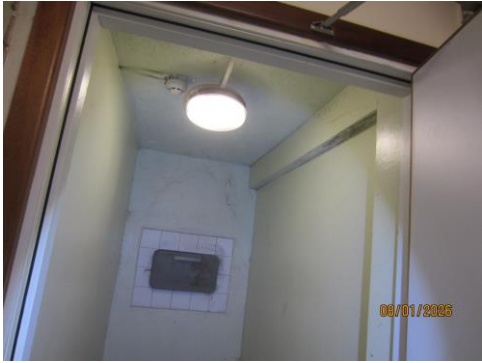
<b>Level of ID:</b>	Visually inspected	<b>Ref:</b>	As S02
	<b>Building / Floor:</b> HPC / Ground <b>Area:</b> R36 Refuse Chute <b>Location:</b> Ceiling <b>Description:</b> Artex on concrete <b>Asbestos Type:</b> Chrysotile <b>Amount:</b> 3m2

Remove in accordance with the Control of Asbestos Regulations 2012 and dispose of as hazardous waste.

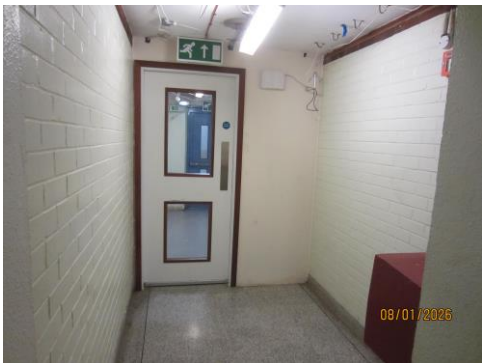
<b>Level of ID:</b>	Visually inspected	<b>Ref:</b>	As S02
	<b>Building / Floor:</b> HPC / Ground <b>Area:</b> R37 Circulation <b>Location:</b> Ceiling <b>Description:</b> Artex on concrete <b>Asbestos Type:</b> Chrysotile <b>Amount:</b> 10m2

Remove in accordance with the Control of Asbestos Regulations 2012 and dispose of as hazardous waste.

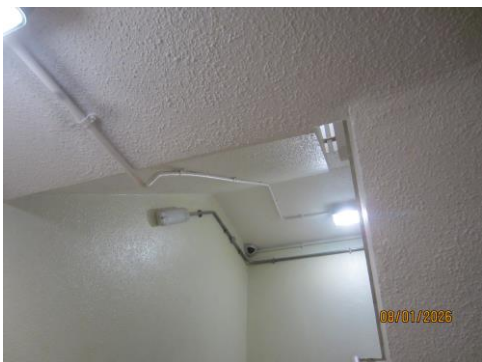
<b>Level of ID:</b>	Sampled	<b>Ref:</b>	S13
	<b>Building / Floor:</b> HPC / Ground <b>Area:</b> R38 Stairs <b>Location:</b> Ceiling <b>Description:</b> Artex on concrete <b>Asbestos Type:</b> Chrysotile <b>Amount:</b> 21m2

Remove in accordance with the Control of Asbestos Regulations 2012 and dispose of as hazardous waste.

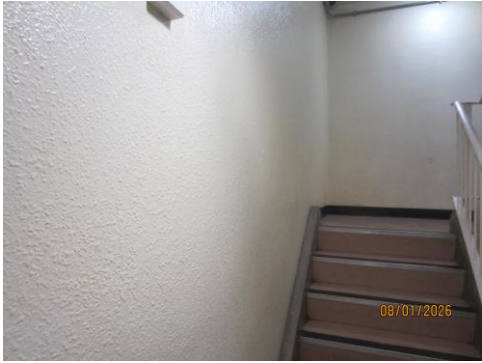
<b>Level of ID:</b>	Sampled	<b>Ref:</b>	S14
	<p><b>Building / Floor:</b> HPC / Ground</p> <p><b>Area:</b> R38 Stairs</p> <p><b>Location:</b> Wall</p> <p><b>Description:</b> Further samples indicate chrysotile in the wall artex</p> <p><b>Asbestos Type:</b> Chrysotile</p> <p><b>Amount:</b> 30m2</p>

Remove in accordance with the Control of Asbestos Regulations 2012 and dispose of as hazardous waste.

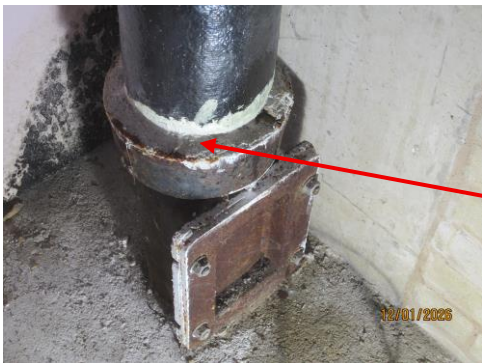
<b>Level of ID:</b>	Sampled	<b>Ref:</b>	S22
	<b>Building / Floor:</b> HPC / Ground <b>Area:</b> R39 Cupboard <b>Location:</b> Floor <b>Description:</b> Sealing compound to down pipe joint <b>Asbestos Type:</b> Amosite <b>Amount:</b> Item			
<b>Recommendations:</b>				
Remove in accordance with the Control of Asbestos Regulations 2012 and dispose of as hazardous waste.

<b>Level of ID:</b>	Sampled	<b>Ref:</b>	S19
	<b>Building / Floor:</b> HPC / Ground <b>Area:</b> R39 Cupboard <b>Location:</b> Floor <b>Description:</b> Pitch Fibre S&V pipe <b>Asbestos Type:</b> No asbestos detected <b>Amount:</b> Chrysotile			
<b>Recommendations:</b>				
Remove in accordance with the Control of Asbestos Regulations 2012 and dispose of as hazardous waste.

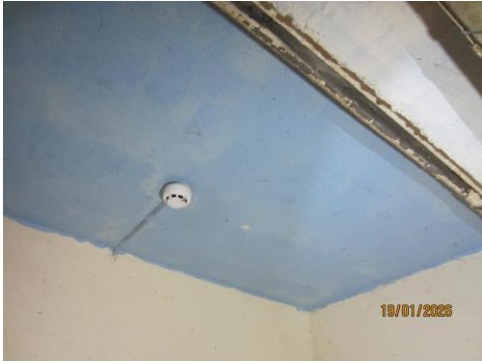
<b>Level of ID:</b>	Sampled	<b>Ref:</b>	S20
	<p><b>Building / Floor:</b> HPC / Ground  <b>Area:</b> R40 Bin Store  <b>Location:</b> Ceiling  <b>Description:</b> Artex on concrete  <b>Asbestos Type:</b> Chrysotile  <b>Amount:</b> 12m2</p>

Remove in accordance with the Control of Asbestos Regulations 2012 and dispose of as hazardous waste.

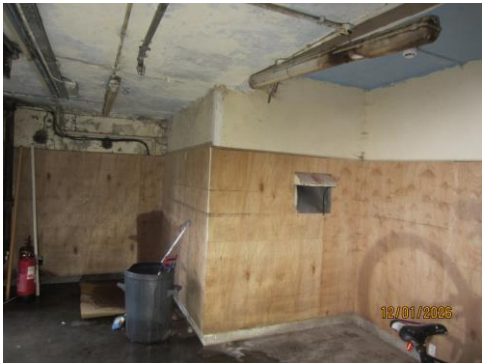
<b>Level of ID:</b>	Sampled	<b>Ref:</b>	S21
	<p><b>Building / Floor:</b> HPC / Ground  <b>Area:</b> R40 Bin Store  <b>Location:</b> Wall  <b>Description:</b> Artex on concrete, timber low level protection  <b>Asbestos Type:</b> Chrysotile  <b>Amount:</b> 45m2</p>
