Demolition Asbestos Survey

In accordance with HSG264 - Asbestos: The Survey Guide

Floors 13 to 17, Holme Park Court, Berry Brow, Huddersfield, HD4 7NH

Issue number:	1
Survey number:	7923 HPC 13 - 17
Survey date:	January 2026
Client:	Metropolitan Demolition
Survey carried out by:	Phil Cox & Graham Brown
Survey compiled by:	Phil Cox & Graham Brown
Survey checked by:	Phil Cox & Graham Brown
Survey Issued	09/02/2026

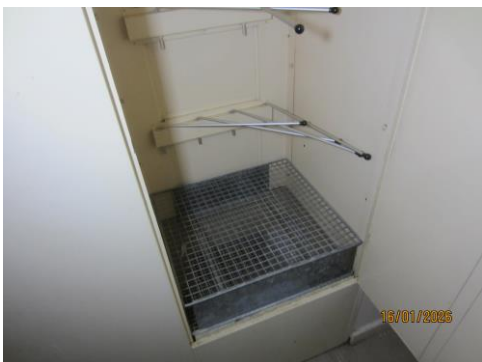
Level of ID:	Visually inspected	Ref:	
	Building / Floor: HPC / Thirteenth Area: Flat 22, R03 Drying cabinet Location: Wall Description: Metal Asbestos Type: No suspect material Amount: m2

No action required

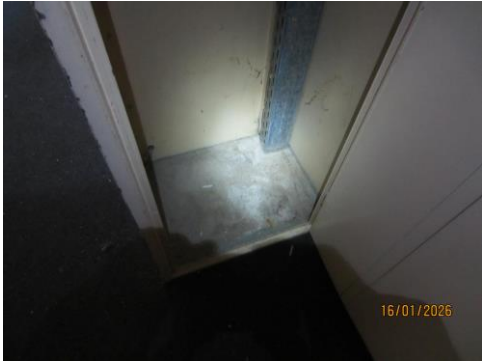
Level of ID:	Visually inspected	Ref:	
	<p>Building / Floor: HPC / Thirteenth</p> <p>Area: Flat 22, R04 Electric cupboard</p> <p>Location: Floor</p> <p>Description: Concrete</p> <p>Asbestos Type: No suspect material</p> <p>Amount: m2</p>			
Recommendations:				
No action required

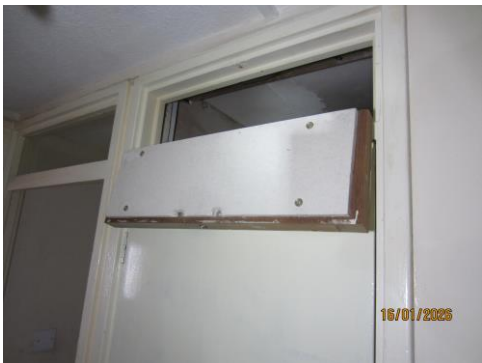
Level of ID:	Visually inspected	Ref:	
	<p>Building / Floor: HPC / Thirteenth</p> <p>Area: Flat 22, R05 Tank cupboard</p> <p>Location: Wall</p> <p>Description: Header panel to door sampled. Stud wall, modern tank & insulation</p> <p>Asbestos Type: No suspect material</p> <p>Amount: m2</p>			
Recommendations:				
No action required

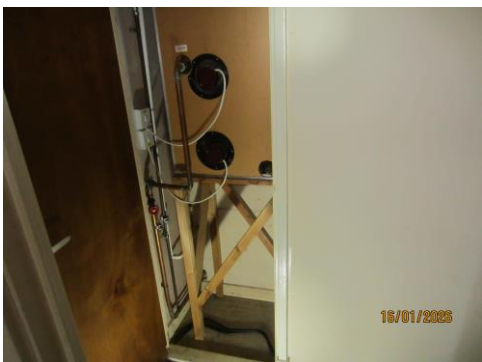
Level of ID:	Visually inspected	Ref:	
	<p>Building / Floor: HPC / Thirteenth</p> <p>Area: Flat 22, R05 Tank cupboard</p> <p>Location: Floor</p> <p>Description: Vinyl on concrete</p> <p>Asbestos Type: No suspect material</p> <p>Amount: m2</p>			
Recommendations:				
No action required

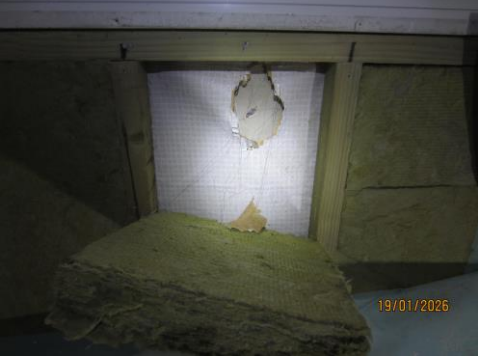
Level of ID:	Sampled	Ref:	S04
	Building / Floor: HPC / Fifteenth Area: Communal, R04 Corridor Location: Wall Description: Cement panel below window Asbestos Type: No asbestos detected Amount: m2

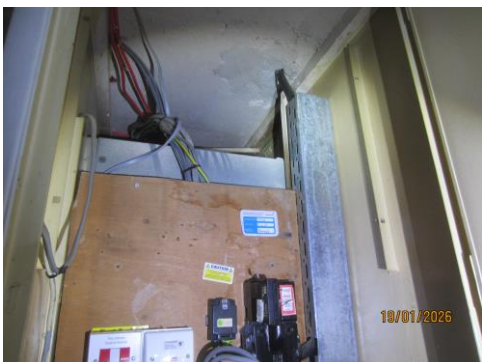
Level of ID:	Visually inspected	Ref:	
	<p>Building / Floor: HPC / Fifteenth</p> <p>Area: Flat 7, R04 Electric cupboard</p> <p>Location: Wall</p> <p>Description: Stud wall, timber backing panel, modern electrics</p> <p>Asbestos Type: No suspect material</p> <p>Amount: m2</p>

No action required

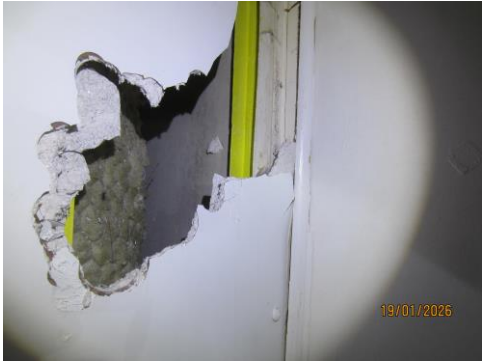
Level of ID:	Visually inspected	Ref:	
	Building / Floor: HPC / Fifteenth Area: Flat 7 R06 Toilet Location: Wall Description: Stud wall, Supalux IPS and divider panel Asbestos Type: No suspect material Amount: m2			
Recommendations:				
No action required

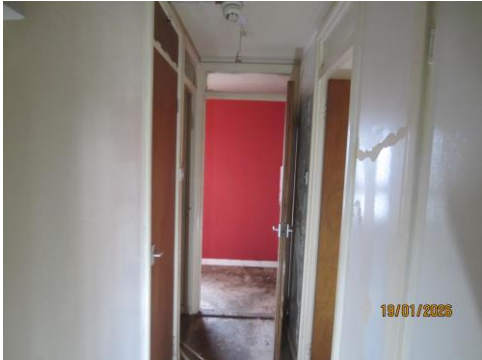
Level of ID:	Visually inspected	Ref:	As S10
	Building / Floor: HPC / Sixteenth Area: Flats 1 to 6 Location: Floor Description: Bitumen on floor slab below floor covering Asbestos Type: Chrysotile Amount: 199 m2

Remove bitumen in accordance with the Control of Asbestos Regulations 2012 and dispose of as hazardous waste.

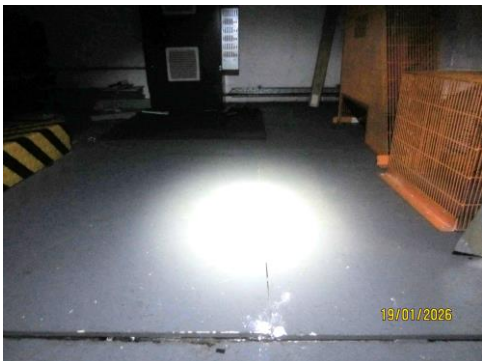
Level of ID:	Visually inspected	Ref:	S01
	Building / Floor: HPC / Seventeenth Area: Lift motor Room Location: Floor Description: Concrete, part boarded Asbestos Type: No asbestos detected Amount: m2

No action required

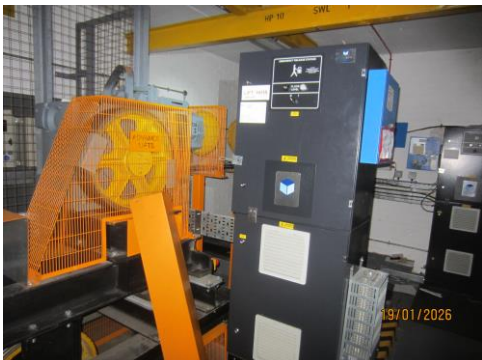
Level of ID:	Visually inspected	Ref:	
	Building / Floor: HPC / Seventeenth Area: Lift motor Room Location: Floor Description: Modern lift & motors - installed post 2008 Asbestos Type: No suspect material Amount: m2

No action required

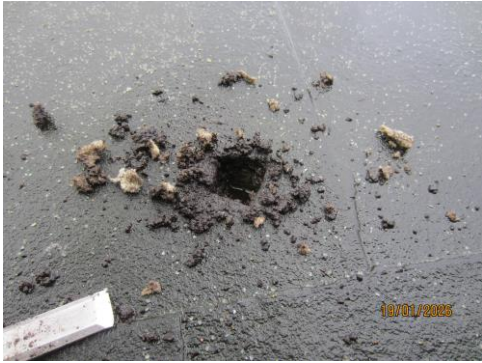
Level of ID:	Visually inspected	Ref:	S02
	<p>Building / Floor: HPC / Seventeenth</p> <p>Area: External roof</p> <p>Location: Floor</p> <p>Description: Built up felt on Concrete</p> <p>Asbestos Type: No asbestos detected</p> <p>Amount: m2</p>			
Recommendations:				
No action required
