Demolition Asbestos Survey

Floors 5 - 8, Holme Park Court, Berry Brow, Huddersfield, HD4 7NH

Issue number:	1
Survey number:	7923. HP floors 5-8
Survey date:	January 2026
Client:	Metropolitan Demolition
Survey carried out by:	Phil Cox & Graham Brown
Survey compiled by:	Phil Cox & Graham Brown
Survey checked by:	Phil Cox & Graham Brown
Survey Issued	06/02/2026

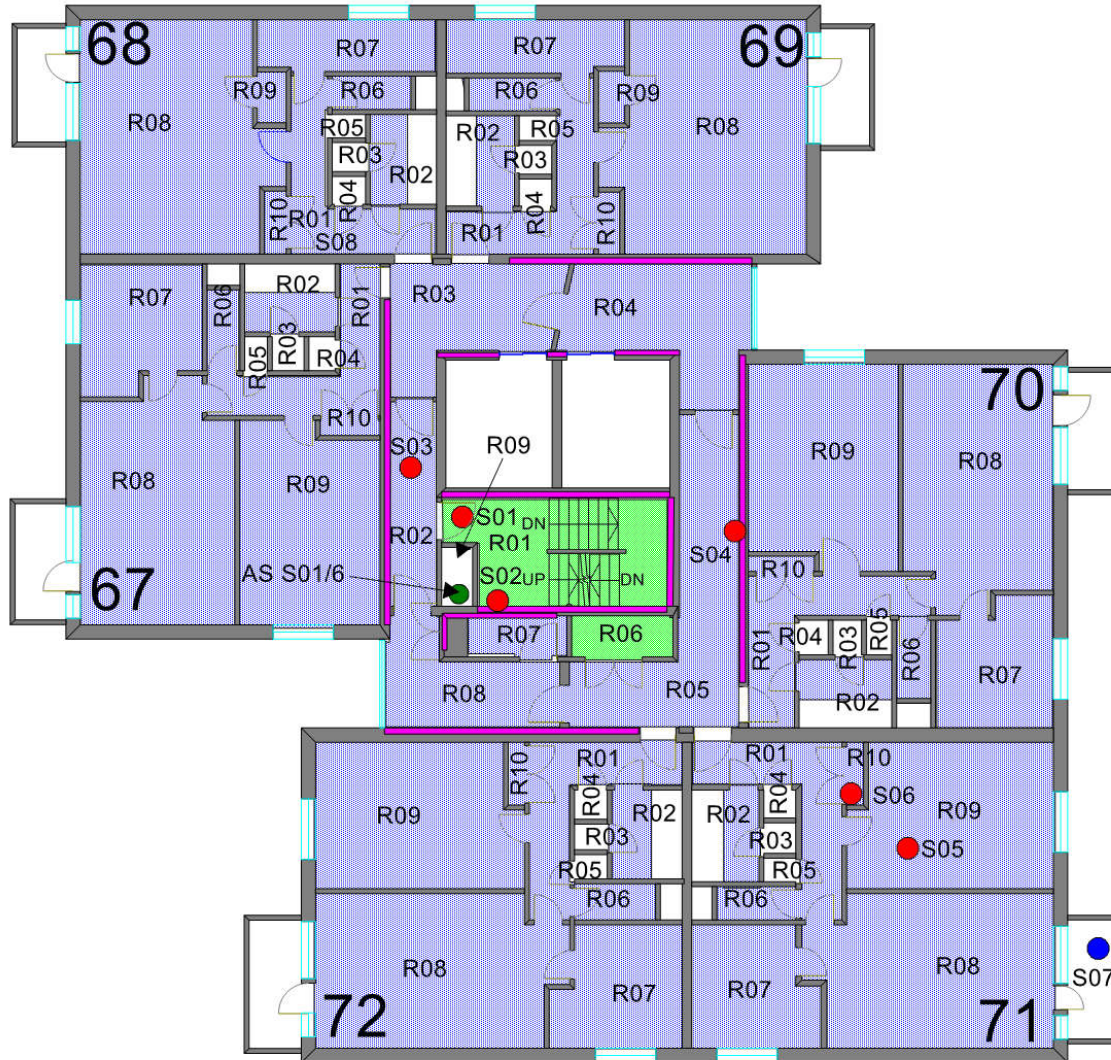
FIFTH FLOOR

Summary of Asbestos Identified and/or Presumed.							
Item	Location	Position	Description	Quantity m2	Type of Asbestos	Level of ID	Recommendations
1	HPC/Fifth/Communa l, R01 Stairs	Ceiling	Artex on concrete	12	Chrysotile	S01	Remove artex in accordance with the Control of Asbestos Regulations 2012 and dispose of as hazardous waste.
2	HPC/Fifth/Communa l, R01 Stairs	Wall	Artex on concrete	30	Chrysotile	S02	Remove artex in accordance with the Control of Asbestos Regulations 2012 and dispose of as hazardous waste.
4	HPC/Fifth/Communa l, R02 Landing	Ceiling	Artex on concrete	4.5	Chrysotile	As S01	Remove artex in accordance with the Control of Asbestos Regulations 2012 and dispose of as hazardous waste.
5	HPC/Fifth/Communa l, R02 Landing	Wall	Artex on concrete, masonry	13.5	Chrysotile	As S02	Remove artex in accordance with the Control of Asbestos Regulations 2012 and dispose of as hazardous waste.
6	HPC/Fifth/Communa l, R02 Landing	Floor	Bitumen on floor slab below floor covering	4.5	Chrysotile	As S03	Remove bitumen in accordance with the Control of Asbestos Regulations 2012 and dispose of as hazardous waste.

7	HPC/Fifth/Communa l, R03 Corridor	Ceiling	Artex on concrete	7	Chrysotile	As S01	Remove artex in accordance with the Control of Asbestos Regulations 2012 and dispose of as hazardous waste.
8	HPC/Fifth/Communa l, R03 Corridor	Wall	Artex on concrete	14.5	Chrysotile	As S02	Remove artex in accordance with the Control of Asbestos Regulations 2012 and dispose of as hazardous waste.
9	HPC/Fifth/Communa l, R03 Corridor	Floor	Bitumen on floor slab below floor covering	8.5	Chrysotile	S03	Remove bitumen in accordance with the Control of Asbestos Regulations 2012 and dispose of as hazardous waste.
10	HPC/Fifth/Communa l, R04 Corridor	Ceiling	Artex on concrete	8.5	Chrysotile	As S01	Remove artex in accordance with the Control of Asbestos Regulations 2012 and dispose of as hazardous waste.

Summary of Asbestos Identified and/or Presumed.							
Item	Location	Position	Description	Quantity m2	Type of Asbestos	Level of ID	Recommendations
11	HPC/Fifth/Communa l, R04 Corridor	Wall	Artex on concrete	18	Chrysotile	As S02	Remove artex in accordance with the Control of Asbestos Regulations 2012 and dispose of as hazardous waste.
12	HPC/Fifth/Communa l, R04 Corridor	Floor	Bitumen on floor slab below floor covering	8.5	Chrysotile	As S03	Remove bitumen in accordance with the Control of Asbestos Regulations 2012 and dispose of as hazardous waste.
13	HPC/Fifth/Communa l, R05 Corridor	Ceiling	Artex on concrete	12	Chrysotile	As S01	Remove artex in accordance with the Control of Asbestos Regulations 2012 and dispose of as hazardous waste.
14	HPC/Fifth/Communa l, R05 Corridor	Wall	Artex on concrete	24	Chrysotile	S04	Remove artex in accordance with the Control of Asbestos Regulations 2012 and dispose of as hazardous waste.

15	HPC/Fifth/Communa l, R05 Corridor	Floor	Bitumen on floor slab below floor covering	12	Chrysotile	As S03	Remove artex in accordance with the Control of Asbestos Regulations 2012 and dispose of as hazardous waste.
16	HPC/Fifth/Communa l, R06 Service riser	Ceiling	Artex on concrete	2.5	Chrysotile	As S01	Remove artex in accordance with the Control of Asbestos Regulations 2012 and dispose of as hazardous waste.
19	HPC/Fifth/Communa l, R07 Refuse chute room	Ceiling	Artex on concrete	2.5	Chrysotile	As S01	Remove artex in accordance with the Control of Asbestos Regulations 2012 and dispose of as hazardous waste.
20	HPC/Fifth/Communa l, R07 Refuse chute room	Wall	Artex on concretel	12	Chrysotile	As S04	Remove artex in accordance with the Control of Asbestos Regulations 2012 and dispose of as hazardous waste.
21	HPC/Fifth/Communa l, R07 Refuse chute room	Floor	Bitumen on floor slab below floor covering	2.5	Chrysotile	As S03	Remove bitumen in accordance with the Control of Asbestos Regulations 2012 and dispose of as hazardous waste.

Summary of Asbestos Identified and/or Presumed.							
Item	Location	Position	Description	Quantity m2	Type of Asbestos	Level of ID	Recommendations
22	HPC/Fifth/Communa I, R08 Corridor	Ceiling	Artex on concrete	6	Chrysotile	As S01	Remove artex in accordance with the Control of Asbestos Regulations 2012 and dispose of as hazardous waste.
23	HPC/Fifth/Communa I, R08 Corridor	Wall	Artex on concrete	9.5	Chrysotile	As S04	Remove artex in accordance with the Control of Asbestos Regulations 2012 and dispose of as hazardous waste.
24	HPC/Fifth/Communa I, R08 Corridor	Floor	Bitumen on floor slab below floor covering	6	Chrysotile	As S03	Remove bitumen in accordance with the Control of Asbestos Regulations 2012 and dispose of as hazardous waste.
27	HPC/Fifth/Communa I, R09 Riser	Pipework	Pitch fibre S&V pipe	2.5 linm	Chrysotile	As S01/6	Remove Pitch fibre pipe in accordance with the Control of Asbestos Regulations 2012 and dispose of as hazardous waste.

29	HPC/Fifth/Flat 71, R01 Hallway	Ceiling	Artex on concrete	4.5	Chrysotile	As S05	Remove artex in accordance with the Control of Asbestos Regulations 2012 and dispose of as hazardous waste.
31	HPC/Fifth/Flat 71, R01 Hallway	Floor	Bitumen on floor slab below floor covering	4.5	Chrysotile	As S06	Remove bitumen in accordance with the Control of Asbestos Regulations 2012 and dispose of as hazardous waste.
32	HPC/Fifth/Flat 71, R02 Bathroom	Ceiling	Artex on concrete	2.5	Chrysotile	As S05	Remove artex in accordance with the Control of Asbestos Regulations 2012 and dispose of as hazardous waste.
34	HPC/Fifth/Flat 71, R02 Bathroom	Floor	Bitumen on floor slab below floor covering	1.5	Chrysotile	As S06	Remove bitumen in accordance with the Control of Asbestos Regulations 2012 and dispose of as hazardous waste.
44	HPC/Fifth/Flat 71 R06 Toilet	Ceiling	Artex on concrete	2	Chrysotile	As S05	Remove artex in accordance with the Control of Asbestos Regulations 2012 and dispose of as hazardous waste.

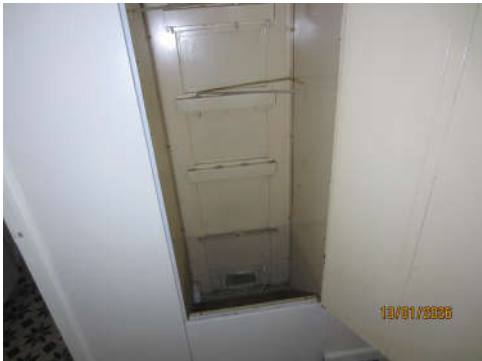
Level of ID:	Visually inspected	Ref:	
	<p>Building / Floor: HPC / Fifth</p> <p>Area: Flat 71, R03 Drying cabinet</p> <p>Location: Wall</p> <p>Description: Metal</p> <p>Asbestos Type: No suspect material</p> <p>Amount:</p>

No action required

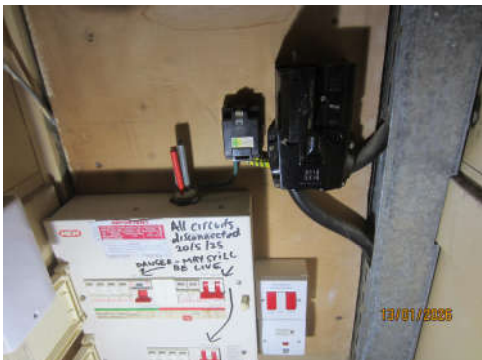
Level of ID:	Visually inspected	Ref:	
	<p>Building / Floor: HPC / Fifth</p> <p>Area: Flat 71, R04 Electric cupboard</p> <p>Location: Wall</p> <p>Description: Stud wall, timber backing panel, modern electrics</p> <p>Asbestos Type: No suspect material</p> <p>Amount:</p>

No action required

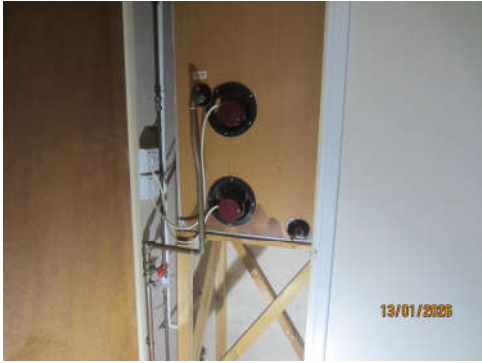
Level of ID:	Visually inspected	Ref:	
	Building / Floor: HPC / Fifth Area: Flat 71, R05 Tank cupboard Location: Wall Description: Stud wall, modern tank & insulation Asbestos Type: No suspect material Amount:			
Recommendations:				
No action required

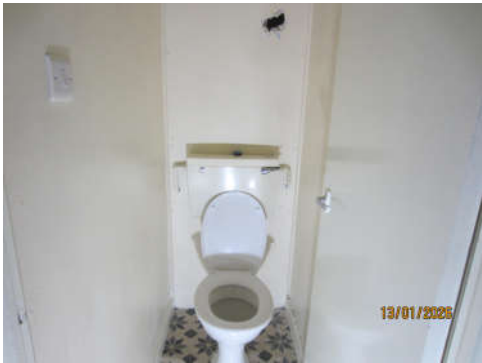
Level of ID:	Visually inspected	Ref:	
	Building / Floor: HPC / Fifth Area: Flat 71 R06 Toilet Location: Wall Description: Stud wall, Supalux IPS and divider panel Asbestos Type: No suspect material Amount:			
Recommendations:				
No action required

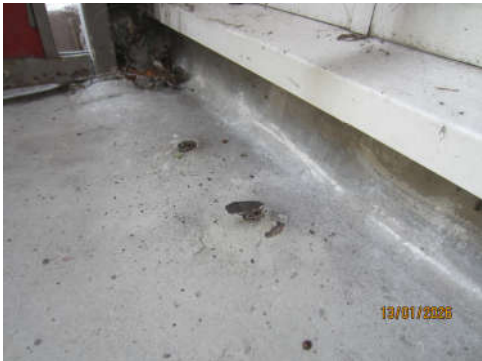
Level of ID:	Sampled	Ref:	S07
	Building / Floor: HPC / Fifth Area: Flat 71 Balcony Location: Floor Description: Ashphalt Asbestos Type: No asbestos detected Amount:

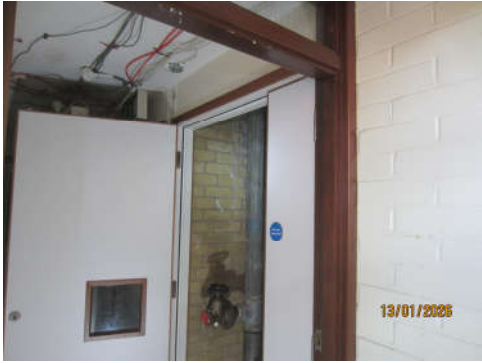
Level of ID:	Visually inspected	Ref:	
	Building / Floor: HPC / Seventh Area: Communal, R09 Riser Location: Pipework Description: Flange gasket to pipework Asbestos Type: No suspect material Amount:			
Recommendations:				
No action required

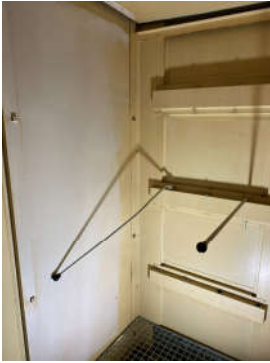
Level of ID:	Visually inspected	Ref:	
	<p>Building / Floor: HPC / Seventh</p> <p>Area: Flat 57, R03 Drying cabinet</p> <p>Location: Wall</p> <p>Description: Metal</p> <p>Asbestos Type: No suspect material</p> <p>Amount:</p>			
Recommendations:				
No action required

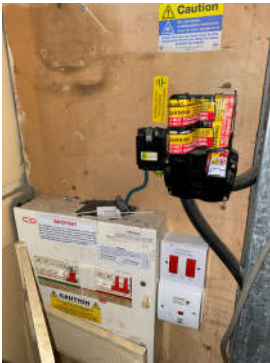
Level of ID:	Visually inspected	Ref:	
	<p>Building / Floor: HPC / Seventh</p> <p>Area: Flat 57, R04 Electric cupboard</p> <p>Location: Wall</p> <p>Description: Stud wall, timber backing panel, modern electrics</p> <p>Asbestos Type: No suspect material</p> <p>Amount:</p>			
Recommendations:				
No action required

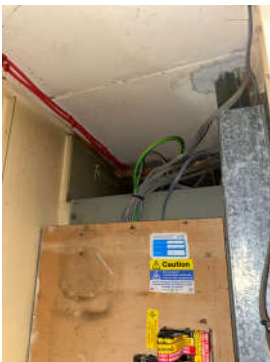
Level of ID:	Visually inspected	Ref:	
	<p>Building / Floor: HPC / Seventh</p> <p>Area: Flat 57, R05 Tank cupboard</p> <p>Location: Ceiling</p> <p>Description: Concrete</p> <p>Asbestos Type: No suspect material</p> <p>Amount:</p>			
Recommendations:				
No action required

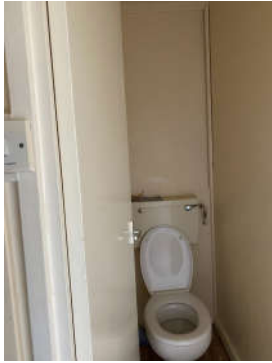
Level of ID:	Visually inspected	Ref:	
	<p>Building / Floor: HPC / Seventh</p> <p>Area: Flat 57 R06 Toilet</p> <p>Location: Wall</p> <p>Description: Stud wall, Supalux IPS and divider panel</p> <p>Asbestos Type: No suspect material</p> <p>Amount:</p>			
Recommendations:				
No action required
