ROAD SAFETY AUDIT- STAGE 1

Proposed Residential Development

Chapelgate, Hepworth

Chippings, Hepworth
Proposed Access & Internal Layout
Stage 1 Road Safety Audit

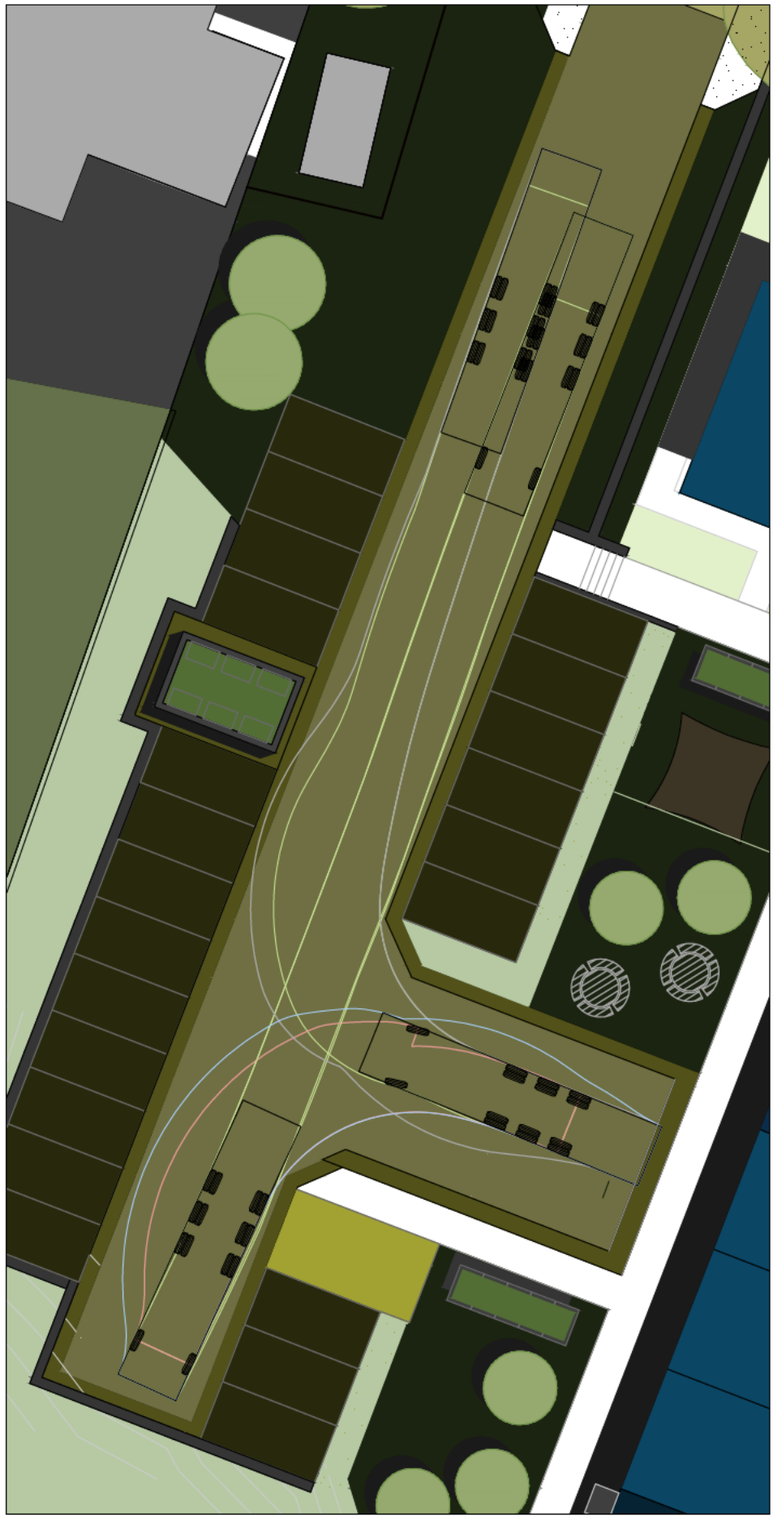
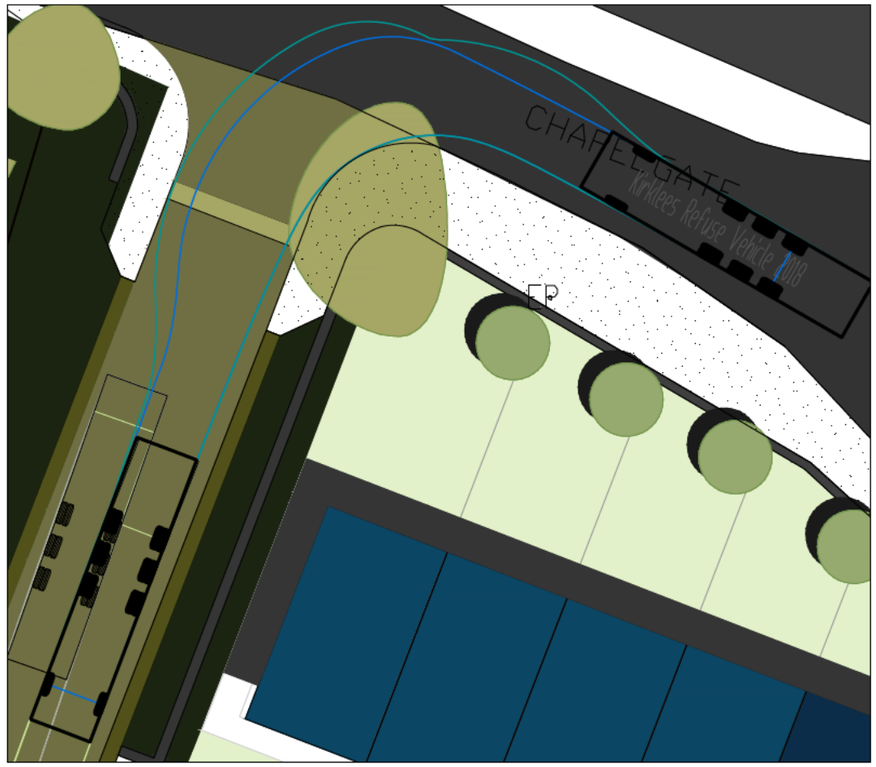
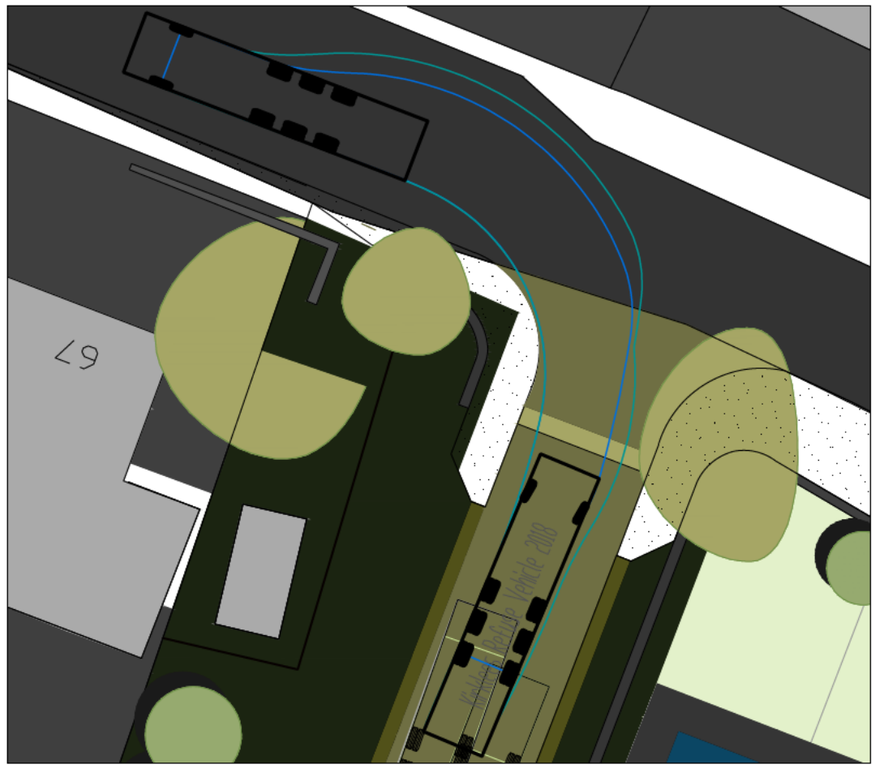
FIGURE 3

The proposed turning head may lead to large vehicles reversing over excessive distances.

OVERALL LENGTH	11.850m
OVERALL WIDTH	2.500m
OVERALL BODY HEIGHT	3.749m
MIN BODY GROUND CLEARANCE	0.302m
TRACK WIDTH	2.490m
LOCK TO LOCK TIME	6.00s
WALL TO WALL TURNING RADIUS	11.000m

SWEPT PATH ANALYSIS

Recommendation accepted – The swept path analysis was undertaken by the 11.85m refuse vehicle however there is a discrepancy in the architect's plan regarding the vehicle dimensions. This is shown on the revised site layout.

Recommendation accepted – The footway routing along the eastern boundary has been re-aligned in order to achieve adequate visibility for cars to see any pedestrians existing the site onto Dean Bridge Lane. This is shown on the revised site layout.
