**Phase I Environmental Site Assessment**

**Units 1-9, Centre 27, Bankwood Way Birstall,  
Leeds, WF17 9TB**

**Delta-Simons Project No. 14-0672.01**

**PHASE I ENVIRONMENTAL SITE ASSESSMENT**  
**UNITYS 1-9, CENTRE 27, BANKWOOD WAY, BIRSTALL, LEEDS, WF17 9TB**  
**DELTA-SIMONS PROJECT NUMBER: 14-0672.01**

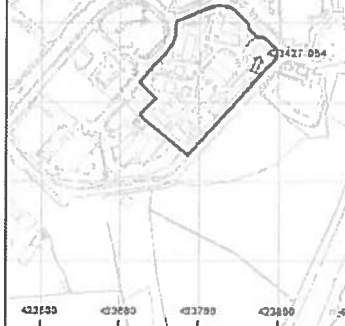
| <b>Coal Mining Risk</b> | <p>The Site is located within an area which may potentially be affected by coal mining, with maps showing a coal seam outcropping on the Site and two BGS boreholes highlighting shallow former mine workings.</p> <p>A Coal Authority report dated June 2014 indicates that the Site is in the likely zone of influence from workings in 6 seams of coal at shallow to 240 m depth, last worked in 1920. The Site is not in the likely zone of influence of any present underground coal workings. Future workings for coal are unlikely. There is one mine entry shown within or within 20 m of the Site. The approximate location is shown in the extract from the Coal Authority Report, as follows:</p> |

| | <p>Reproduced by permission of Ordnance Survey on behalf of HMSO. © Crown copyright and database right 2014. All rights reserved. Ordnance Survey Licence number: 100020315</p> <p><b>Key</b></p> <p>Approximate position of enquiry boundary shown </p> <p>Disused Adit or Mineshaft </p> | |

| | <p>There are no records of what steps, if any, have been taken to treat the mine entry. The Coal Authority Report is presented in Appendix IV.</p> | |
