## **HERITAGE IMPACT STATEMENT**

Elim Pentecostal Church  
Daisy Hill  
Dewsbury  
West Yorkshire  
WF13 1LY  
United Kingdom

Elim Pentecostal Church, formerly Central Methodist Church, is a Grade II listed building situated on Daisy Hill in Dewsbury. The west elevation faces Wellington Street and the south elevation faces Daisy Hill. The north elevation faces the adjacent property, the Registrars' office, and the east elevation faces the Magistrate's Court.

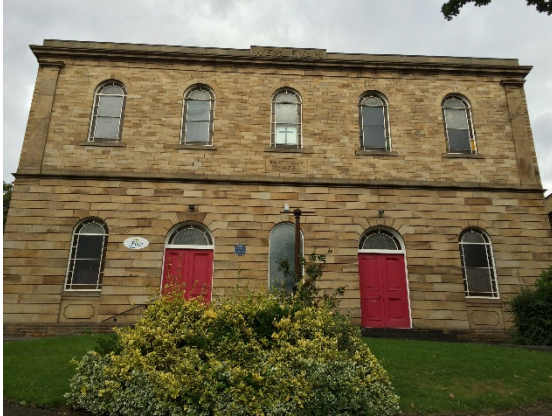
**Photo 1  
Front / South Elevation**

The building was constructed in 1839 as the Central Methodist Church. The south elevation consists of rusticated ashlar to the ground floor atop a rock faced plinth. Hammer dressed stone covers the side elevations. The south elevation is 2 storeys high with string course and a 5-bay façade. The upper floor is framed in wide flat Tuscan pilasters. The elevation is topped with a frieze, moulded eaves cornice and blocking course, the centre of which is raised and has the word WESLEYAN in raised capitals. There are five round arched 1st floor windows with marginal glazing along with three similar outer ground floor windows with apron. The central ground floor window consists of stained glass and has a memorial apron to 1st World War. There are two symmetrically placed double, panelled doors with semi-circular fanlights and a small flight of stone steps leading to each. A central tablet reads 'CENTENARY CHAPEL'. The west elevation consists of a 6-bay façade with 1st floor windows as before, and square headed ground floor windows all with marginal glazing. To the left, a further 2 bays of lower eaves height with a hipped roof.
