MILL POND ASSESSMENT

Project Number: **15271**

Client: **Mr Z Hinchcliffe**

Site Address: **Dobroyd Mills, Holmfirth**

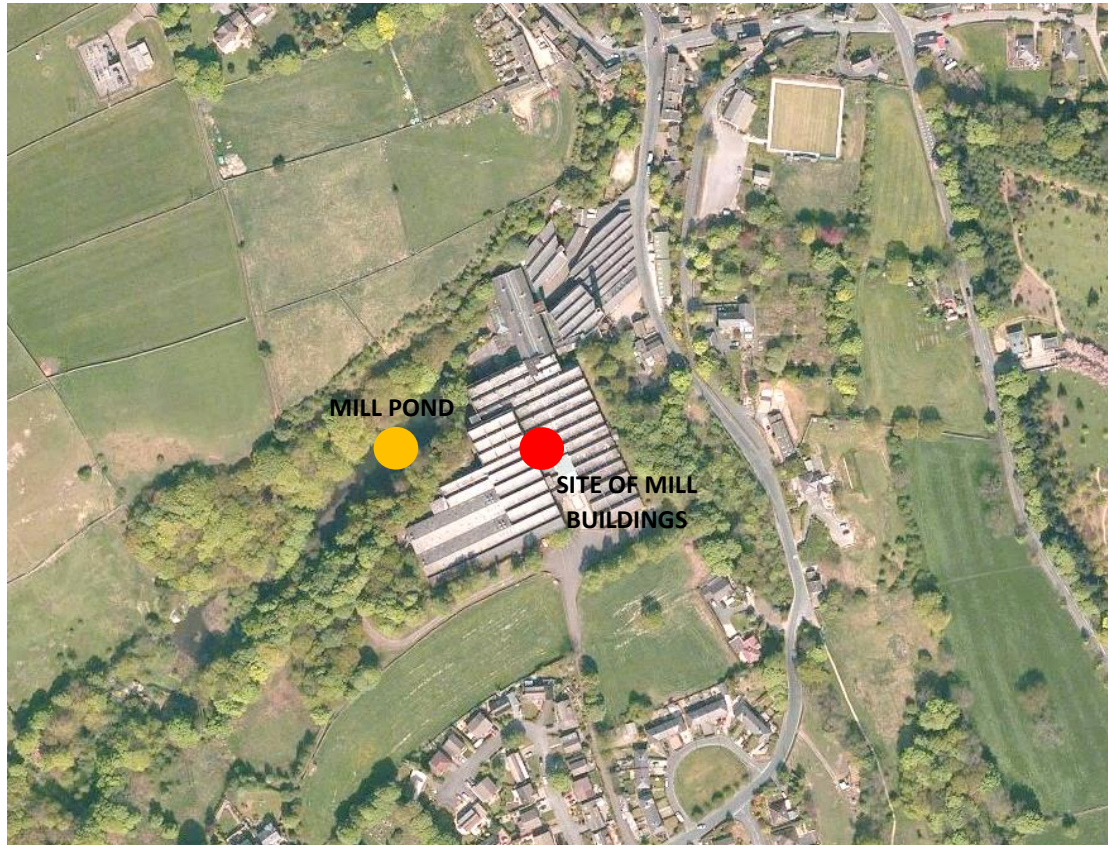
Figure 2: Aerial Photograph

As with many former mill sites within the region the Dobroyd Mills was historically powered by water driven turbines. To facilitate a constant supply of water to the turbines, an elevated mill pond was constructed. The pond is still present on site but is not currently in use and lies redundant. Figure 2 shows an aerial view of the site.

The Mill Pond is located to the Northwest of the existing mill buildings (Figure 2) and has an area of approximately 3500m² and is approximately 120m long and 30m wide. A Mill Pond Assessment undertaken by Kirklees council indicates that the Pond has a capacity of approximately 1933m³. The pond is contained within the base of a valley and its boundaries are formed largely by masonry retaining walls. The Pond is fed by a secondary pond immediately up stream and outfalls to a culvert which passes beneath the mill buildings.
