**ARBORICULTURAL METHOD STATEMENT
to BS 5837:2012
at
Holme House
Oxford Road
Cleckheaton
West Yorkshire
BD19 4LA**

Client:
Croft Care Group

JCA Ref:
13931d/ChC

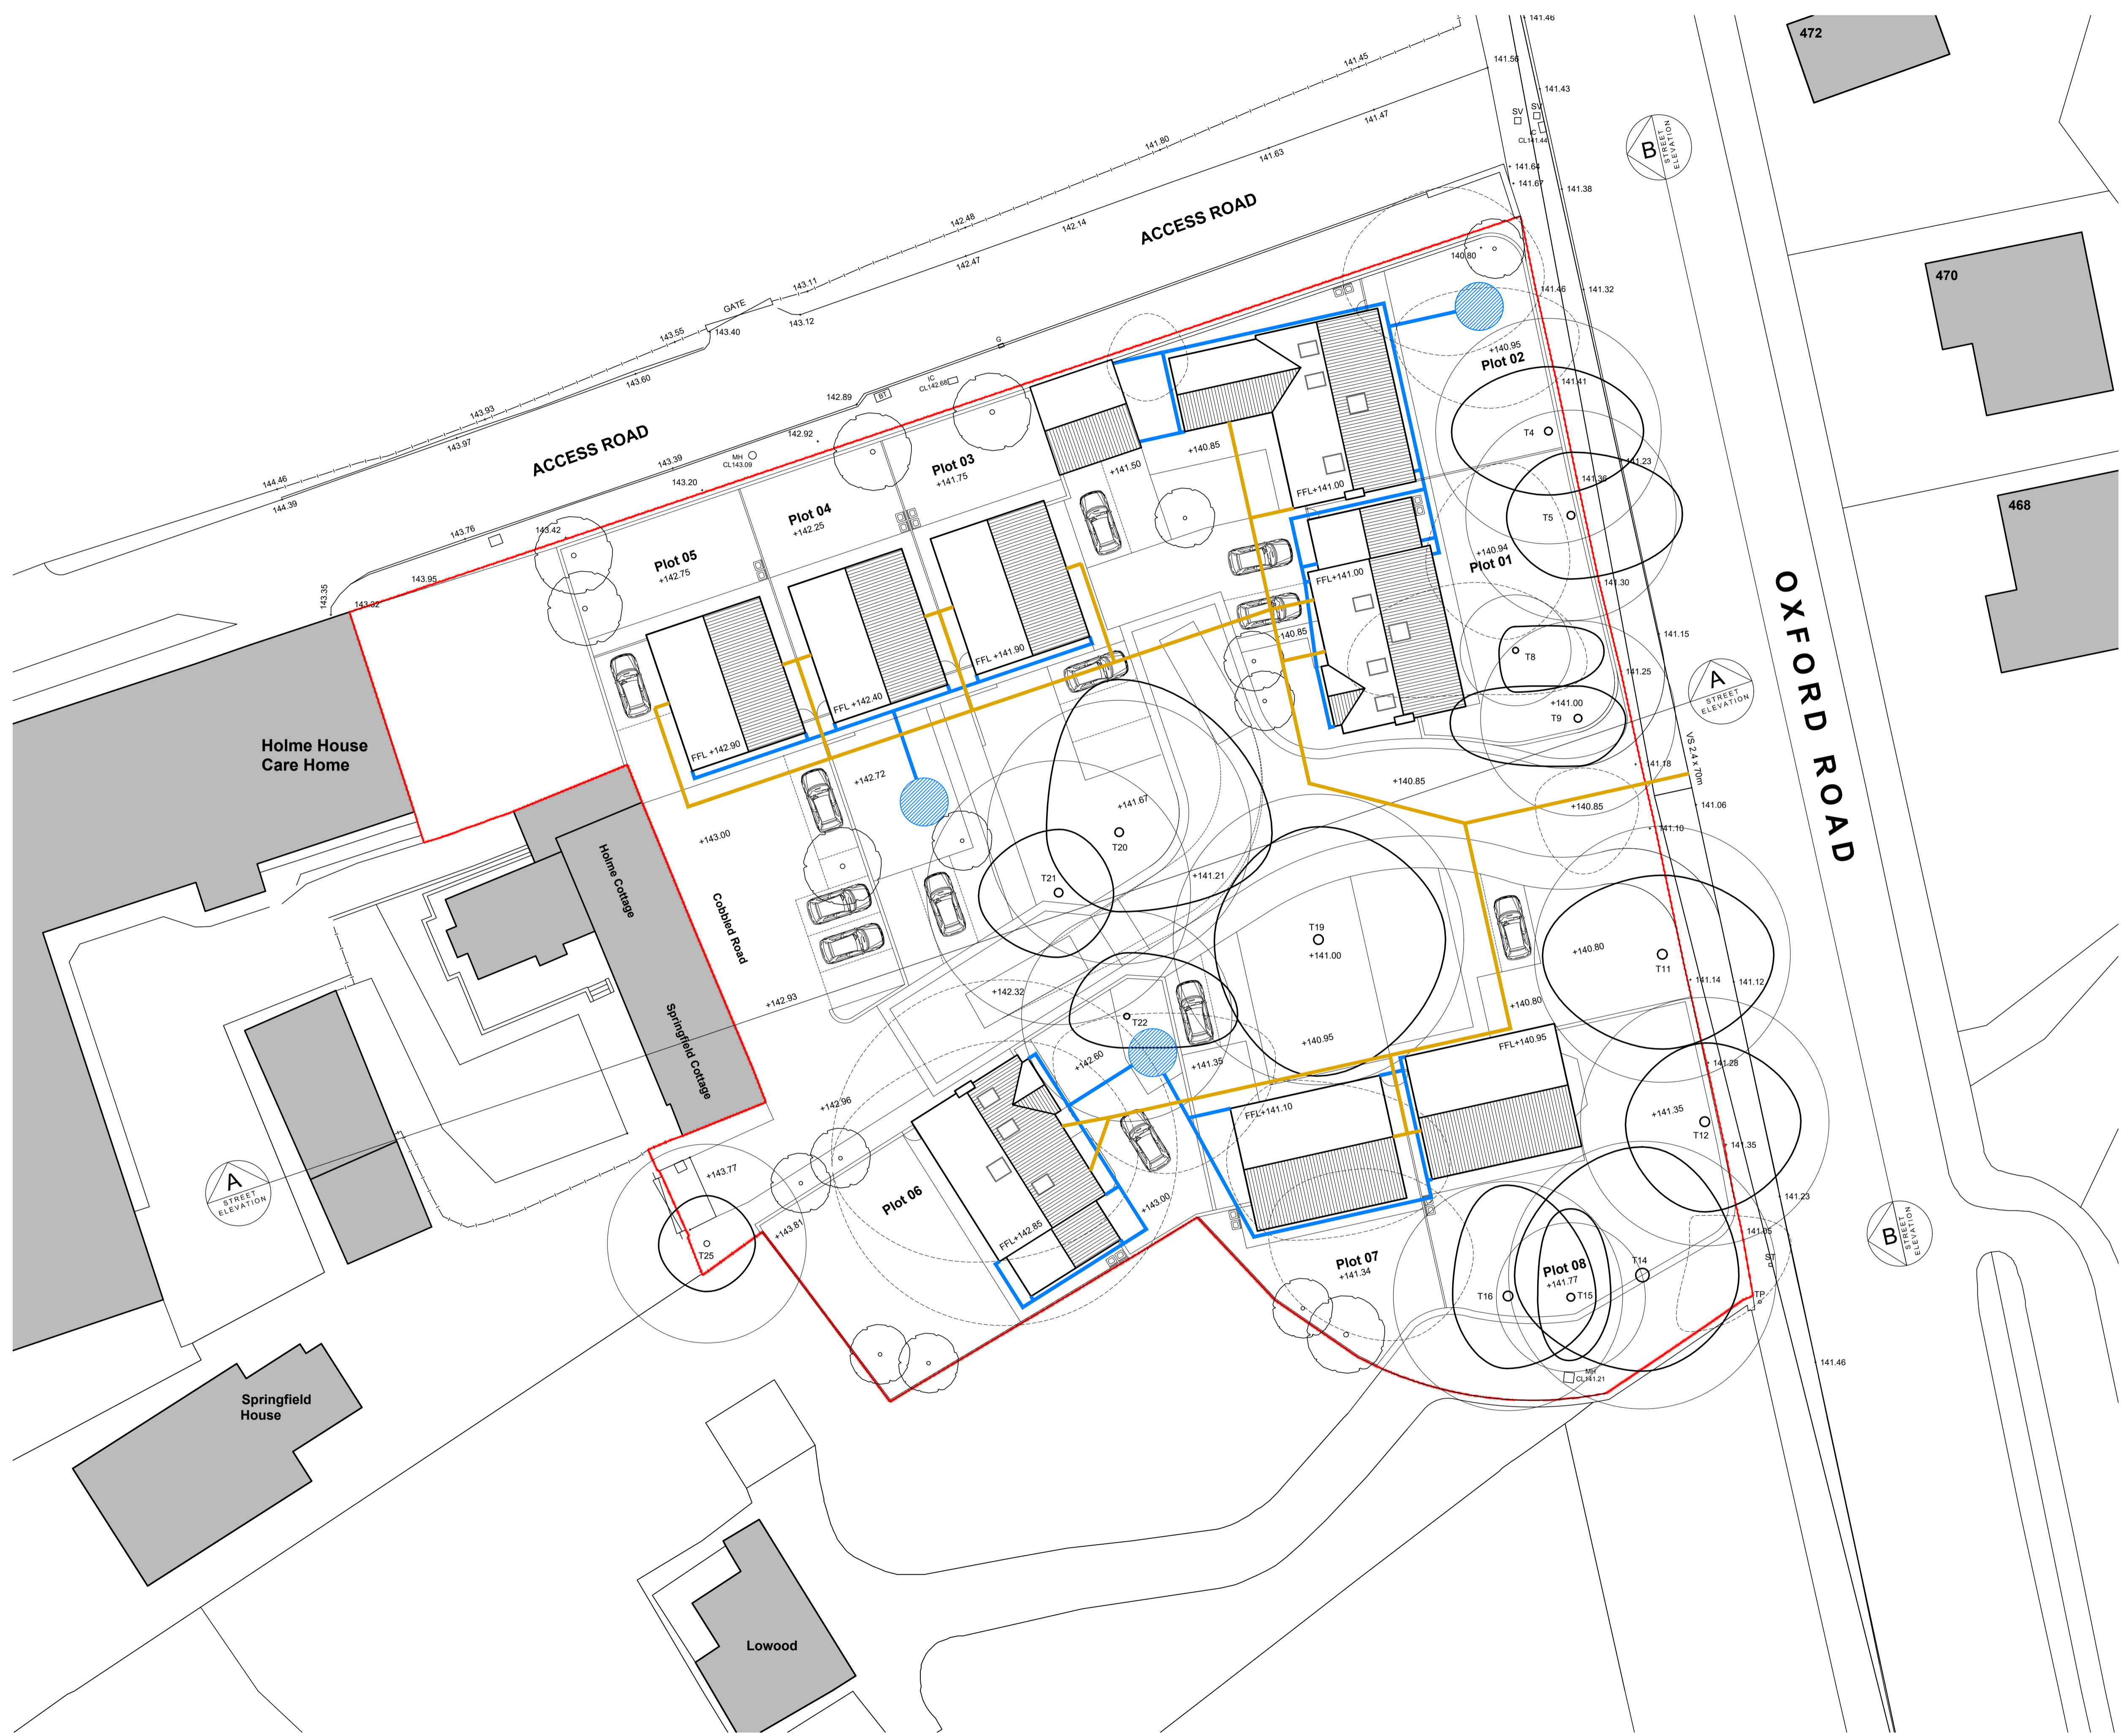
- Indicative Foul Route
- Indicative Surface Water Route
- Soakaway [5m from dwelling]
