**HUDDERSFIELD TOWN AFC  
CANALSIDE CAMPUS**

**INITIAL SITE INVESTIGATION  
REVIEW SUMMARY**

**REVISION S1**

**PROJECT 6981**

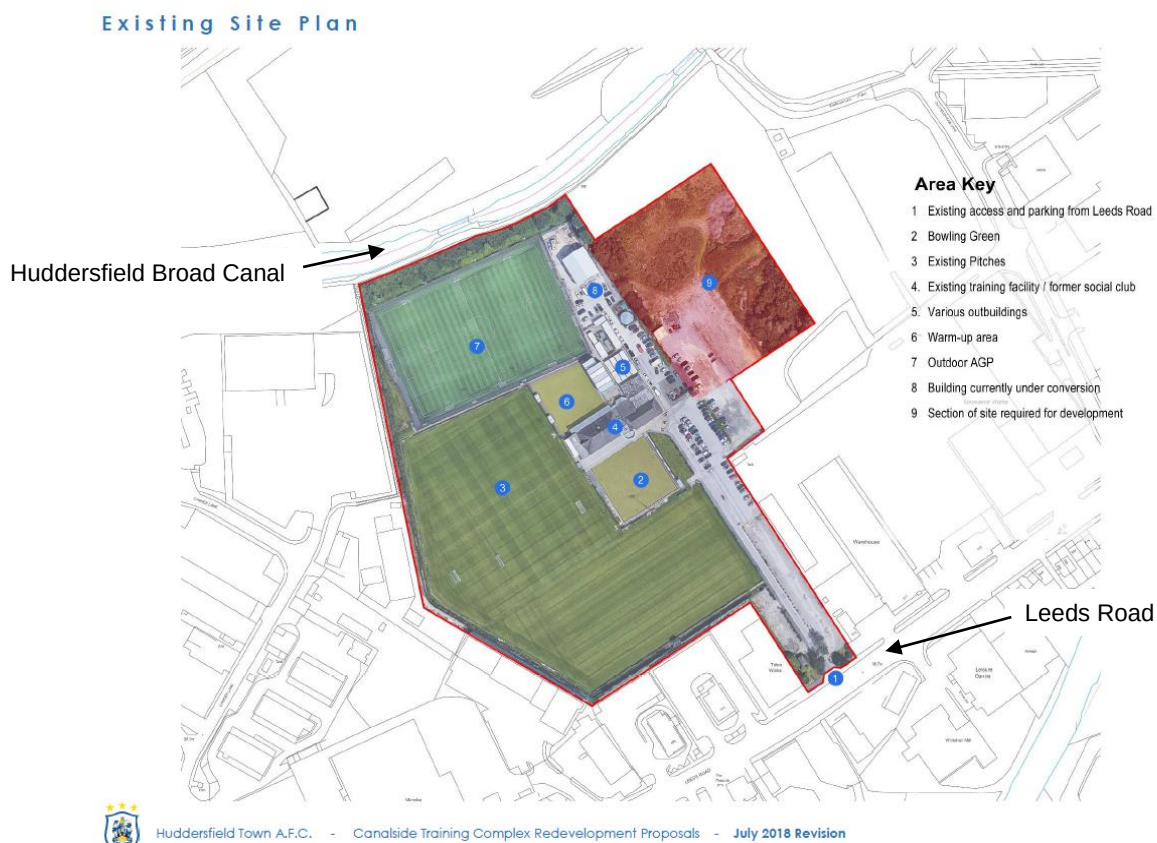
The site is currently occupied by football training facility/former social club, pitches, bowling green, car parking and outbuildings.

Figure 1: Existing site plan

The site is located between Leeds Road and the southern side of the Huddersfield Broad Canal in Huddersfield. There are two locks on the Canal in the section along the northern site boundary. The development site is centred around national grid reference (NGR) 415664, 418362 and ground level is around 57m AOD. Site area is around 64,156 m<sup>2</sup>.
