Job			
Black Bull 11 Market Place Dewsbury			
Drawing title			
Proposed Works First Floor Fire Exit Door			
Date	Scale@A2		
January 2018	1: 20		
Drawing No.	Drawn by	Rev	
4221-PL-14	DDA	-	
ARCTIC ASSOCIATES LTD 33 Queen Street Morley Leeds, LS27 8EE T: 0113 263 7040 design@arctic-associates.co.uk www.arctic-associates.co.uk <small>Information contained within representation</small>

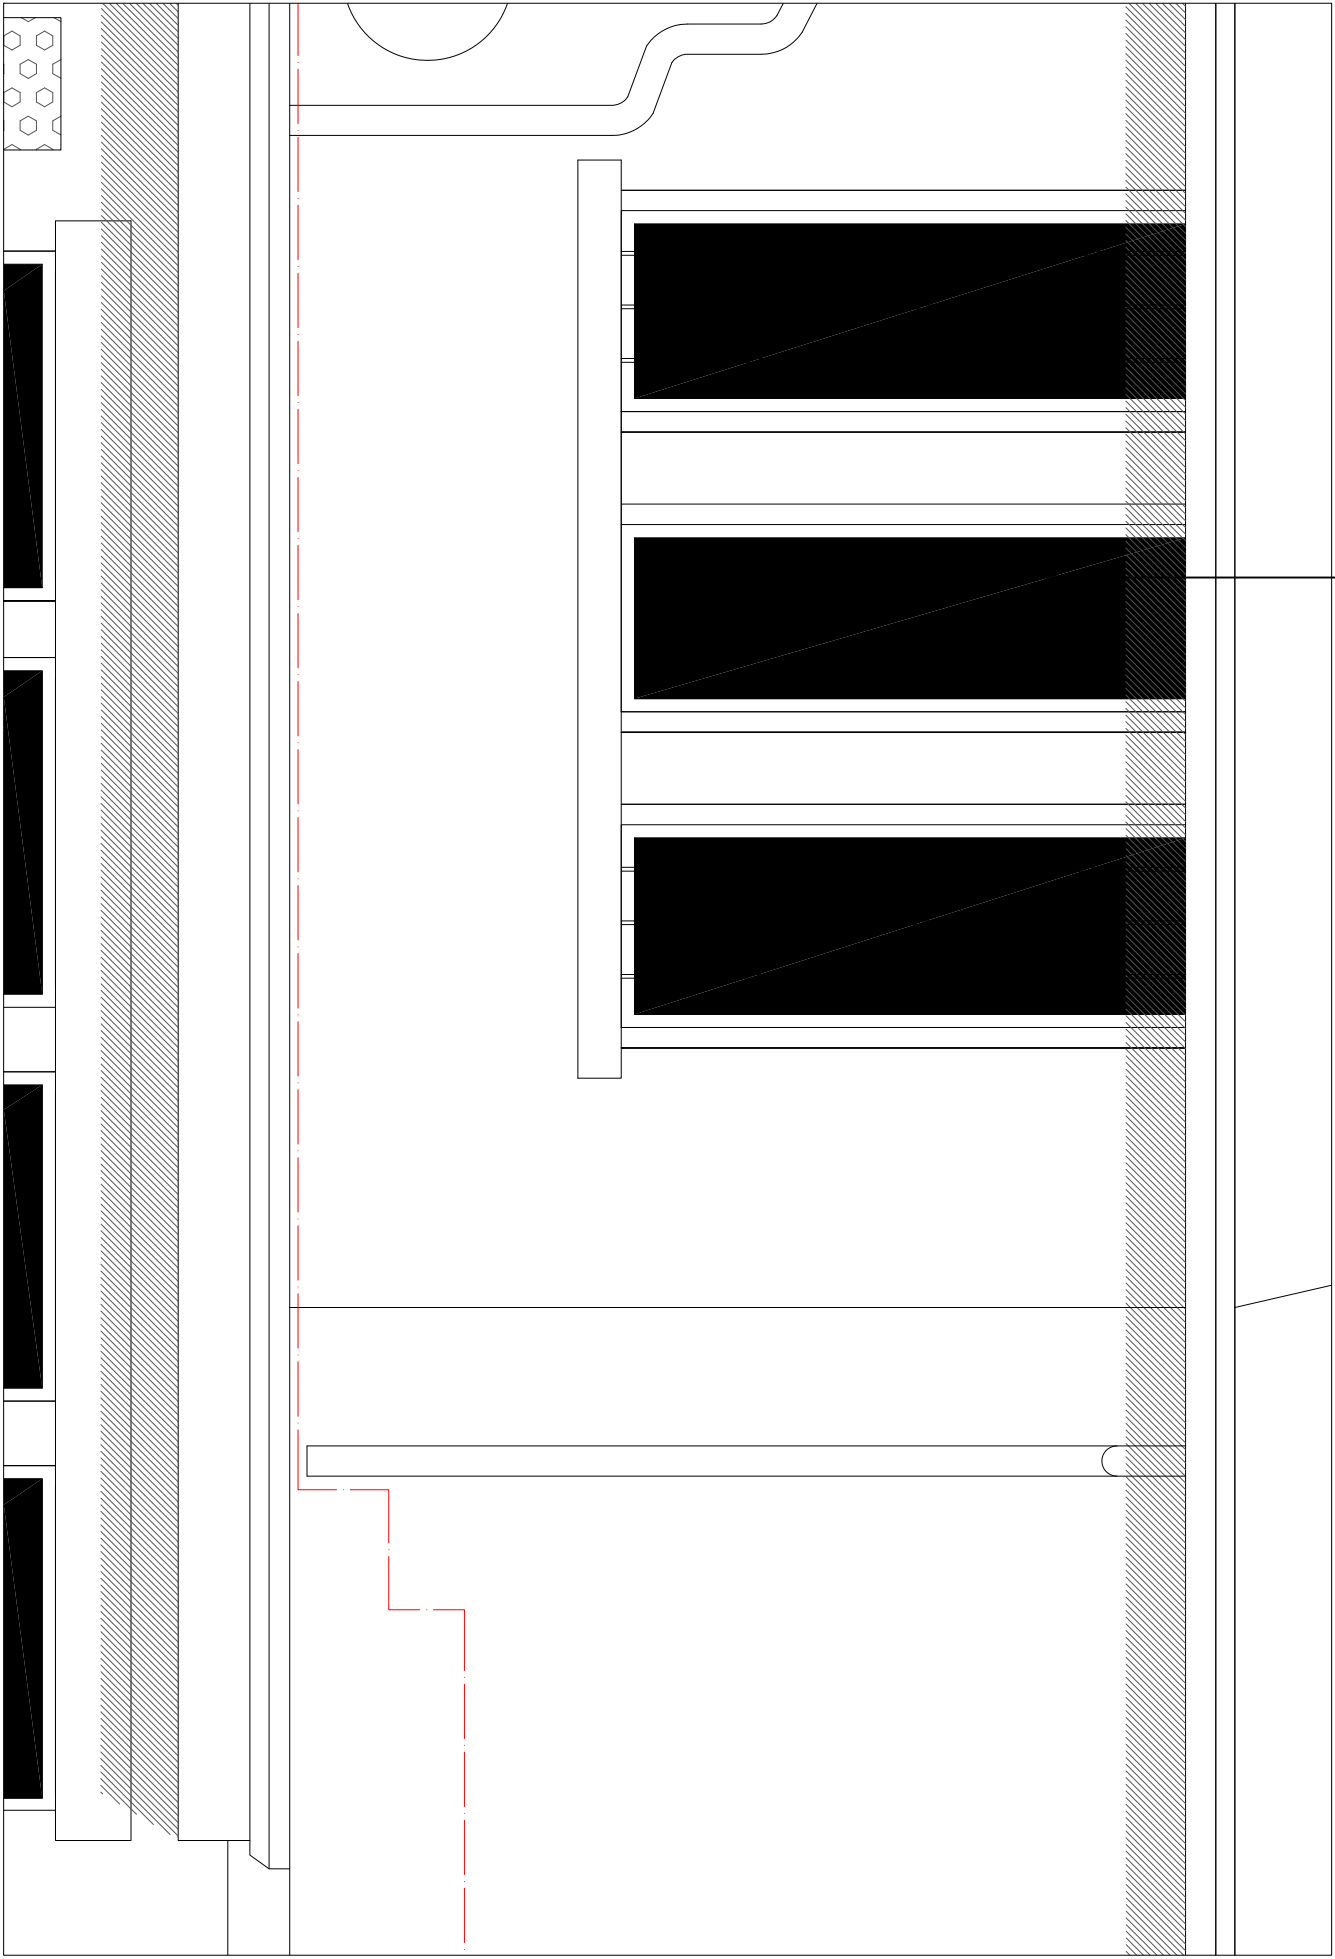
Existing timber frame sash windows protected with perforated metal Sheet and security bars.

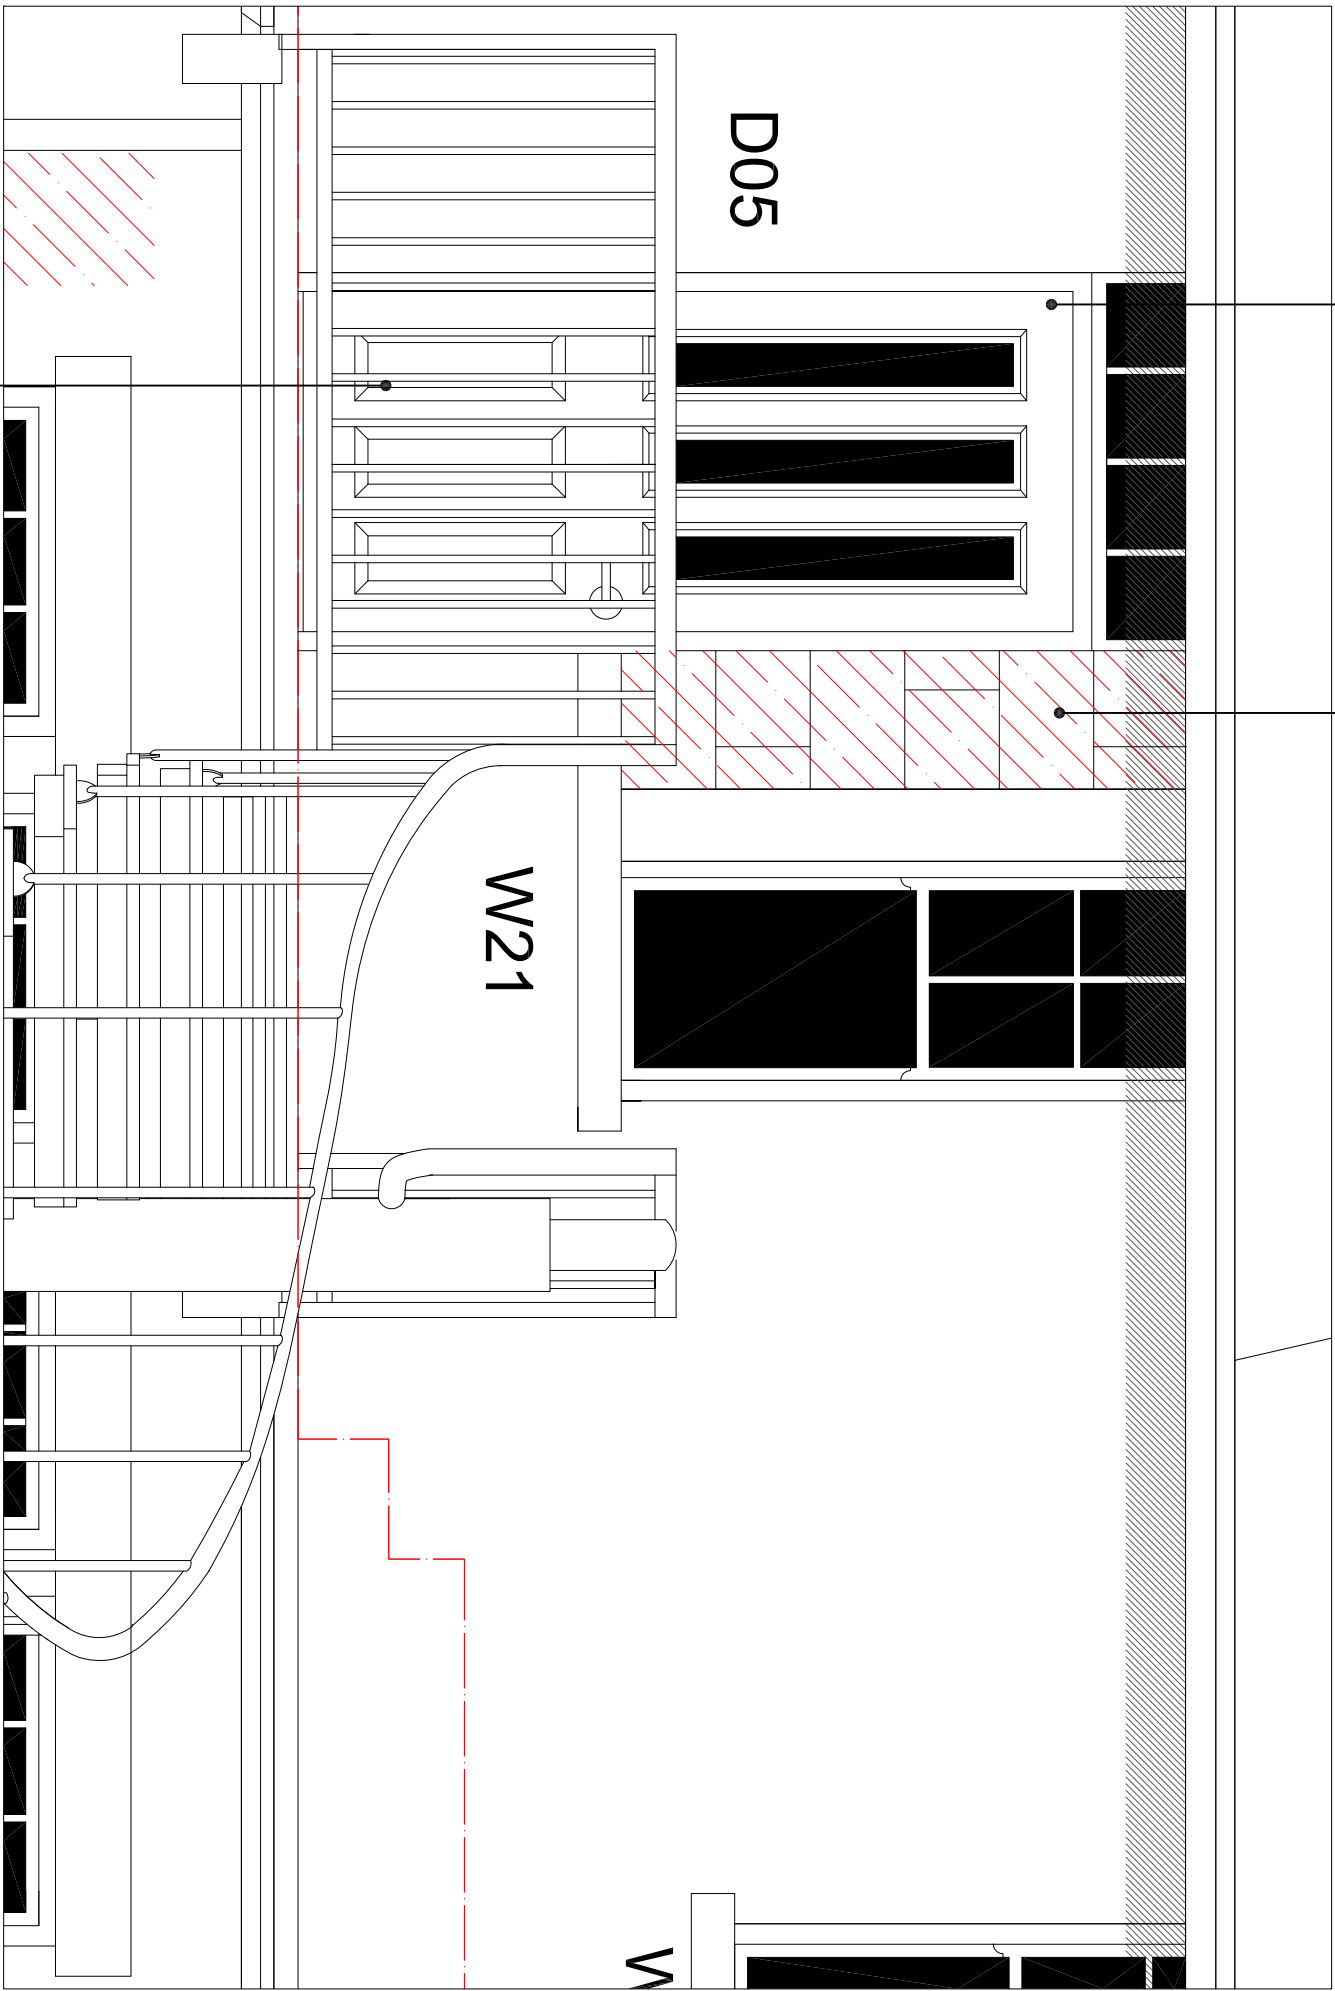
Existing rainwater pipe draining internal enclosed gutter to be removed.

Stone sill to be cut to suit new opening.

New hard wood glazed timber door to replace existing windows. Colour to be confirmed.

Central window to be sealed with stone to match existing wall.
